NEDIES PROJECT

Lessons Learnt from Maritime Disasters

EUR 20409 EN

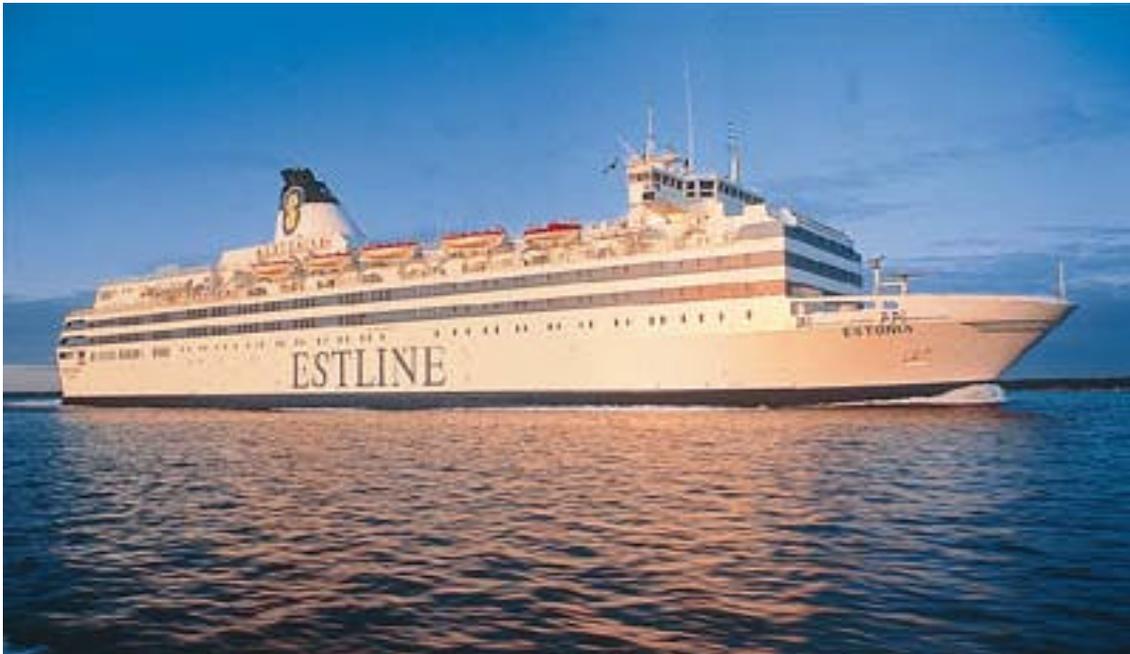
*Figure 2.1.a - The ro-ro passenger ferry ESTONIA.
© Accident Investigation Board Finland*

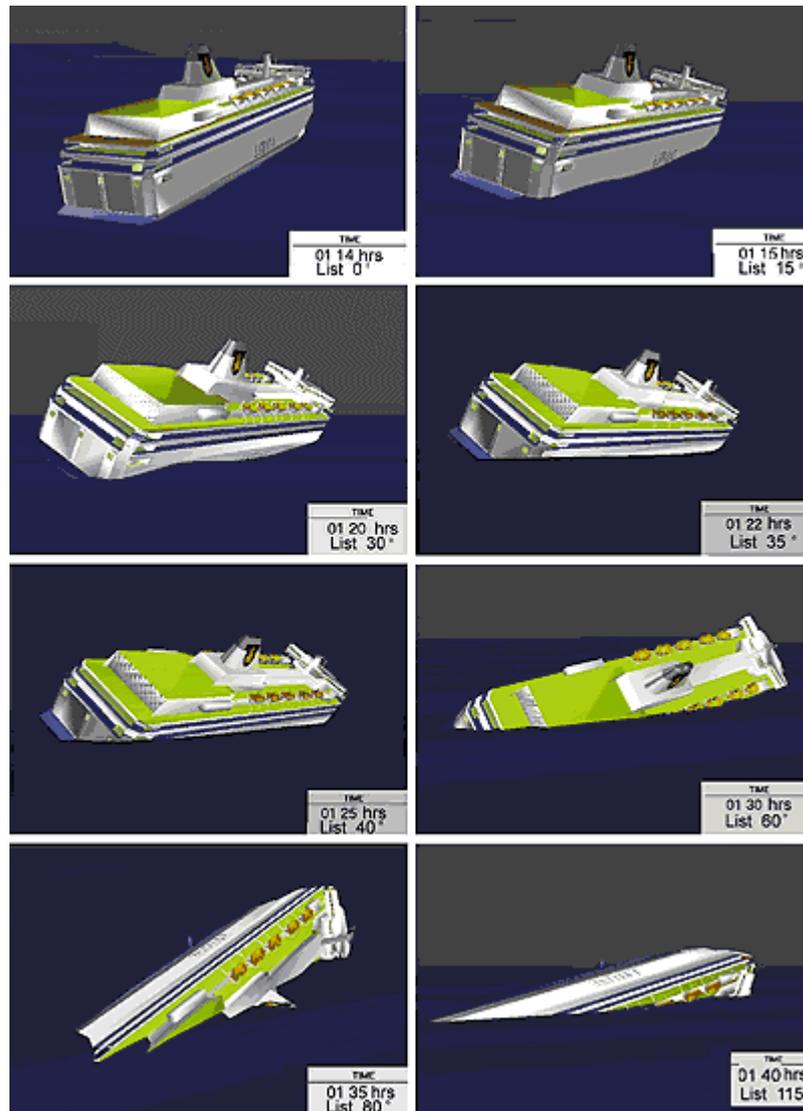
*Figure 2.1.c - Computer-generated pictures illustrating the development of the list and sinking of the vessel.
© Accident Investigation Board Finland*

- The ESTONIA capsized due to large amounts of water entering the car deck, loss of stability and subsequent flooding of the accommodation decks.
 - Large amounts of water entered the car deck and in a few minutes a starboard list of more than 15° developed.

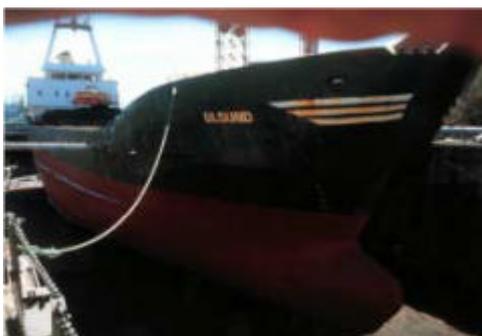
Figure 2.3.a – The MV Ulsund.
© Accident Investigation Board Finland
