The L'Aquila (Italy) earthquake of 6 April 2009: report and analysis from a field mission

Anna Bosi, Francesco Marazzi, Artur Pinto

European Commission, Joint Research Centre, IPSC, ELSA, via E. Fermi 2749, TP 480, I-21027 Ispra (VA), Italy

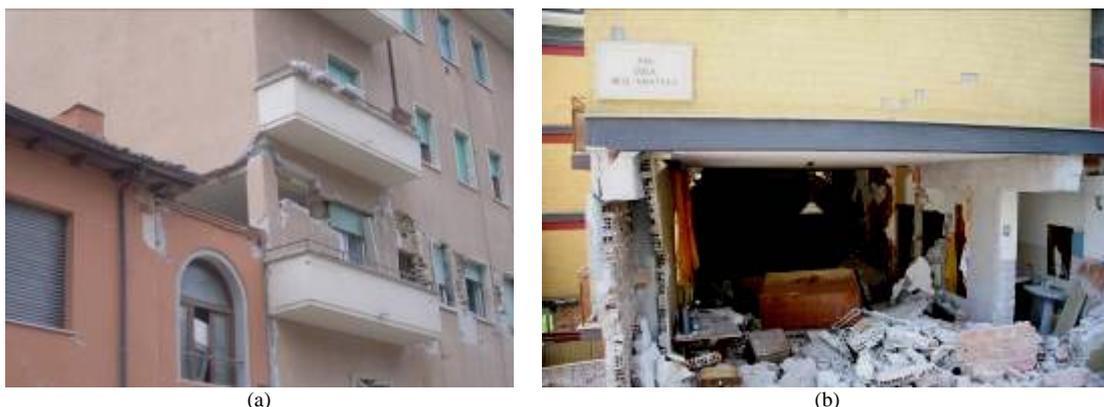
Figure 3.1: Examples of insufficient conceptual design.

Figure 3.1a shows two adjacent buildings with floors not coinciding in elevation, which is an example of insufficient conceptual design. As a result of pounding, the reinforced concrete frame was severely damaged at the storey that corresponds to the roof of the stiffer masonry building.

It was common practice in the past to arrange frames in one of the main directions of the building, as show in Figure 3.1b, which resulted in low strength and stiffness in the other direction. This building was probably excited mainly in the strong direction, as evidenced also by the out-of-plane collapse of the external walls in the weak direction.

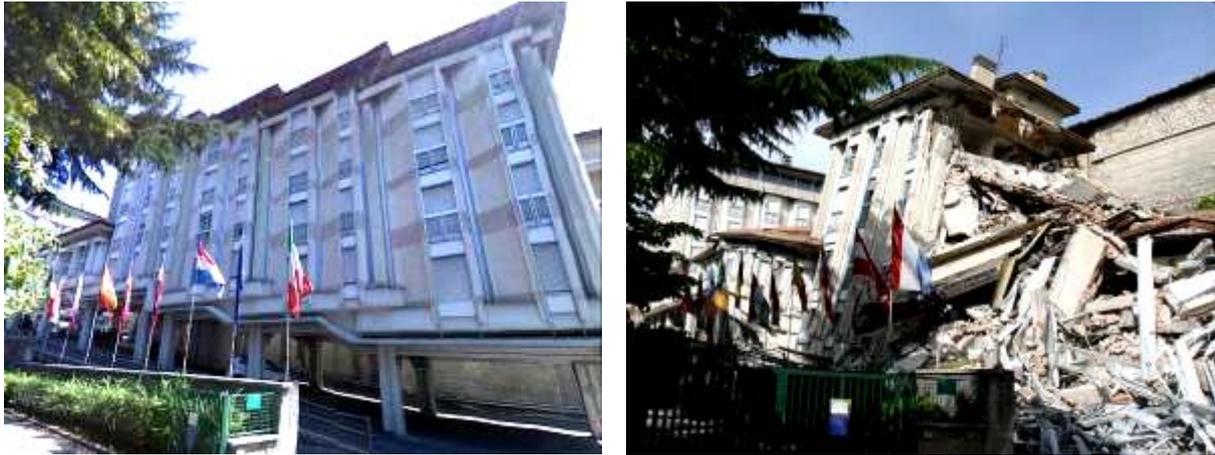
Figure 3.2: Damage due to irregularities in elevation

Figure 3.2a shows a 4-storey building before the earthquake (source: Google Maps). In addition to the open ground storey, the slabs of each bay were constructed at different heights so as to follow the natural slope. These irregularities in elevation contributed to the collapse shown in Figure 3.2b, although other seismic deficiencies, such as use of smooth rebars and lack of stirrups, were observed. It is noted that the part of the building that was standing on level ground (left side of Figure 3.2b) did not collapse.

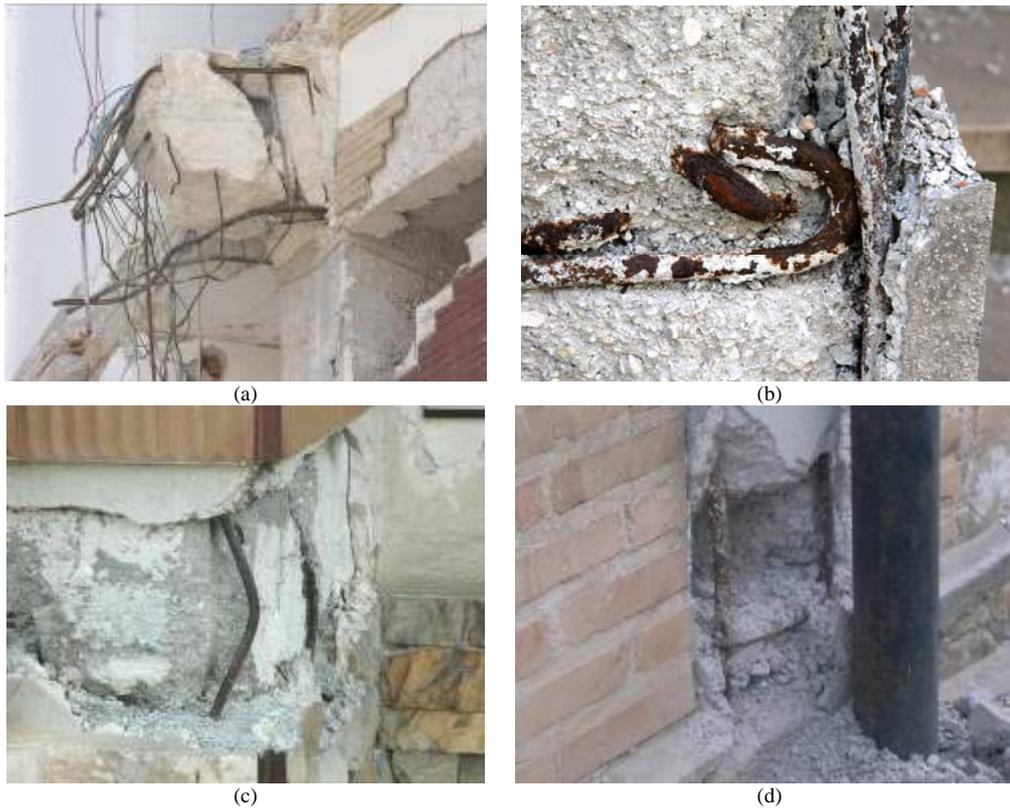
Figure 3.3: Insufficient detailing of reinforcement

Detailing of longitudinal and transverse reinforcement did not conform to requirements that ensure local ductility of structural elements. Smooth rebars were used in most of the damaged buildings and were therefore pulled out of the concrete, as shown in Figure 3.3a. Another common feature was the presence of hooks at the end of the rebars, which may not provide sufficient anchoring. In the case of external joints it was observed that the horizontal rebars with hooks were pushing the vertical rebars and the concrete cover out of the joint, Figure 3.3b. The absence of transverse reinforcement resulted in buckling of vertical rebars, Figure 3.3c, lack of confinement of concrete in the critical regions, Figure 3.3d, as well as reduced shear resistance.

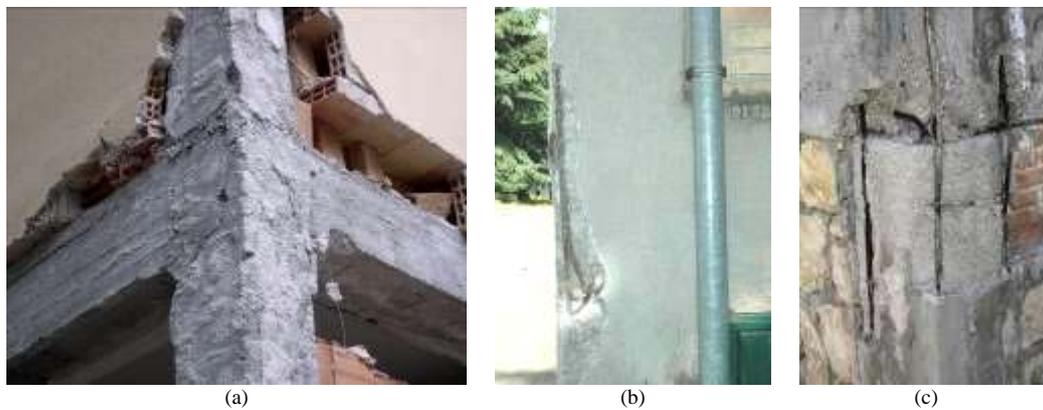
Figure 3.4: Damage to beam-column joints

Shear damage of a joint, evidenced by diagonal cracks, is shown in Figure 3.4a. In the majority of the examined old buildings, there were no stirrups within the joint and very few in the critical regions of framing beams and columns. Splicing of longitudinal rebars was often done within the joint, Figure 3.4b. Sliding failure was commonly observed at the cross-section at the top of columns where the casting of concrete was interrupted, Figure 3.4c. This could also be partially due to the impulse-like shaking because of the small epicentral distance.

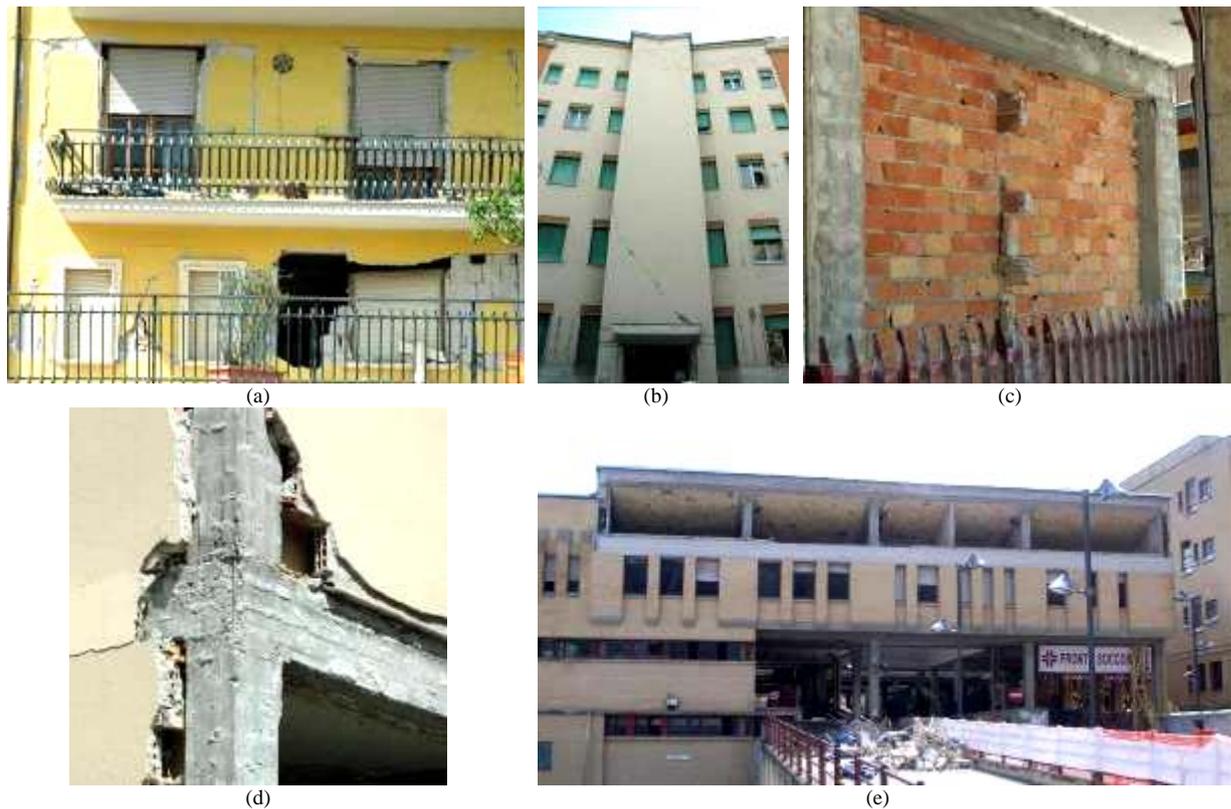
Figure 3.5: Damage of masonry infills

Diagonal cracking, separation from beams and columns and partial collapse was observed on many masonry infills, e.g. Figure 3.5a. A recurrent feature was the continuous façade or envelope of buildings that behaved like a free-standing masonry wall independent of the frame structure but was not designed as such. Figure 3.5b shows diagonal cracking at the base of a 4-storey high external wall. Similar damage of masonry infills was observed also in new reinforced concrete frames and will be discussed in the following section.

Figure 3.5e shows the building that housed the First Aid unit of the L'Aquila regional hospital. A masonry wall, reportedly carrying the hospital sign (Fanale et al, 2009), was running along the façade of the building. This wall was simply resting on the beam and lacked any lateral support along its 20-25 m and collapsed out-of-plane during the earthquake.

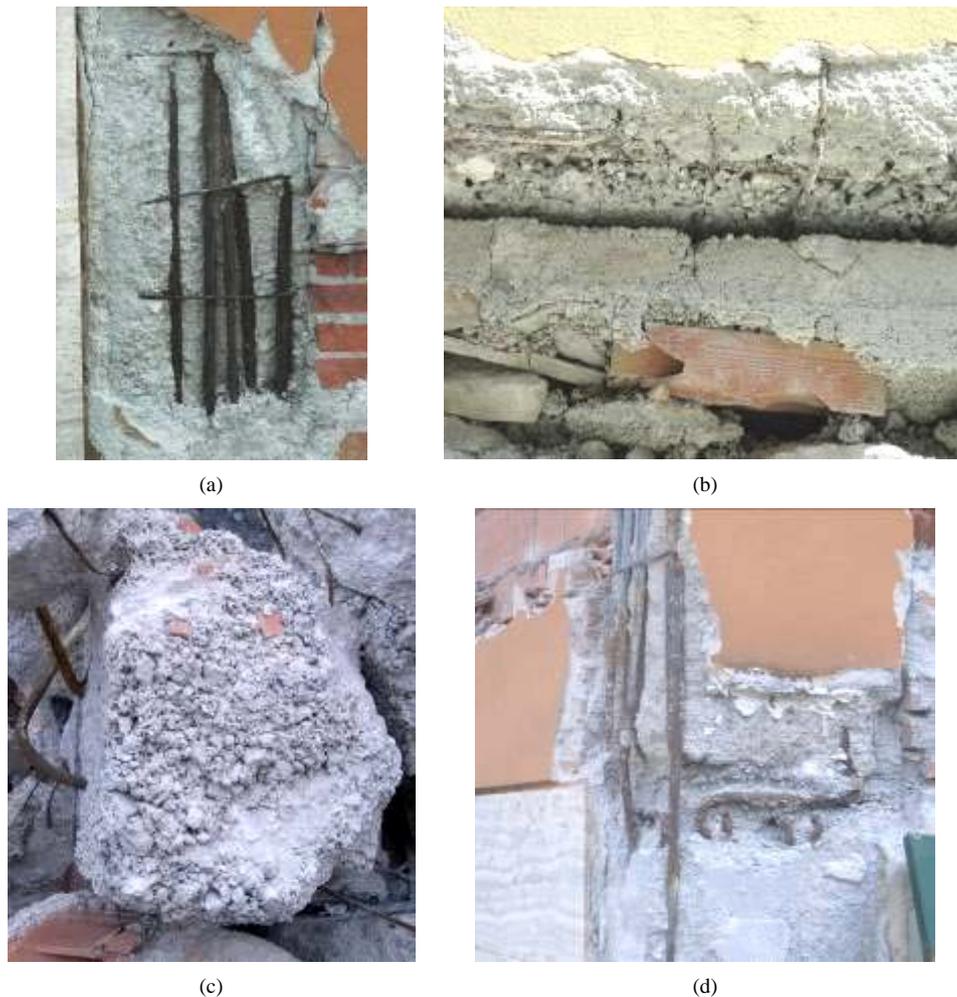
Figure 3.6: Lack of maintenance and low quality of execution and materials

Figure 3.6a shows one of the many examples of corroded longitudinal reinforcement which is attributed to insufficient concrete cover and lack of maintenance. Low quality of execution is also evidenced in Figure 3.6b which shows a beam with practically no concrete cover and concentration of aggregates at the bottom flange. Figure 3.6c shows a cross-section of a collapsed element where low quality of concrete is obvious. A corner joint is shown in Figure 3.6d, where the inappropriate anchoring and splicing of longitudinal reinforcement, the lack of stirrups and the concentration of aggregates at the bottom of the joint are shown.

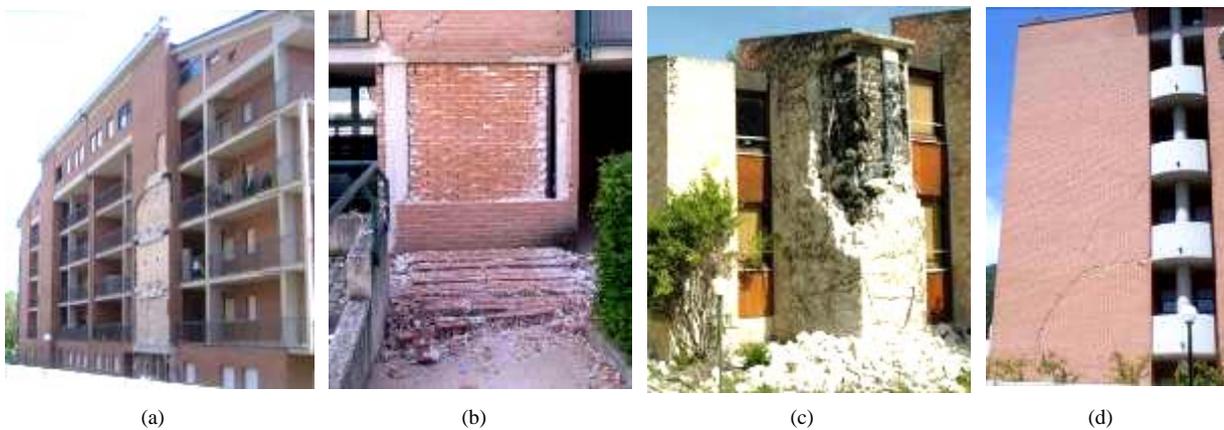
Figure 3.8: Damage of continuous masonry façades

Continuous masonry façades were common also in new reinforced concrete buildings, due to a combination of aesthetic and architectural reasons, requirements for thermal insulation as well as local building tradition. As in older buildings, façades were constructed as two-leaf walls that create a continuous envelope around the building. Due to the lack of connection between the leaves, out-of-plane collapse was frequent, as shown in Figures 3.8a and 3.8b. This type of damage is a potential cause of injury for people as well as damage to assets and installations. It is reported that collapsed infills blocked emergency exits in public buildings and that those buildings could not be used after the earthquake, even though there was no other damage.

Part of a building in the Coppito Campus of the University of L'Aquila is shown in Figure 3.8c. The building is composed of modules, as the one shown in the figure, arranged in a V-shape in plan. Part of the envelope of the building consists of a 2-storey stone masonry wall that in many cases collapsed partially, due to pounding with the reinforced concrete frame. Apart from that, the buildings in the campus suffered minor damage mainly of non-structural elements and at the time of the visit were used by the Civil Protection and some Schools of the University.

The other common type of damage to masonry façades was diagonal cracking. Figure 3.8d shows a continuous external masonry wall that extends along the six storeys of the building and apparently lacks any horizontal or vertical confining element. It was most probably constructed without any previous verification of its resistance to lateral loading. This wall actually behaved as a cantilever with some lateral restraint provided by the parapet of the balconies. Similar damage was observed in several new reinforced concrete buildings.

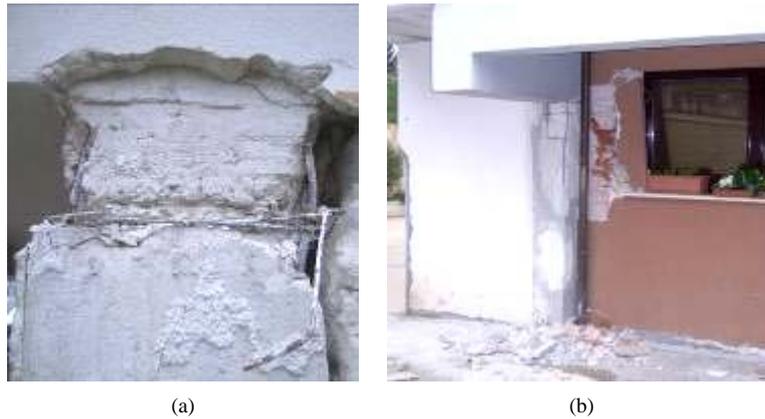
Figure 3.9: Transverse reinforcement in new reinforced concrete buildings

Figure 3.9a shows a close-up view of a column critical region in a new reinforced concrete building. The stirrups are made of smooth rebars of small diameter, with 90-degree hooks and large spacing. As a result of insufficient detailing, the stirrups are open and the longitudinal rebars are buckled. Figure 3.9b shows similar damage of a column with largely-spaced stirrups and no differentiation within the critical region.

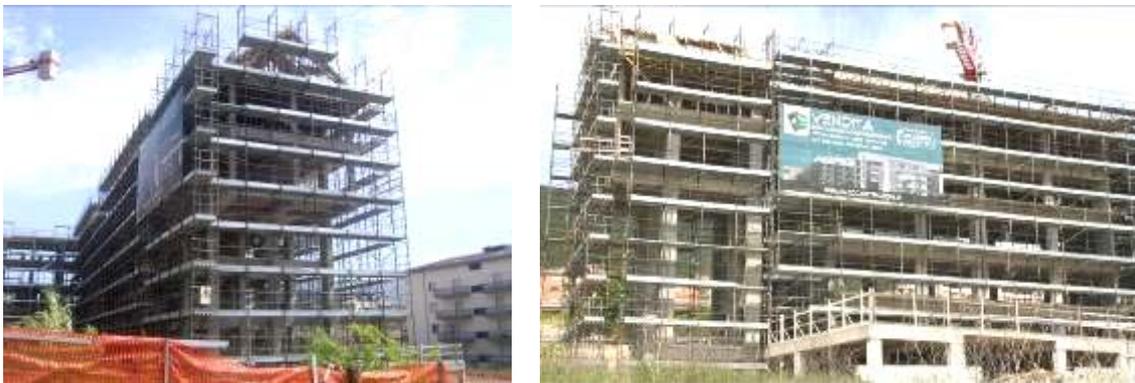
Figure 3.10: New reinforced concrete building with irregularities in elevation

construction when the earthquake occurred. At one extremity of the building the slabs of the first and second storey are interrupted to create a 3-storey high open space. The two last storeys extend outside the perimeter of the lower storeys. Columns in this part do not continue to the foundation, but they rest on cantilever beams. Moreover, the beams of the internal frames in the shorter direction are embedded into the slabs, creating a structural system with different stiffness in the two main directions. The construction site was not accessible and therefore it was not possible to closely examine the state of the structure. According to modern seismic codes, such irregularities should be avoided.

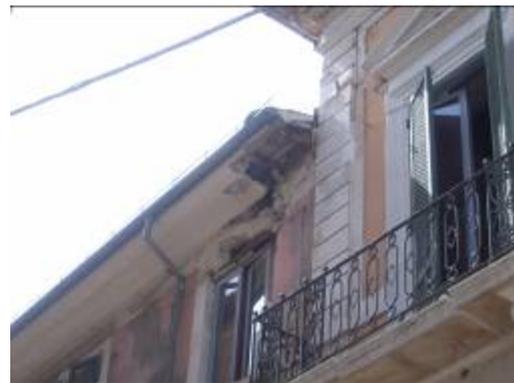
(b) pounding between buildings

Pounding had more destructive effects on buildings with different heights, as for example in Figure 4.1b. Damage is evident on the lower building on the left where non-structural elements of the roof were destroyed and collapsed (note that the left building has a flexible wood roof, this justifies the fact that the right building suffered only minor damages).

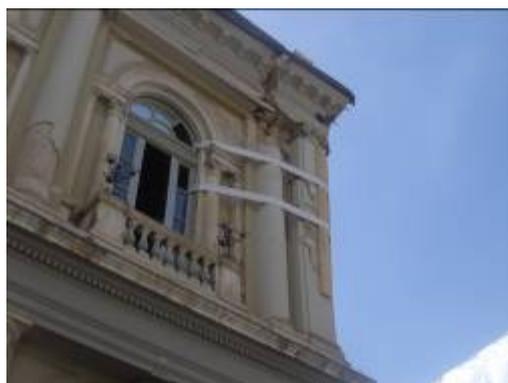
(c) damage at corners

Figure 4.1c shows the effects of the earthquake on the corner of an important palace (the national library): when not properly connected to the rest of the building, corners often suffer important damage or even total expulsion.

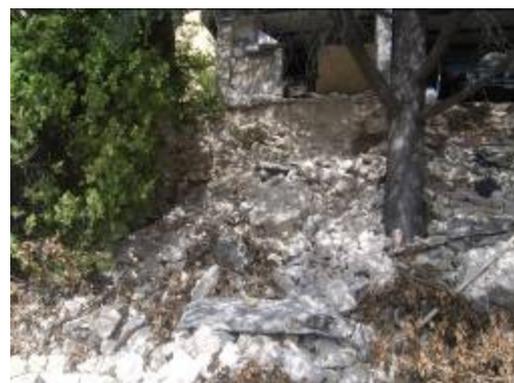
(d) retaining wall

Figure 4.1d is representative of another problem not directly related to buildings: the stability of the retaining walls. L'Aquila is constructed on a hill, so there was very often the need to build retaining walls to support the buildings foundations. Since these walls are often

constructed in masonry without any special provision for earthquakes, most of them have collapsed.

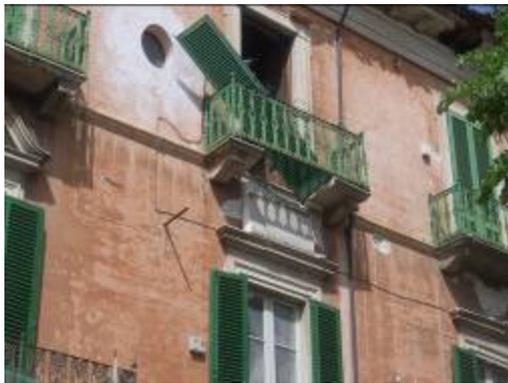
(a) balcony and shutter

Non-structural damages have also an important role in the safety issue. Figure 4.2 shows some examples of danger for pedestrians. In Figure 4.2a the balcony has partially collapsed and the shutter leaning against it is in a very unsafe equilibrium. Figure 4.2b shows the tiles of an old roof: they have slid and are now leaning around the very margin. Therefore, at the time of the visit, not only the risk of total collapse of buildings, but also risks due to non-structural damage made the centre of the city of L'Aquila not accessible if not assisted by the Fire Brigades.

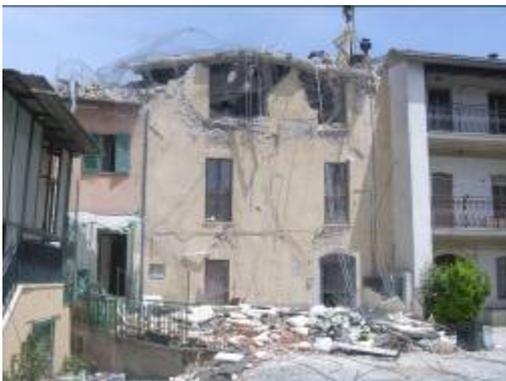
(a) heavy concrete roof

A large amount of the buildings suffered damages mainly caused by incorrect original design or following retrofitting. Figure 4.4a gives an example of a heavy concrete roof constructed on an old masonry building. This roof has probably substituted a lighter wood one, but in parallel no effort has been done to increase the resistance of the load-bearing walls. The increased mass of the new roof caused lateral forces exceeding the masonry strength and causing collapse of the walls. Figure 4.4b shows the collapse of an arch overhanging a door. The arch was not properly connected to the wall. Figure 4.4c is an example of the effect of not properly connected corners of buildings. Figure 4.4d evidences that one portion of the building was adjunct to the other one without properly connecting them together, even if the presence of steel ties has prevented the house from more serious damages.

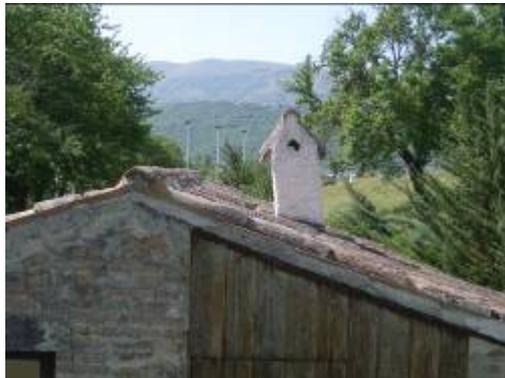
(a) tilted chimney

Non-structural damages were also frequent. Figure 4.5a shows a tilted chimney in the surrounding of the Rex Romoli buildings on a hill nearby Coppito and Figure 4.5b shows a chimney with the upper part completely collapsed. Figure 4.5c evidences the collapse of a portion of a stone non-structural wall of the Rex Romoli, while the concrete structural core of

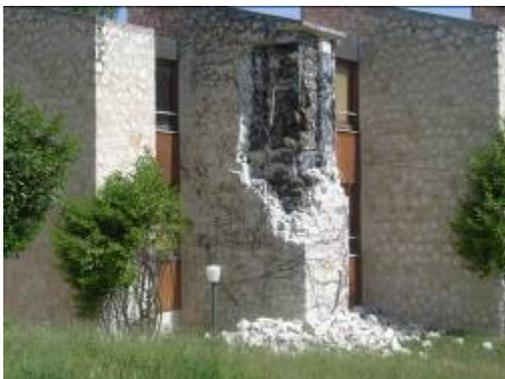
(c) collapsed wall

the wall resisted well to the earthquake. Similar damages were observed in other corner positions. Figure 4.5d shows the damage in the infill between the window and the door of a two-storey house.

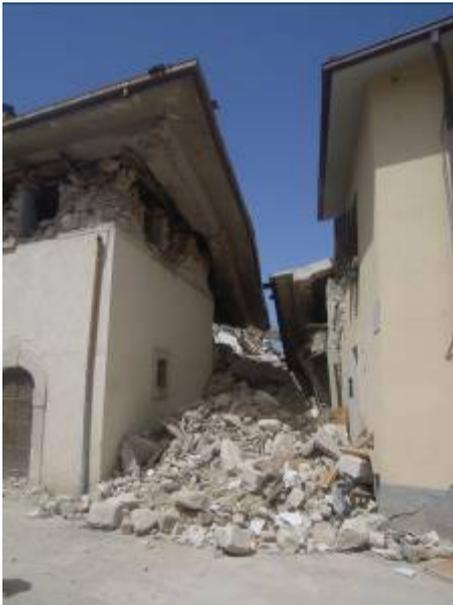
(a) heavy concrete roof

Figure 4.6a shows the effect of a very heavy concrete roof placed on bad quality masonry: the forces and the horizontal displacements generated by the movement of its large mass caused

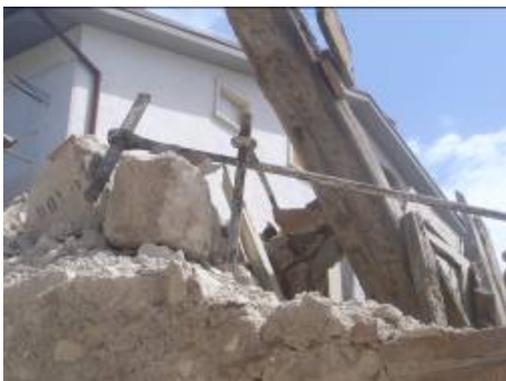
(c) heavy concrete roof

Only a very limited number of buildings seemed to have steel ties passing through the floors and anchored to the façade of the buildings. These ties, if well designed and located, have the positive effect of increasing the global stiffness, generating a “rigid-box” behaviour of the structure, preventing the separation and out-of-plane collapse of the façades and the loss of support of the slabs and the roofs. In most of the buildings in Onna, the presence of ties generated no positive effects because of the extremely bad quality of the masonry that caused severe local damage or complete collapse at the anchor point of the steel ties (Figure 4.6c).

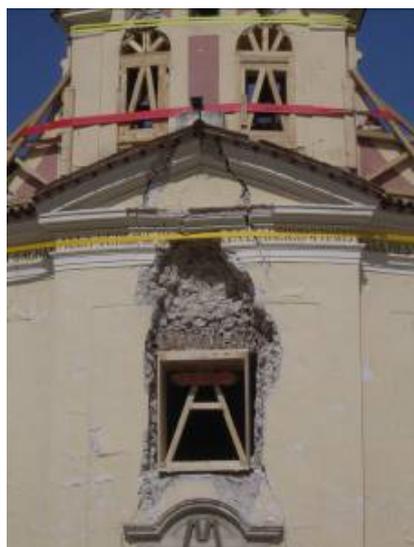
(a) bad quality masonry of the Concezione church

The quality of masonry varies from round stones with poor mortar (Figure 4.8a) to large and well squared stone blocks (Figure 4.8b). The Matrice church also has steel ties, strengthened corners and a simpler (and less vulnerable) configuration. The difference in the damage level is evident.

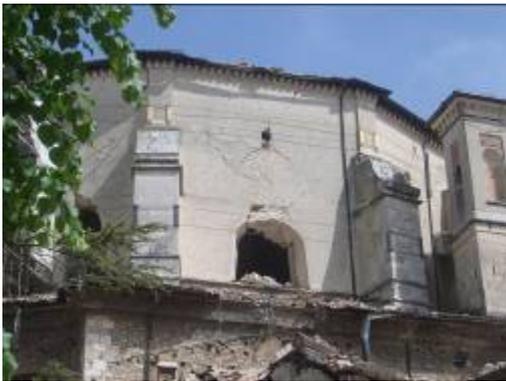
(a) Sant'Agostino

The church of Sant'Agostino (Figure 4.9a) suffered the collapse of the bell tower and severe damages at the drum. The church of San Francesco di Paola (Figure 4.9b) has the upper part of the façade destroyed and damages to the roof. The church of San Bernardino (Figure 4.9c) had the façade completely saved, but its drum suffered extensive cracks. The church of Santa Maria Paganica (Figure 4.9d) had the roof of the nave completely collapsed together with its apse. The Cathedral of L'Aquila (Duomo, Figure 4.9e and 4.9f) had the drum almost collapsed and the façade heavily damaged.

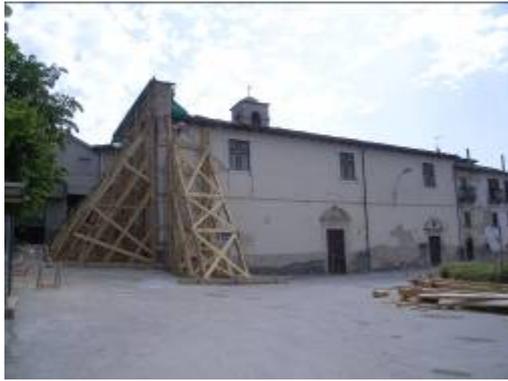
(a) safety provisions for a masonry wall

Figure 4.11 shows the damages to some monuments in Paganica. Figure 4.11a shows the heavy damage of a masonry wall where security provisions have been constructed. Figures 4.11b, 4.11c and 4.11d show a comparison among different situations for the Concezione church: before the earthquake, just after it and in the phase of safety provision measures. Damages are spread all over the building with local collapse of poor quality masonry. Figure 4.12e shows a tower facing on the Concezione square just before the earthquake in comparison with Figure 4.13f where the same tower exhibits diagonal cracks at 45 degree angle inclination clearly showing a torsional damage mechanism.

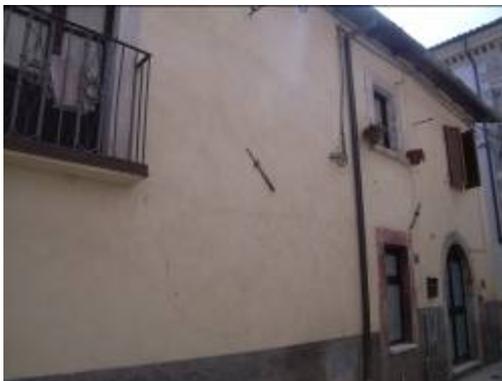
(a) steel ties in common buildings

Prefettura, see Figure 4.10). Figures 4.13a and 4.13b show that ties can increase the safety level both of common building and monuments.
