# IDSL Sea Level Measurement Devices

*Report on the deployment  
and first year of work of the  
IDSLs in the Mediterranean  
area*

ANNUNZIATO Alessandro  
GALLIANO Daniele A.  
BONAITA Matteo

2016

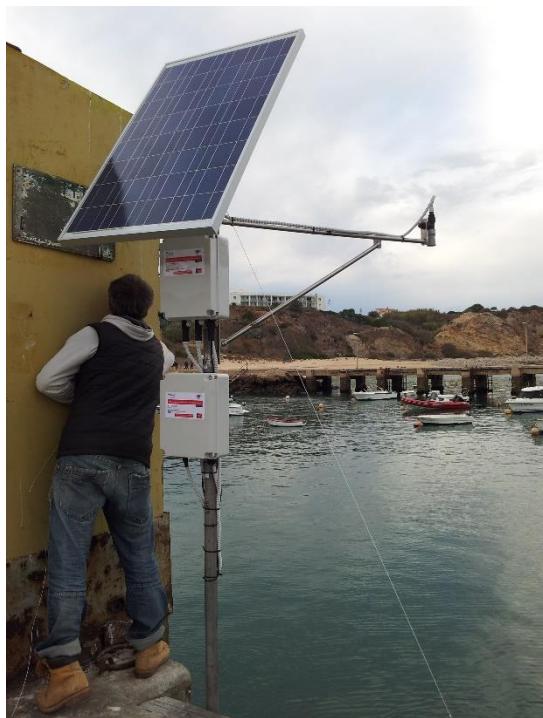
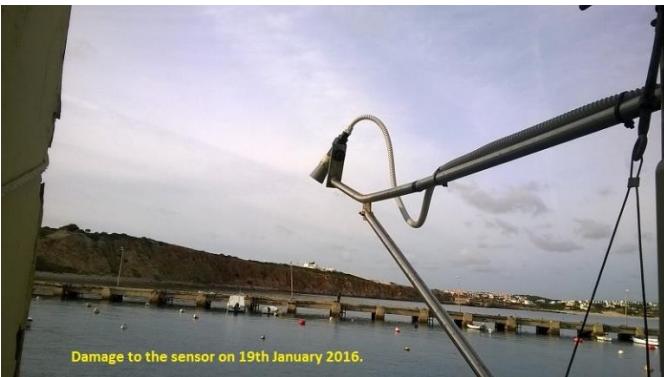
| Date | Description | Notes | Status | Level |
|---|--|--|--|---|
| 27/04/2016 00:00 | The device stopped working | Probably the card is damaged but as this device has no watch dog, it cannot restart | Need to replace the card or the device | Red |
| 27/01/2016 00:00 | During the survey, it was discovered that the sensor was strongly hit, the arm was deformed and the sensor itself rotated (picture below). This was the reason of incorrect signal in low tide. The arm has been realigned but the response is not yet optimal with several incorrect values detected. | It would be useful to: change the installation position in a more boat free location and in that occasion to replace the sensor with a new one | Ongoing | Red |

| Date | Description | Notes | Status | Level |
|---|--|--|--|---|
| 10/06/2016 00:00 | The Control box has been replaced with a new one | New CB and new card | Operational | Green |

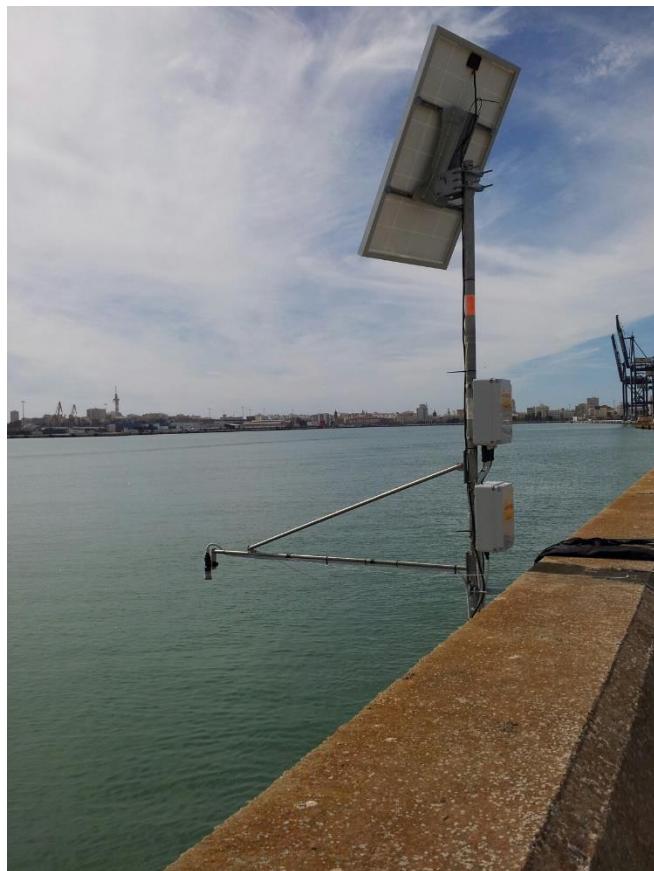
| Date | Description | Notes | Status | Level |
|---|--|--|---|---|
| 14/10/2015<br>00:00 | Device stopped working due to a misconnection of the memory card | Necessary to go onsite or replace the device | | Red |

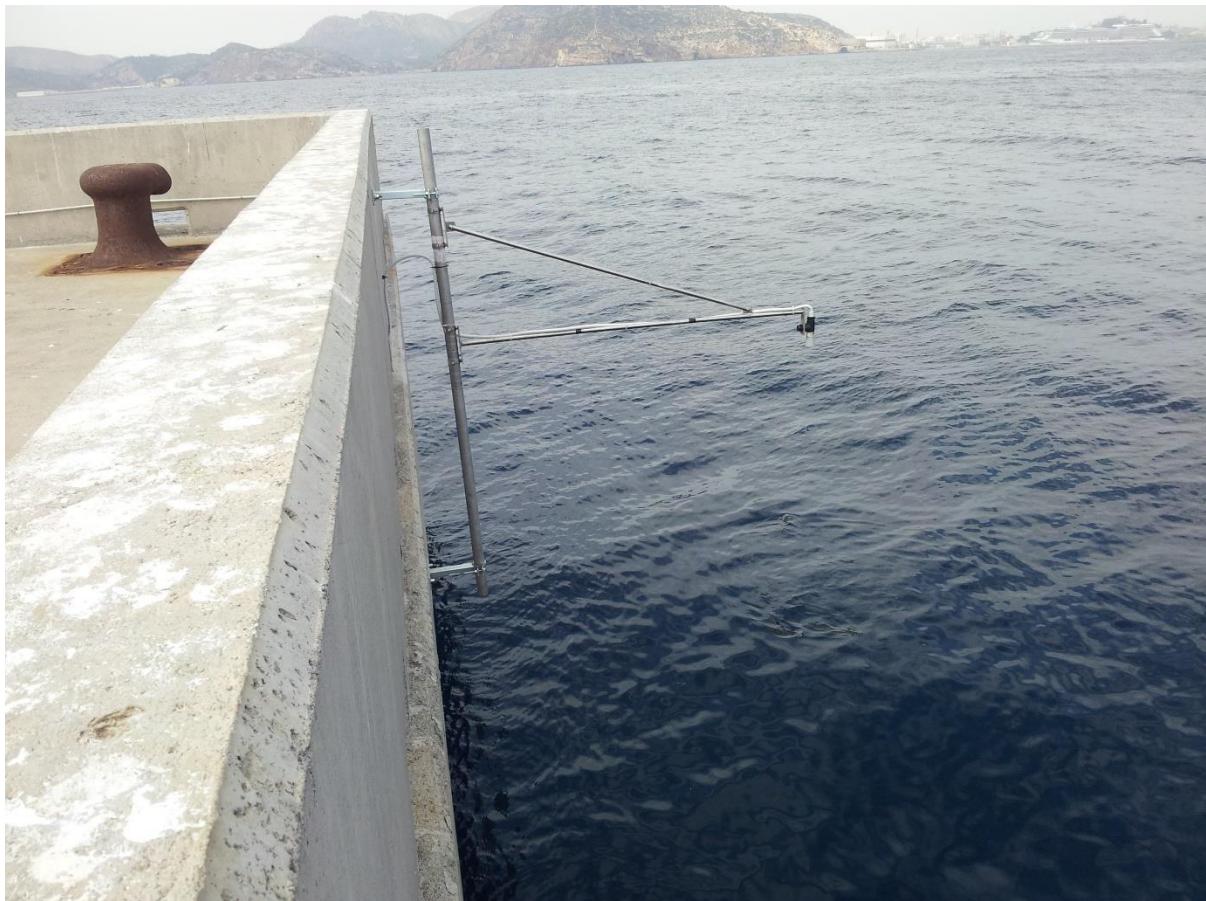
| Date | Description | Notes | Status | Level |
|---|---|---|---|---|
| 16/01/2016<br>00:00 | Since 16 January the sensor started to give wrong oscillating values and since 21 January no data is transmitted to JRC as valid data | Necessary to change the sensor, now foreseen in the second half of February | Ongoing | Red |

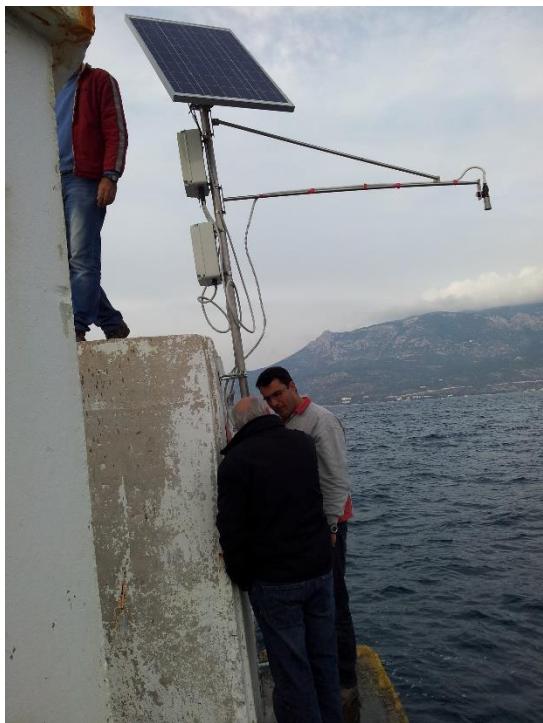
| Date | Description | Notes | Status | Level |
|---|---|--|---|---|
| 14/03/2016<br>07:00 | The data collection is still erratic. We believe that the reason is due to salt deposits on the sensor surface. | There is the need to change the sensor and replace some damaged parts of the device | Ongoing | Red |
| 12/03/2016<br>00:00 | Memory card changed and arm elevation increased by 50 cm | Need to check the response. It was found that the solar panel cable was oxidized and detached. | Online but power very low. Blackout is expected | Yellow |

| Date | Description | Notes | Status | Level |
|---|---|--|---|---|
| 24/03/2016<br>11:00 | A new mission was conducted at the site and several corrective actions have been implemented: the sensor and the control box have been changed, the connecting plugs have been substituted as infiltration of water was detected, the pole has been raised by 11.5 cm | Now the behaviour is much more stable with the new sensor (10 m range) we have not yet out-of-range values. Nevertheless this is a very wavy position and we must expect strong level oscillations in case of bad weather. | Online and working correctly | Green |

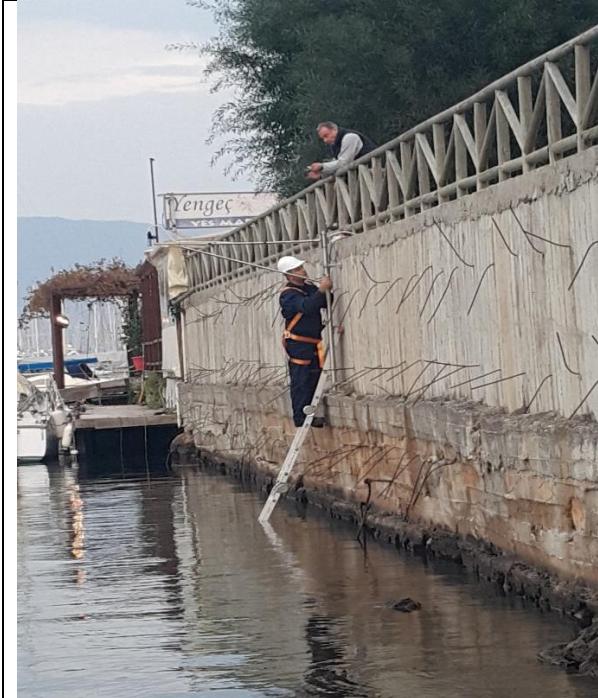
The installation of the sensor in a rather shallow water place

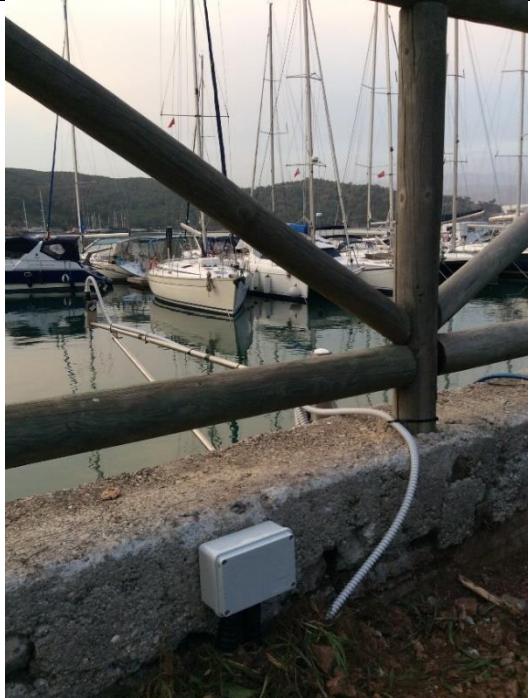
The sensor in Fethye and the incorrect positioning of the temperature sensor which was far from the sensor. This has been then moved on the other side of this wall.

| Date | Description | Notes | Status | Level |
|---|---|--|---|---|
| 23/04/2016 10:00 | Moved the temperature sensor under the level sensor, replaced the memory card | The reason for the move of the temperature sensor was the presence of sudden level changes that have been attributed to the bad placement of the temperature sensor. The memory card was changed because of risk of failure due to high number of writes | Completed | |

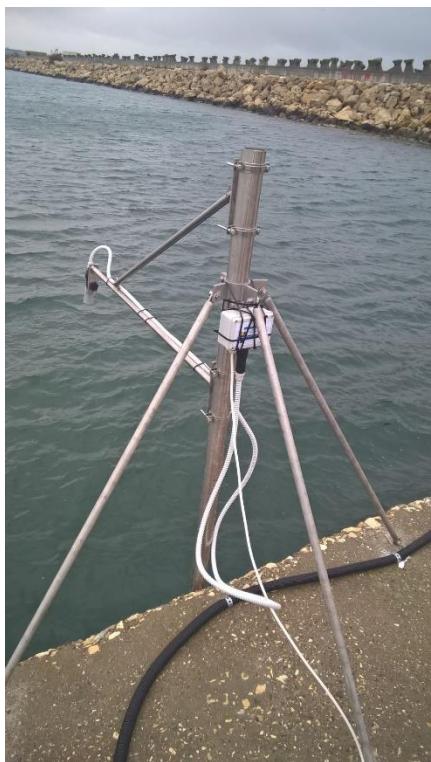
| Date | Description | Notes | Status | Level |
|---|--|--|---|---|
| 26/01/2016 00:00 | Intermittent transmission of data from Mangalia | Possible cause ice formation on the bottom face of the sensor | Ongoing | Yellow |

| Date | Description | Notes | Status | Level |
|---|--|--|---|---|
| 29/01/2016 15:00 | The sensor has been substituted with a new one and the arm inverted in order to raise it by 70 cm. During the change some salt crystals have been found inside the connection between the sensor cable and the 50m connection box. | Data are now flowing correctly | Completed | Green |
