JRC TECHNICAL REPORTS

European Solar Test Installation

Characterisation of c-Si modules after 20 years of outdoor exposure on an electric vehicle.

2017

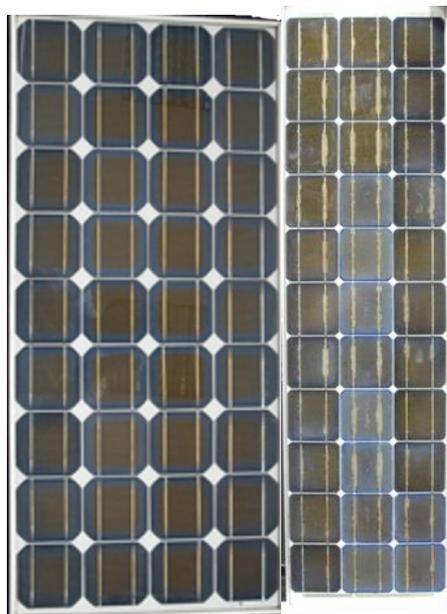
Figure 2 Module type 1 (BP) and module type 2 (Arcosolar) after 20 years of outdoor exposure on the electric car.

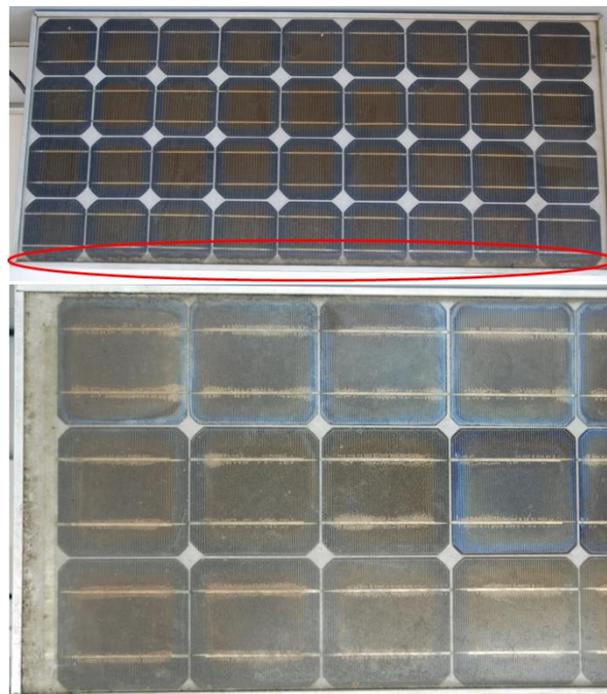
After removal from the electric car, visual inspection was performed on all modules, and some defects were categorised according to the visual inspection data collection tool. Soiling was present in all modules, due to the fact that no cleaning was performed after installation on the car. As the modules were mounted with a low tilt angle or almost horizontal configuration, the soiling was uniformly distributed across the module. In the case of the modules with a minor inclination, soiling was more pronounced in the lower part of the module, close to the frame where soiling accumulated more easily (Figure 3).

Figure 3 soiling accumulating at the lower edge of a module near the frame and uniformly on the glass.

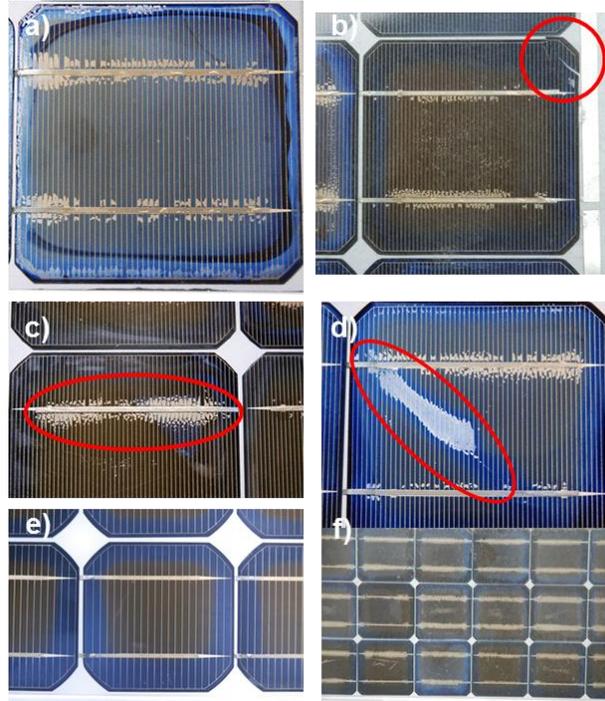
As already reported in previous works [4, 17] some defects are related to the properties of the materials used for manufacturing the modules and therefore affect all modules. Examples of these defects are minor backsheet discoloration, due to properties of the tedlar used as backsheet (as the modules are mounted in direct contact to the roof or the bonnet of the car with low tilt angle, not relevant damages were observed in the backsheet and in the junction box) and discoloration of cell's fingers, due to degradation of the metallization grid. Examples of the usual defects found in some of the modules are shown in Figure 4. They include different types of delamination of the encapsulant close to the cell interconnect ribbons and over the cell, respectively (Figure 4a and 4d), cracked cell, degradation and discoloration of cell interconnect ribbons and busbars, discoloration or yellowing over center of the cells and discoloration over whole cell.

Figure 4 Examples of visual defects: different types of delamination (close to the cell interconnect ribbons and over the cell, respectively) (a),(d), cracked cell (b), degradation and discoloration of cell interconnect ribbons and busbars (c), discoloration or yellowing over center of the cells (e) and discoloration over whole cell (f).

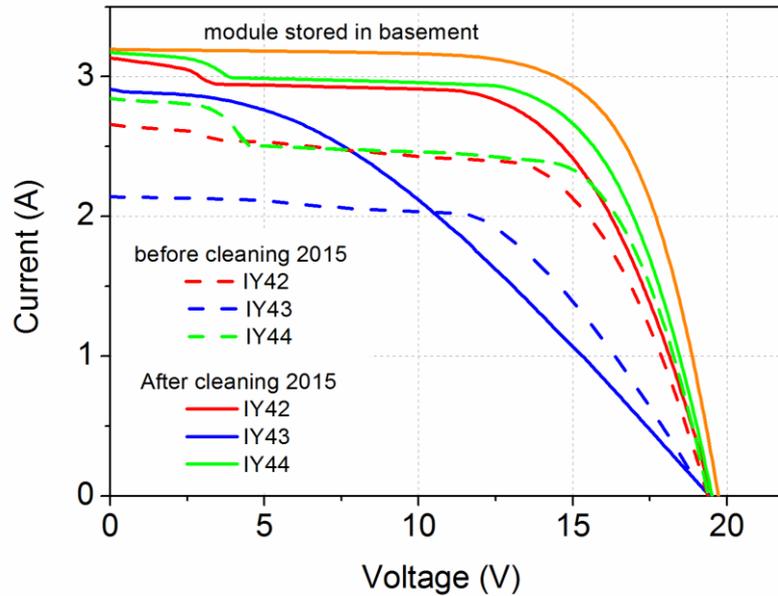
Figure 5 shows the I-V curves of different modules of the same type before and after a manual cleaning after 20 years of outdoor exposure on an electric vehicle and a reference module stored indoor in the basement. The kink in the I-V curves of soiled modules can be observed, and this suggests non-uniform shading. However, the kink in the modules IY42 and IY44 do not disappear after the manual cleaning that suggest other factors, for example, mismatch between cells, damaged or cracked cells. On the other hand, the I_{sc} of the module IY43 is increased after manual cleaning but this module presents a severe failure and the FF decrease below 38%. Table II presents the change (in %) of the electrical parameters of the modules mounted in the car before and after manual cleaning expressed as:

Figure 5 I-V curves of different modules of the same type before cleaning and after manual cleaning after 20 years of outdoor exposure on an electric car.

Where $P_{\max \text{ soiled}}$ is the P_{\max} (or other electrical parameter) of the soiled module before cleaning manually. It is clearly observed that the increase in the P_{\max} of the modules (except in the module IY43) is due to an increase in the I_{sc} and in the I_{mpp} . This improvement in the P_{\max} after cleaning is significantly greater than other reported values for long-term soiling around 9.8% [18]. P_{\max} decrease significantly after manual cleaning for IY43 due to a marked decrease of the FF (-34.1%) that means that severe failure modes were presented in the module and covered by the soiling. This indicates that flat mounting has an impact on soiling.

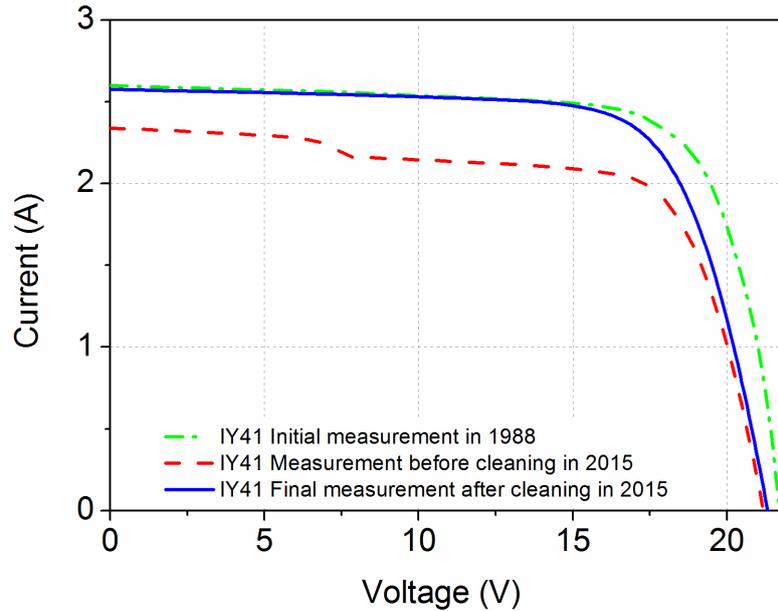
Figure 6 shows the I-V curves of the module IY41 measured initially in 1988 and measured in 2015 before and after manual cleaning. It is also observed the kink in the I-V curve due to the soiling.

Figure 6 I-V curves of the module IY41 after more than 20 years of outdoor use on an electric car.

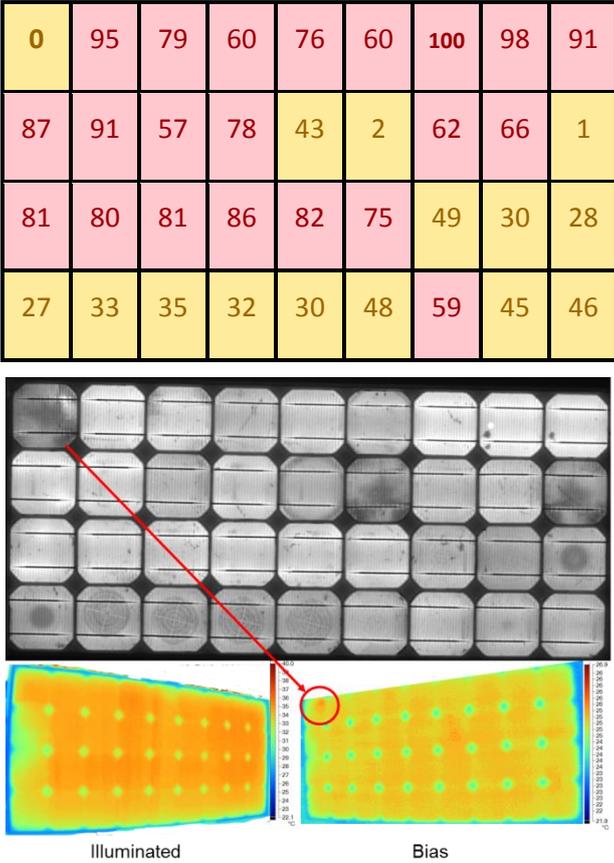
Figure 7 EL images of IY41, relative EL intensity and the respective IR thermography images using continuous light exposure (left) and forward biased module (right).

IY41 presents a homogeneous temperature distribution with only one point hotter than the rest corresponding to the cell with the lower EL intensity. The EL image shows darker cells (with EL intensity below 50%) corresponding to the cells in bottom part of the module close to the edge heavily soiled. However, severely damaged cells were not observed in the EL image (figure 7) for module IY41 in agreement with the I-V measurements. Figure 8a also shows EL intensities below 50% of the maximum on the heavily soiled edge of the module IY42 (top line of the EL intensity table). A spot of

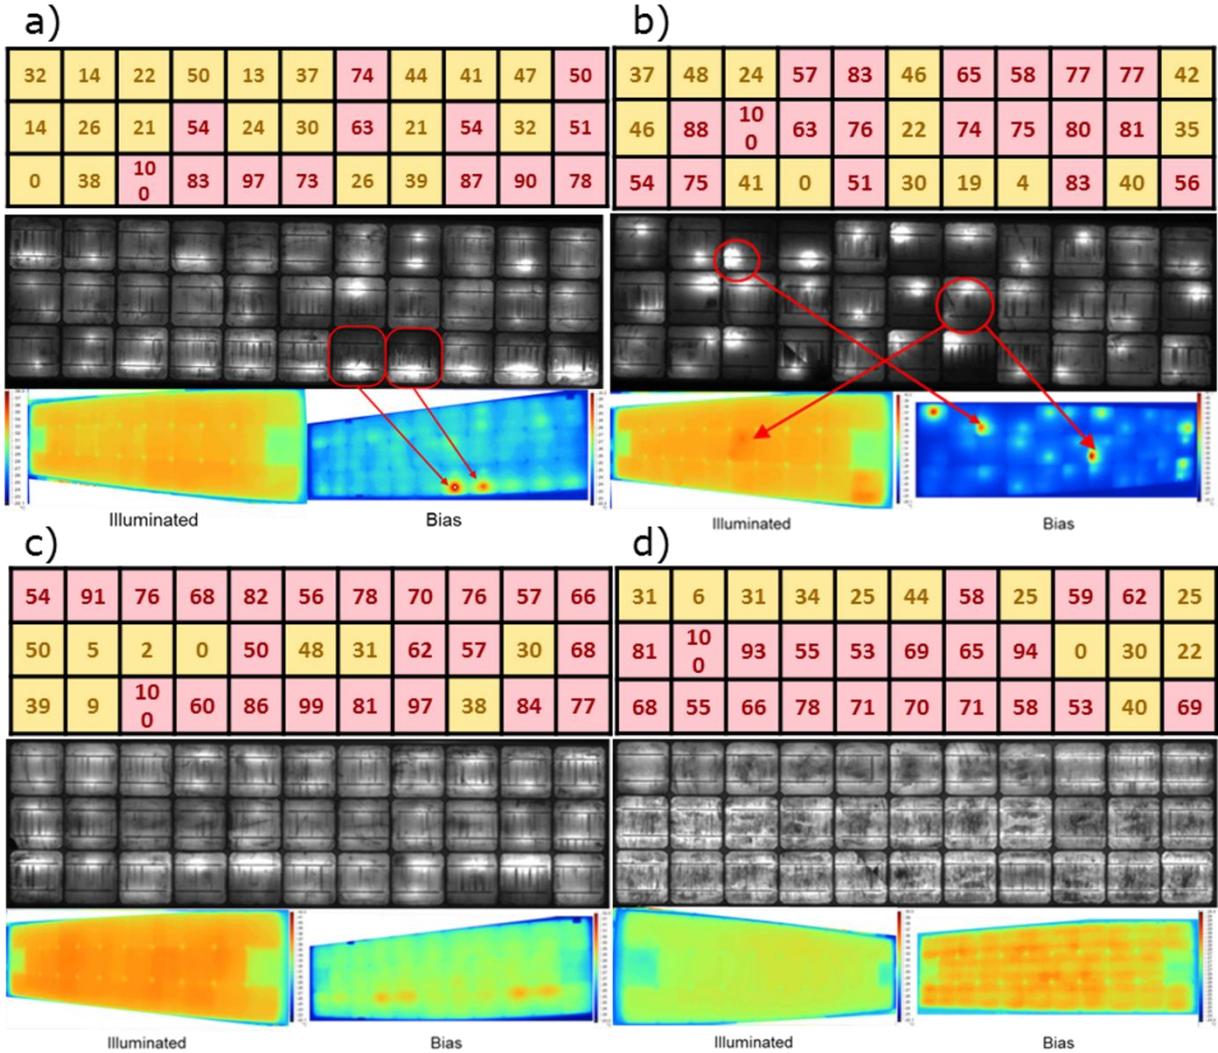
significant higher temperature are observed in two cells by IR thermography when a bias is applied corresponding to focalized regions of higher resistance along the cell interconnect ribbons. The EL and IR image of the damage module IY43 is shown in figure 8b. EL image exhibits brighter spots localized along and close to the busbar or cell interconnect ribbons with a higher resistance that leads to spots of higher temperature as observed in the IR thermography image. The cell with the lowest EL intensity presents a crack between the busbar but it is not reflected as a hot spot. Figure 8c and 8d show the EL images and IR thermography of the modules IY44 and IY45, respectively. No appreciable damage or hot spots are observed and more than 70-75 % of the cells present a relative EL intensity greater than the 50% of the minimum value. EL image of IY44 (Figure 8c) shows the inactive area of the broken cell (first column, second row) and a relative high number of finger interruptions.

Figure 8 EL images, relative EL intensity and the respective IR thermography images using continuous light exposure (left) and forward biased module (right), of the IY42 (a), IY43 (b), IY44 (c) and the module stored in the basement IY45 (d).

The ranking of the absolute average EL intensity of the modules (IY42, IY43, IY44 and IY45 reference module) agree with the order of the modules organized by their P_{\max} after manual cleaning.
