**EUROPEAN COMMISSION  
JOINT RESEARCH CENTRE**

## **The Molise (Italy) earthquakes of 31 October and 1 November 2002: Report and analysis from a field mission**

*E. Mola, G. Tsionis, F. Taucer, A. Pinto*

EUR 20664 EN

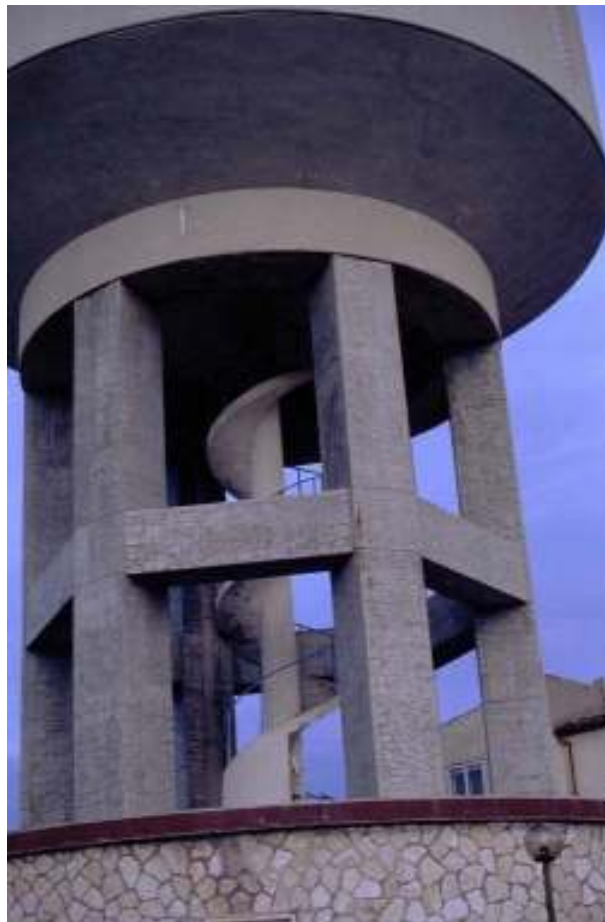
Figure 3.13. Reinforced concrete water tank in Morrone del Sannio

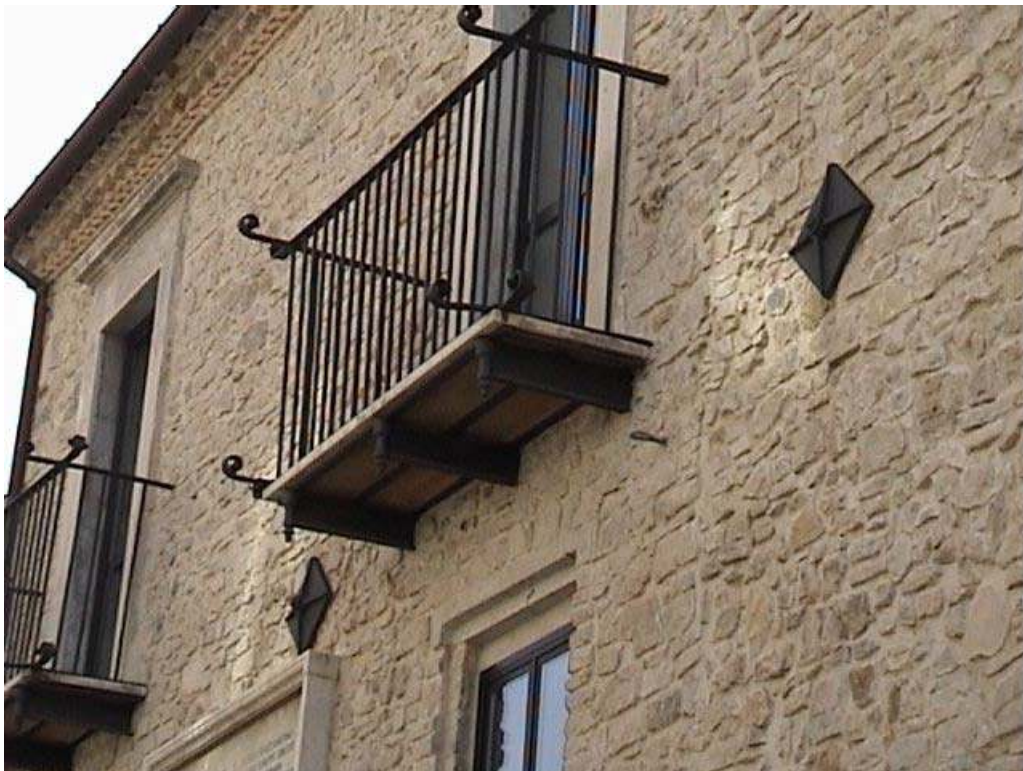
Figure 3.14. Tied masonry structure in Ripabottoni

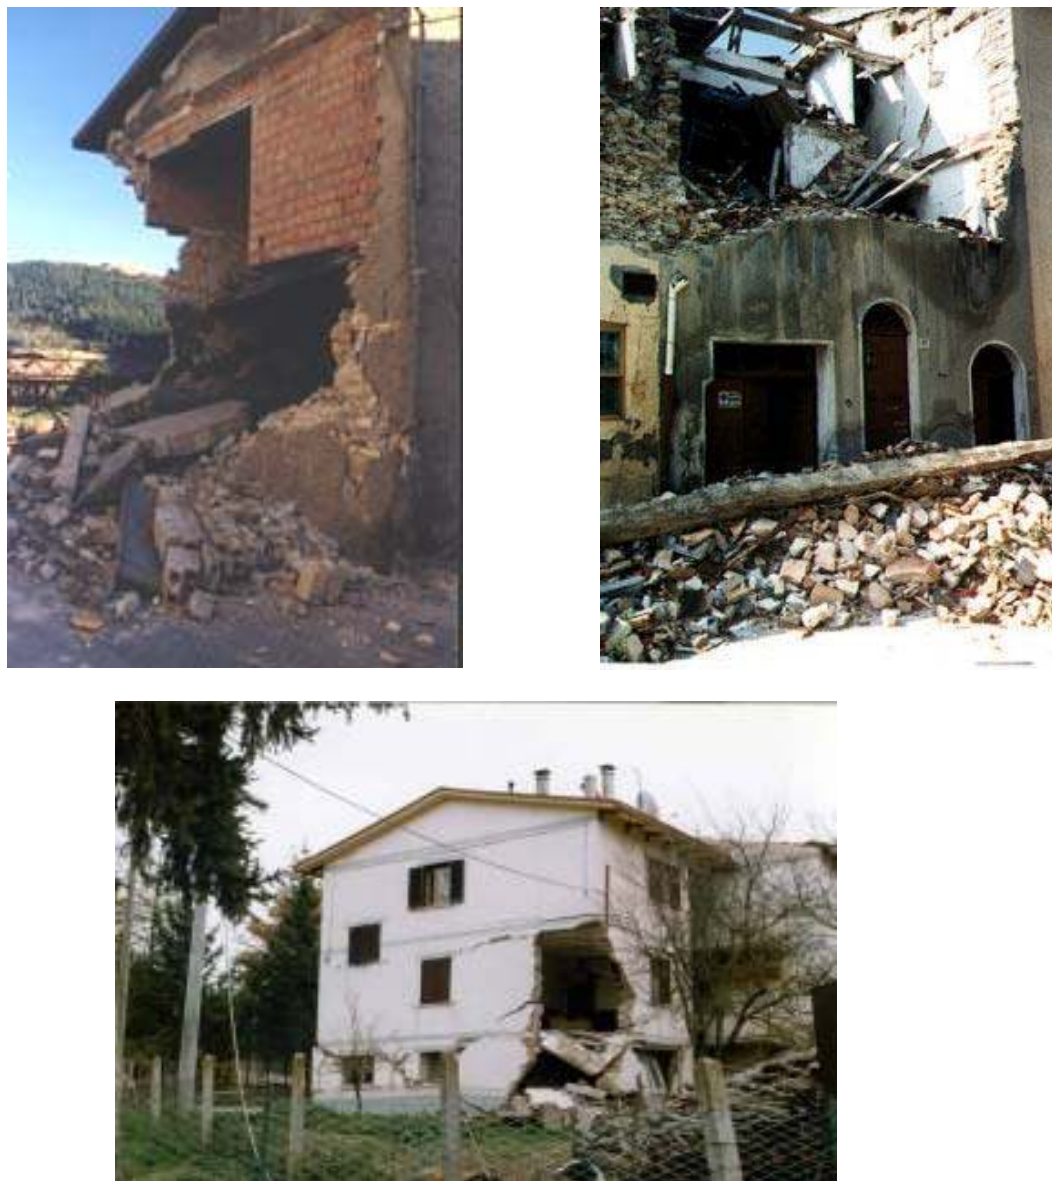
Figure 3.19. Damage of new and old masonry buildings in the Umbria-Marche earthquake [Primitally, 2002]

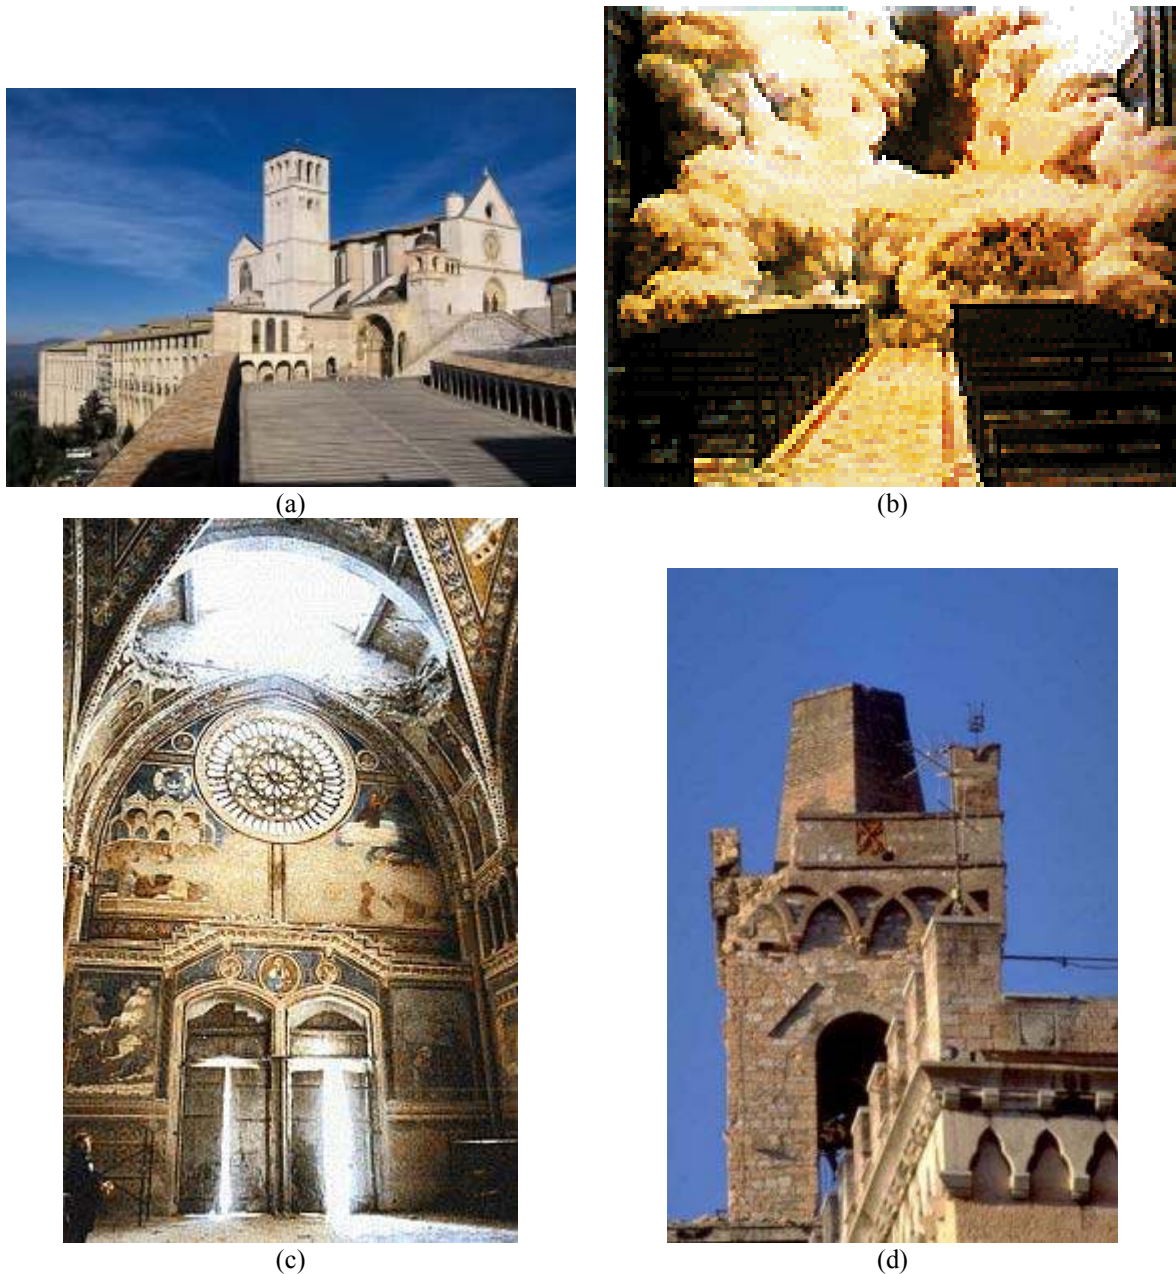
Figure 3.20. General view of the Basilica of San Francesco di Assisi (a), damage at the vaults (b, c) and damage at the bell towers (d) [Moveaboutitaly, Primitaly, Villaschiatti, 2002]

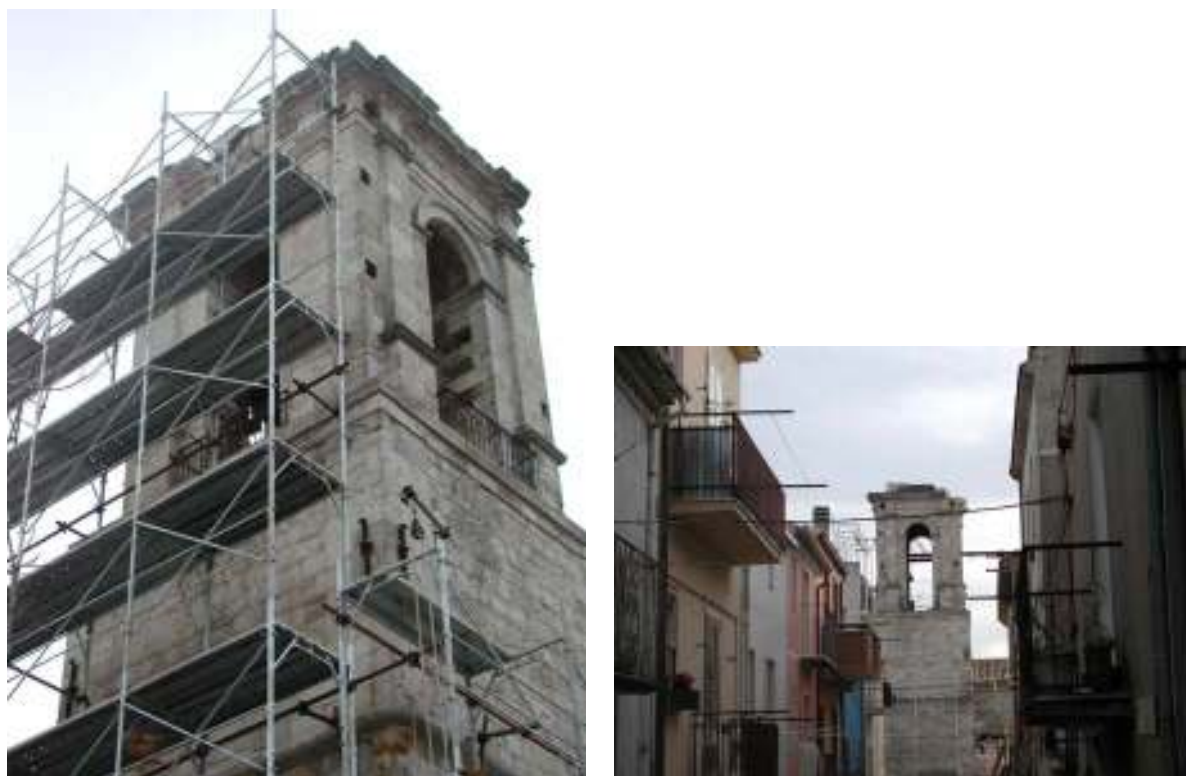
Figure 4.4. Partial collapse of the bell tower of the San Giacomo church in Santa Croce di Magliano

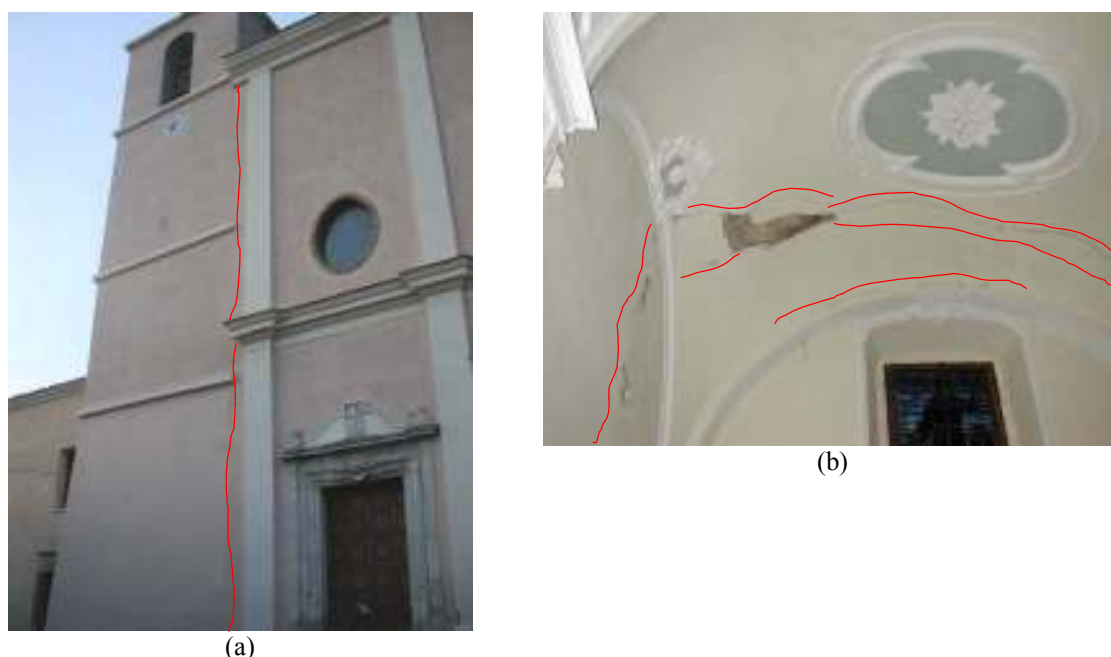
Figure 4.5. Chiesa Madre in Santa Croce di Magliano, separation of the bell tower (a) and damage of the arches and vaults (b)

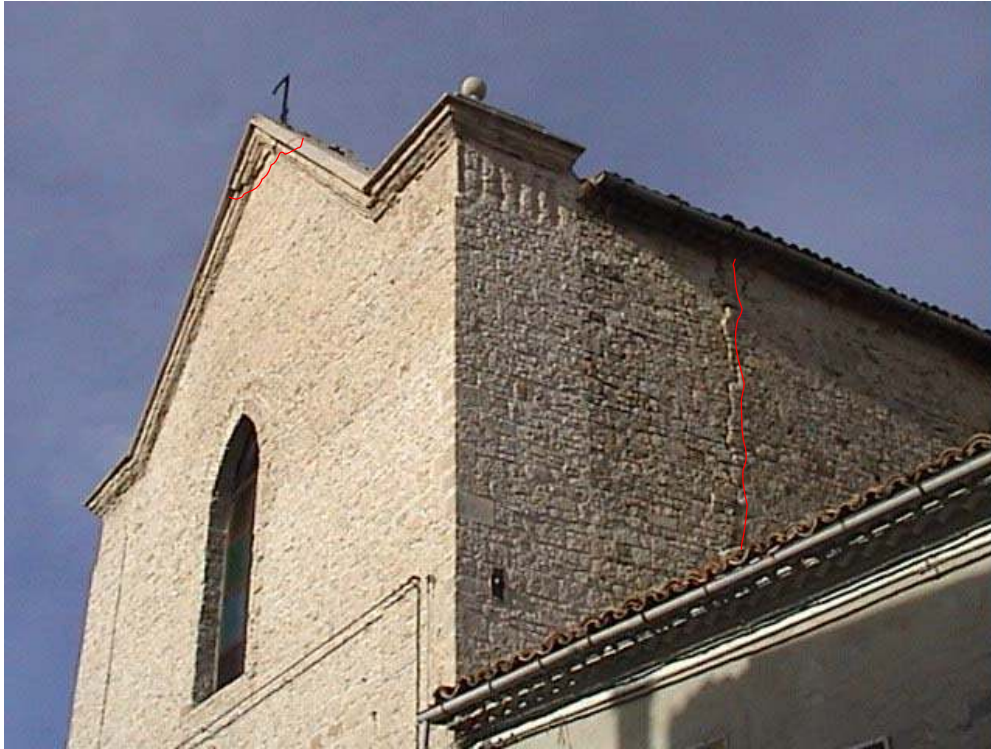
Figure 4.6. Old church in Ripabottoni, separation of the façade and overturning of spire

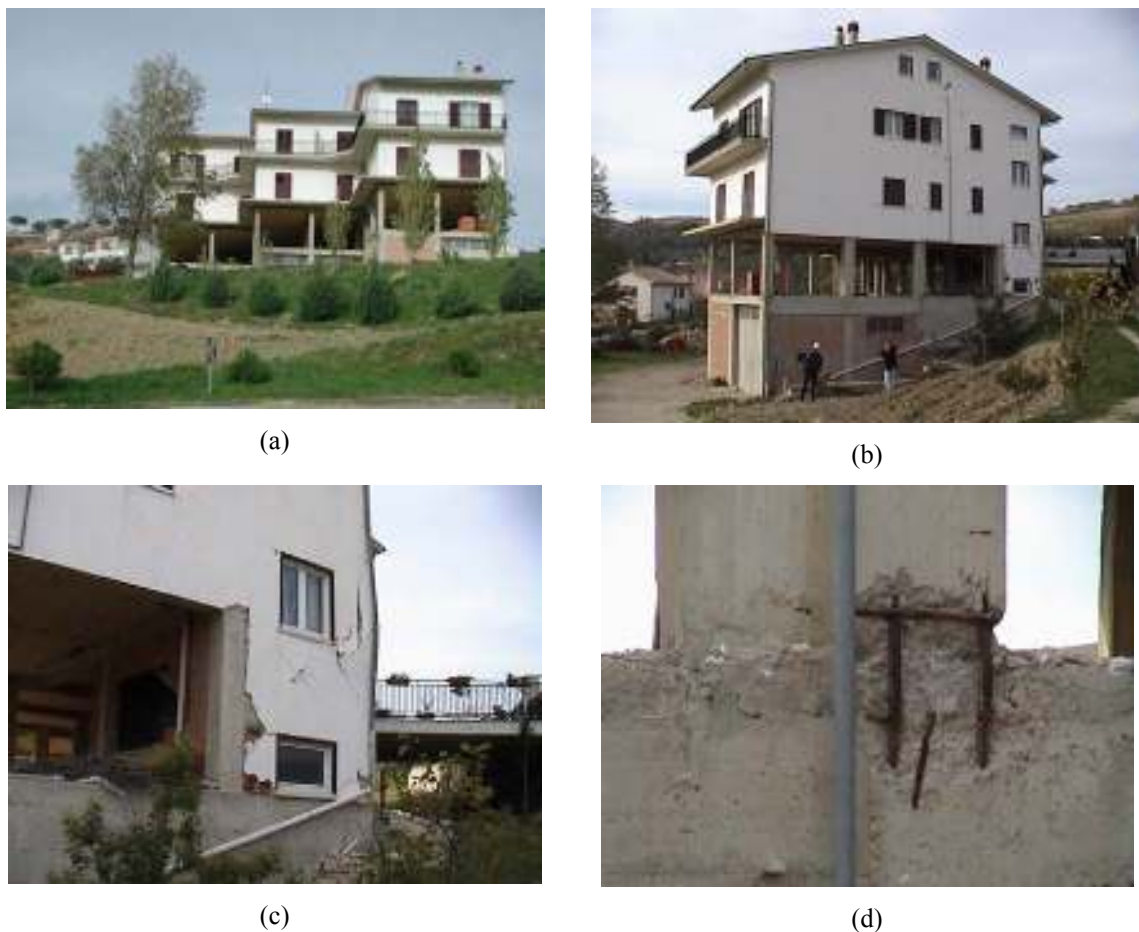
Figure 4.13. Reinforced concrete building in San Giuliano di Puglia, South view (a), East view (b), damage of infills (c) and damage at the base of a column (d)

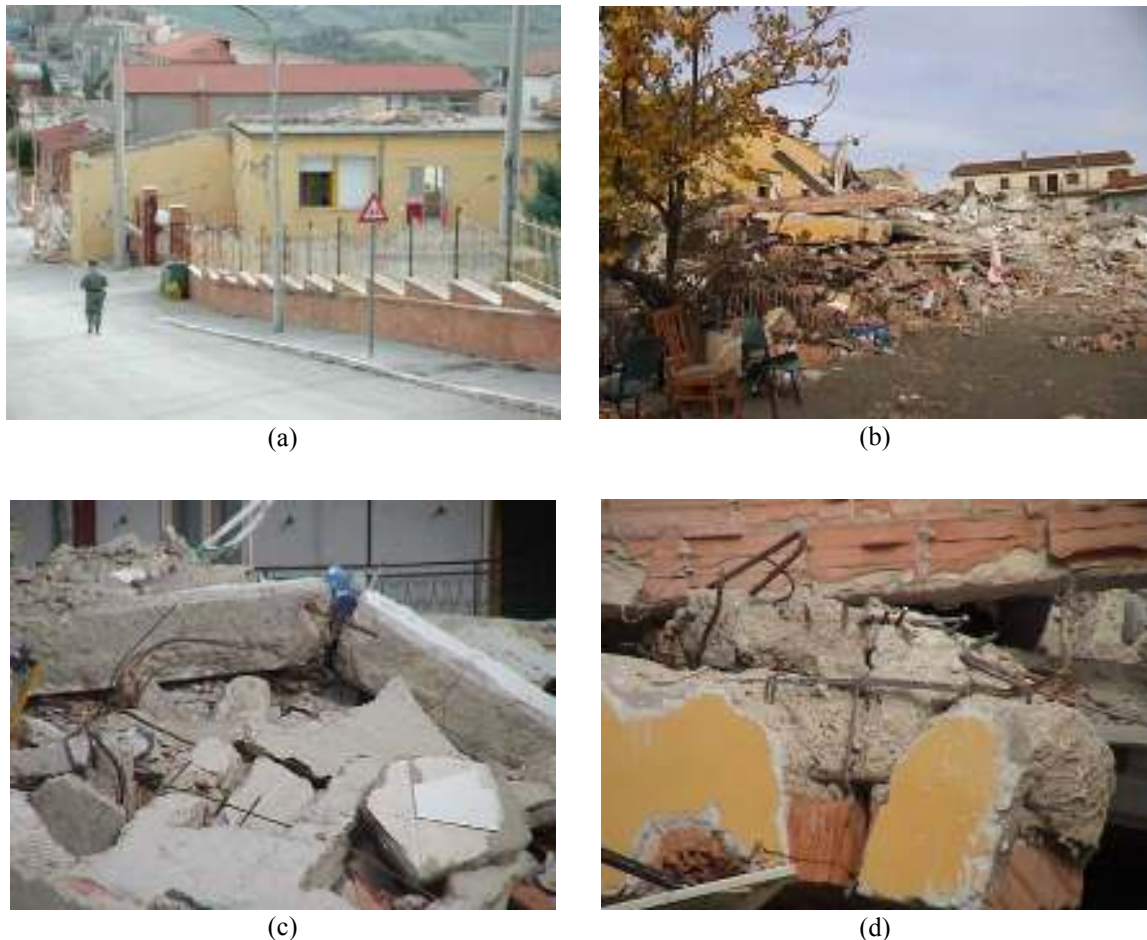
Figure 4.14. The collapsed school – ‘Scuola Francesco Jovine’ of San Giuliano Puglia: a) North view (a), South-west view (b), and details of collapsed RC members (c, d)

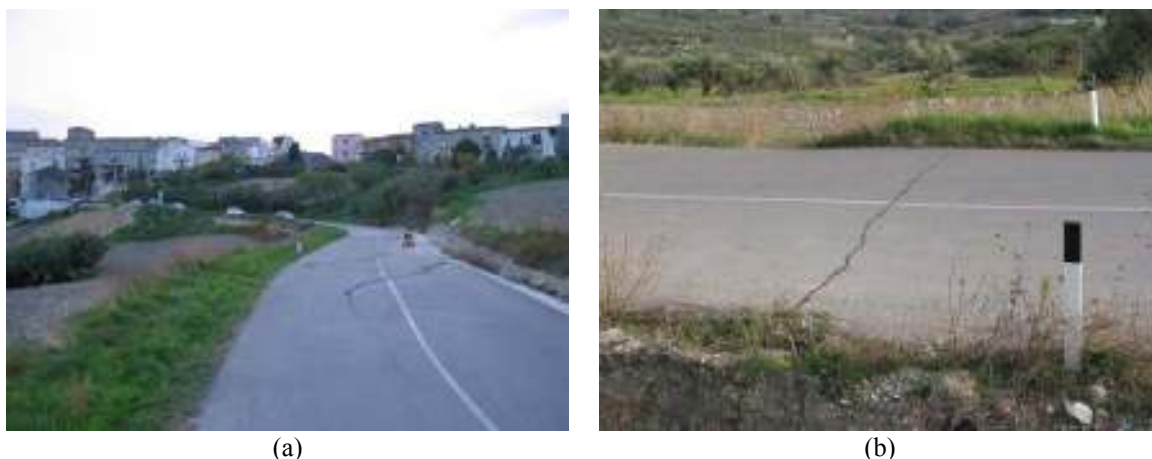
Figure 5.2. San Giuliano di Puglia: longitudinal (a) and transverse (b) cracks in the road [INGV, 2002]

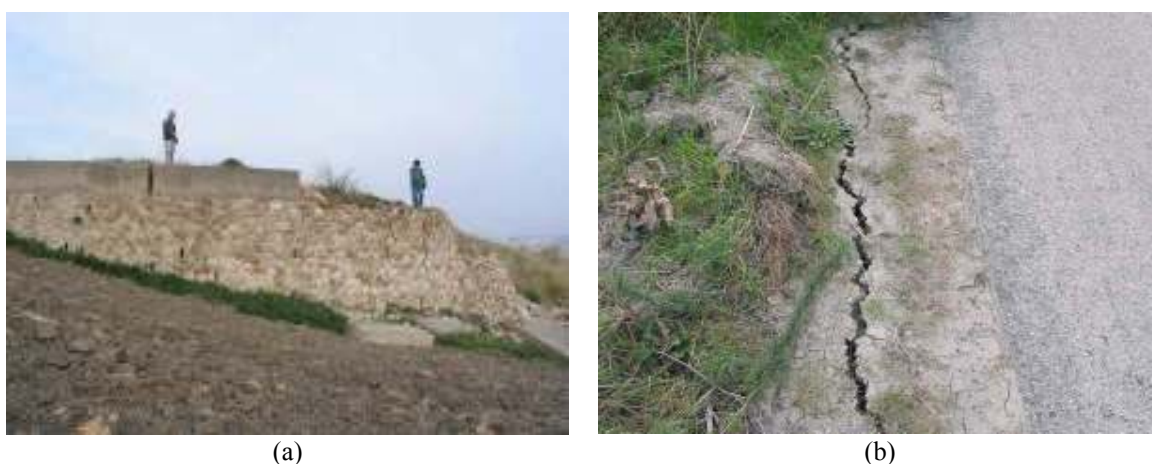
Figure 5.3. Roadside landslide (a) and roadside longitudinal crack (b) in the Vallepare area [INGV, 2002]
