Seismic Retrofitting of RC Frames with RC Infilling (SERFIN Project)

SERIES Transnational Access report

Report EUR 26470 EN

TA Project Final Report

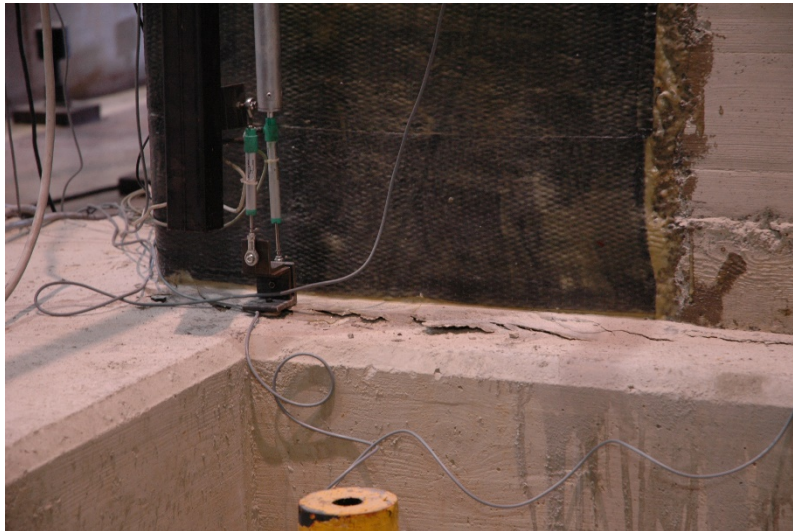
The first failure that could be observed visually was at the bottom of the wall in the south frame. The crack opened under the CFRP jacket at the ground floor as it can be seen in Figure 8.2 and Figure 8.4. In the northern frame such a failure was not observed, but more will be known when the results of the optical metrology become available.

Figure 8.2 Position 6: Crack opens at the bottom of the column - wall

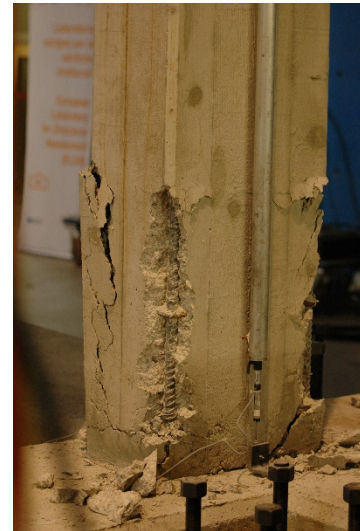
Following the failure in the south frame wall also the column in the column closest to the reaction wall suffered failure in the lap splice zone (Figure 8.3). Throughout the test this column suffered the most severe damage but continued to carry compression load, whereas it was visible that the joint failed in tension. The column on the opposite side (position 5) did not suffer damage, apart from some cracks in the lap splice zone.

Figure 8.3 Position 8: Failure of the column at the bottom

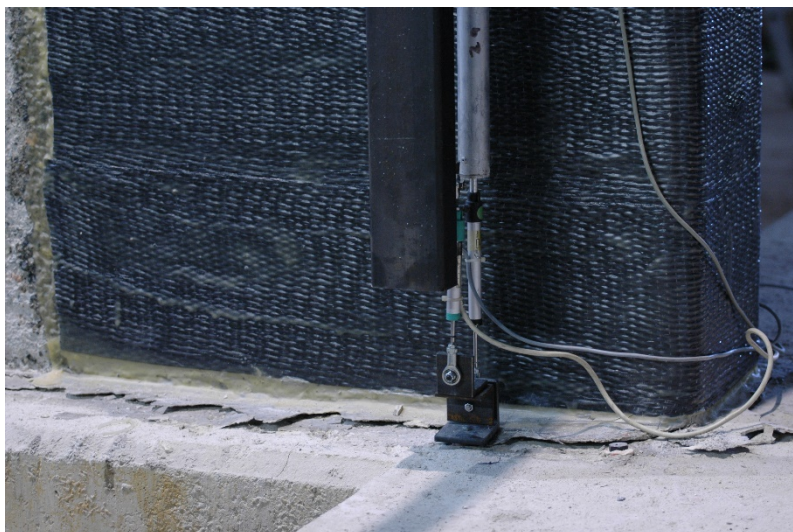
Figure 8.4 Position 7: Crack opens at the bottom of the column - wall

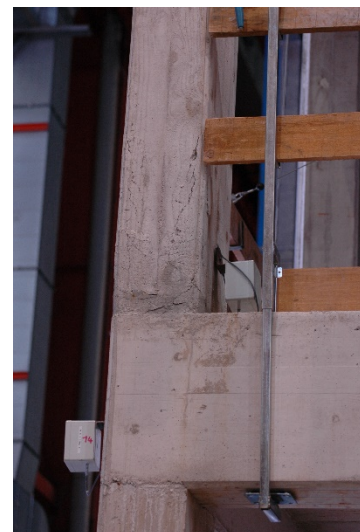
Cracks developed in west columns of both the north and south frames at the first and second storey (Figure 8.5 and Figure 8.7). The cracks, their position and concrete spalling in the latter phase suggest lap splice failure in tension. West columns in the ground floor remained without visual damage.

Figure 8.5 Position 12: Failure of the laps splice joint, N frame

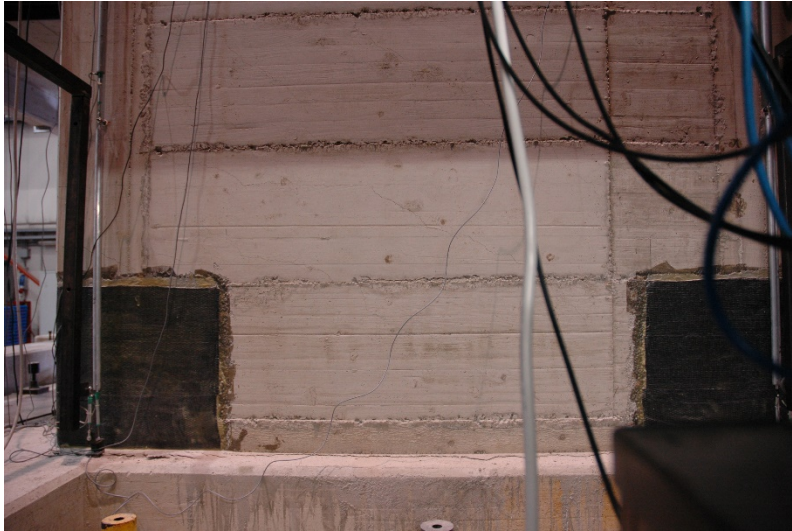
Hairline cracks developed also in the ground floor of the south wall (Figure 8.6) but no major damage was observed in the wall or the connection with the surrounding frame. However a horizontal crack did appear in the foundation beam.

Figure 8.6 Position 1S: Hairline cracks develop in the wall

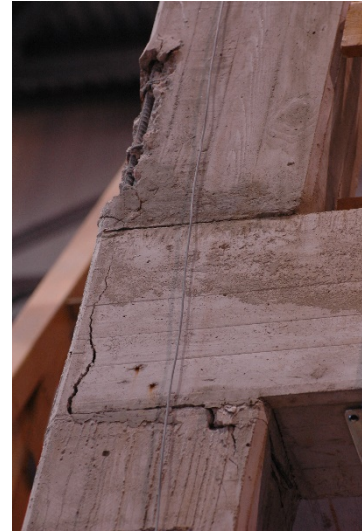
Figure 8.7 Position 29: Failure of the lap splice joint, S frame

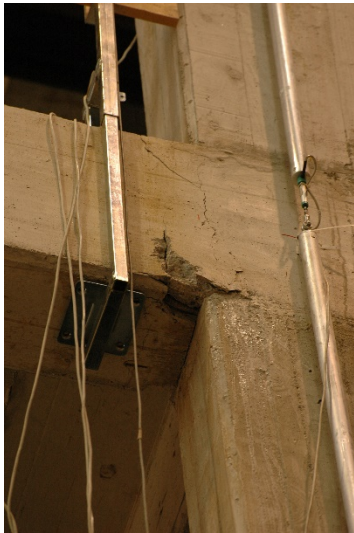
All beams next to the walls at all storeys were damaged in the cyclic test, typically as seen in Figure 8.8. The damage indicates yielding of the longitudinal reinforcement. In spite of the joints not having been designed for ductility, they retained most of their bending capacity, as the level of damage was minor.

Figure 8.8 Position 30: Beam next to the wall is cracked

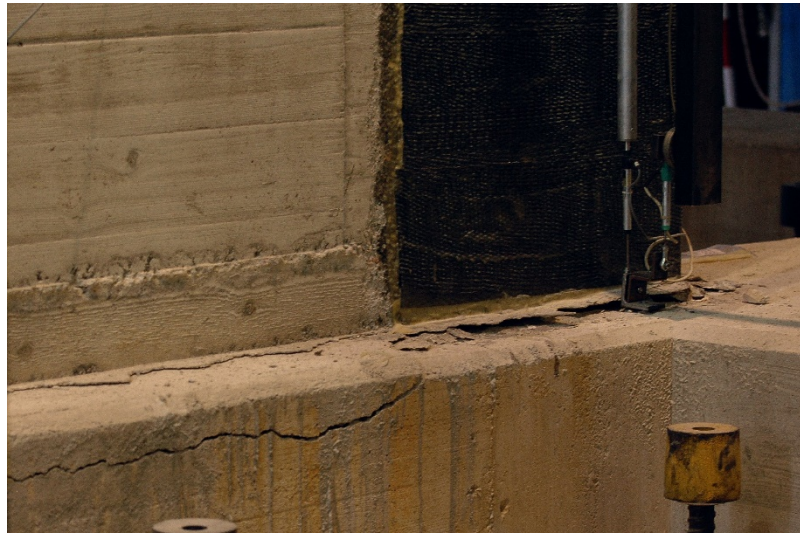
In the last test the horizontal crack opened further at the bottom of the north and south wall (Figure 8.9, Figure 8.10 and Figure 8.12). The crack ran under the CFRP jacket which kept other parts of the columns undamaged. Cracks also developed in the foundation beams (Figure 8.9) under the walls, which compromised local displacement measurements of the transducers fixed at the foundation

Figure 8.9 Position 7: Horizontal crack developed also in the foundation beam

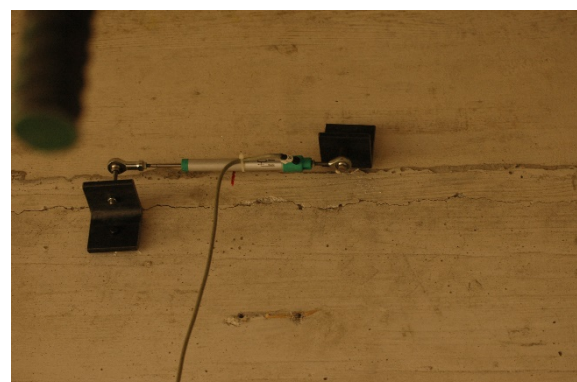
In the ground floor cracks between the infill wall and the surrounding frame were noticed (Figure 8.13), indicating slip between these two elements. However, local measurements show that the horizontal slip (between wall and beam) remained under 0.8mm (Figure 10.56), whereas the vertical slip (between wall and column) remained under 0.4mm (Figure 10.57).

Figure 8.13 Position 1S: Slip crack at the top of the southern wall in the ground floor
