Review of Non-Engineered Houses in Latin America with Reference to Building Practices and Self- Construction Projects

Aikaterini Papanikolaou, Fabio Taucer

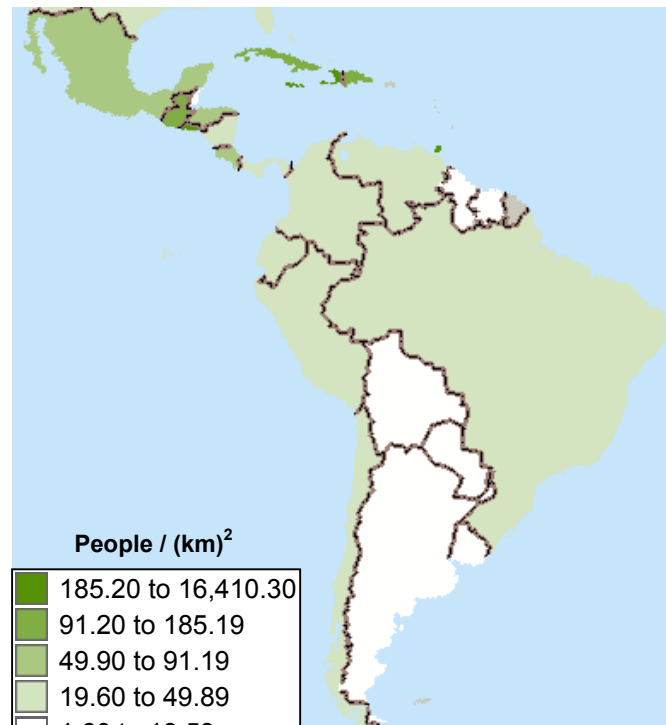
Fig. 1-6 Average number of people per square kilometre.

The total number of deaths and injuries is likely to be much higher in densely populated areas. As demonstrated in Fig. 1-6, this condition holds true for most of the Central American countries. Furthermore, the highest population density in these countries is located in the vicinity of active or dormant volcanoes, as well as in the areas of contact between the tectonic plates that produce frequent and strong earthquakes. An explanation exists for these demographics: people have always chosen to settle in high-risk zones, since these are generally the areas with the most benign climate and the best agricultural lands. Moreover, a relatively large percentage of the population, especially in urban areas, is living in highly vulnerable zones due to a dearth of sufficiently detailed maps revealing such vulnerabilities. Unfortunately, the same dearth extends to regulations and other legal measures that could be duly implemented (SG-SICA, 2002).

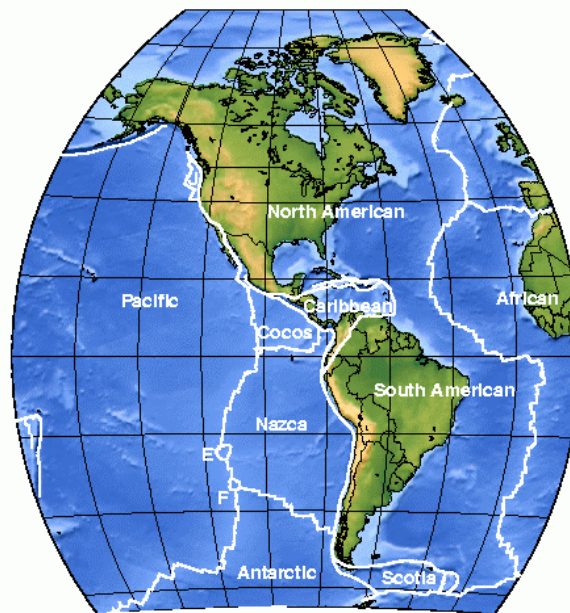
Fig. 1-7 (a) Tectonics of Central America and the Caribbean; (b) The major tectonic plates of the Americas are named in white letters. [sources: (a) Weyl, 1980; (b) http://seismo.ethz.ch/gshap/paigh/shedams_1.gif]

Intense seismic activity in the region is attributed to its geological morphology. The Andes, Caribbean, and Central American mountains, which are the main landforms of the region, are seated where major tectonic plates interact (Figs 1.7a & b). Generally, 90% of all earthquakes occur along the plate boundaries. Almost all of the known major earthquakes in the Americas have occurred along the western edges of these three plates, where they are overriding, or sliding past the Pacific, Cocos, Nazca, and associated smaller plates (Fig. 1-8). Tectonic movement, though, is not the only reason for which earthquakes occur in this part of the world. The mountains of the Caribbean and of Central and South America are geologically young, with a great number of volcanoes¹³ (Fig. 1-9); their activity also induces seismic events.

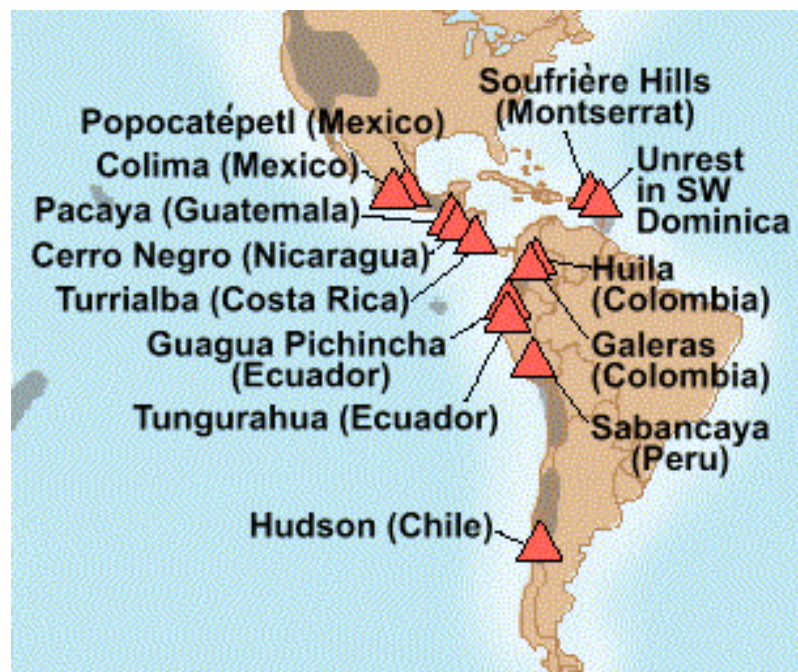
Fig. 1-9 Major volcanoes in Central and South America and the Caribbean.
(source: Ewert et al., 1997)

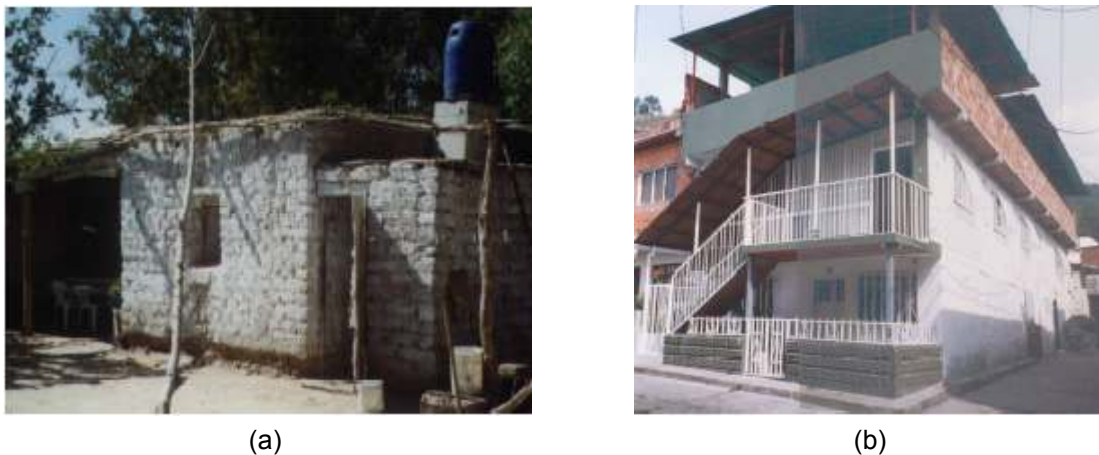
Fig. 1-12 (a) Traditional adobe dwelling in Argentina; (b) Non-engineered reinforced concrete frame building in Venezuela. [sources: (a) EERI, 2003; (b) EERI, 2002]

According to Arya (1994), “non-engineered buildings” are defined as those that are spontaneously and informally constructed in various countries in the traditional manner without any or little intervention by qualified architects and engineers in their design. These vernacular dwellings are proportioned based on experience (rules of thumb passing from one generation to the other) and they are mostly made out of wood, clay, concrete blocks, sun-dried clay bricks (adobe – see Fig. 1-12a), field (or rubble) stone and brick, as well as combinations of these locally available materials. Cement, lime, or clay-mud are generally used for mortar compositions.

Additional to these traditional structures, non-engineered reinforced concrete (RC) frame buildings are also part of the bulk of buildings built today in an informal way, by semi-skilled professional builders (Fig. 1-12b). The quality of concrete and the placement of reinforcement are usually considered to be low. Most non-engineered reinforced concrete buildings consist of moment resisting frames with unreinforced infill walls made of hollow clay bricks or hollow concrete blocks. They are usually two- to five-storeys high and square in plan, although additions/alternations result in more irregular layouts. Weak or soft stories are common, while shear walls are rarely used. Floors are typically reinforced concrete slabs. The larger dimension of the column cross section is usually oriented in the same direction through the whole building, while the short dimension of the cross section matches the wall thickness. This results in the weak direction coinciding with the strong beam – weak column condition.

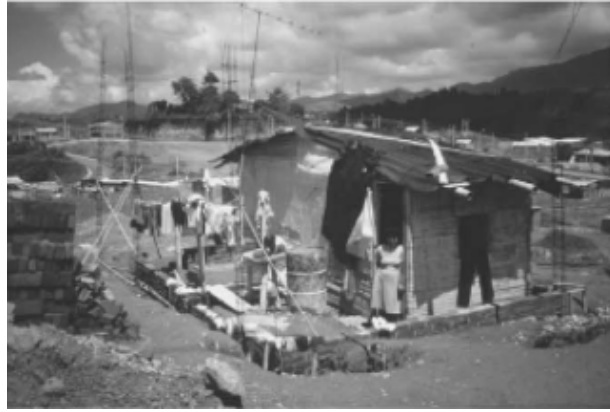
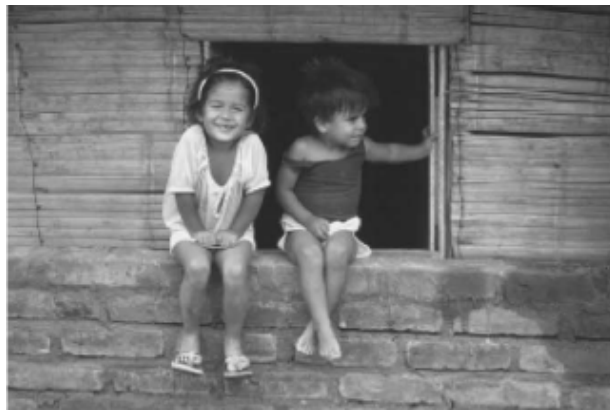
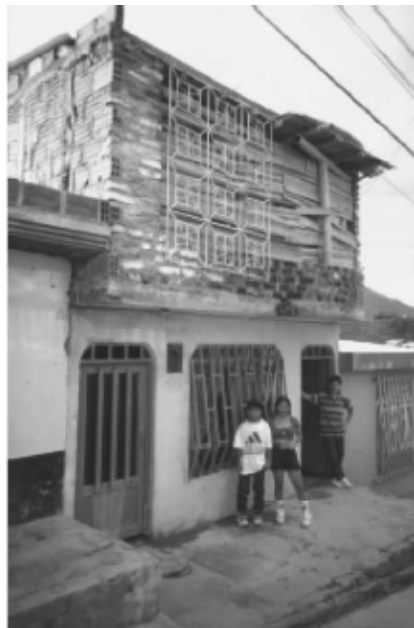
Fig. 1-14 (a) A small bamboo house (*ranchito*) in Pereira, Colombia, around which the family have started to build brick walls (1987); (b) Six months later the brick walls have reached window height; (c) Ten years later, two floors have been built: the family lives on the first floor and rents out the ground floor. (source: Gough and Kellet, 2001)

There are many possible routes from the typically small, temporary, one-room, un-serviced dwellings, to large, permanent, multi-room, fully serviced dwellings. Many houses are slowly, but steadily consolidated in an incremental way with rooms gradually being added and facilities upgraded, as income allows (Fig. 1-14). Other houses remain unchanged, receiving little more than basic maintenance and remain at this stage for long periods; when the opportunity arrives they are expanded as quickly as possible.

The various stages of the consolidation process for the self-built houses are characterized, according to Gough and Kellet (2001), as follows: temporary (non-permanent materials and form), hybrid (a dwelling which includes some permanent construction, combined with temporary elements), developing (a dwelling mainly in permanent, but unfinished materials) and completing (a dwelling with living room, kitchen and at least two bedrooms with wall finishes in some rooms). Because of the continuous and incremental nature of most construction, it is rare to find dwellings, which are regarded by their owners as "*casas terminadas*" (completed houses).

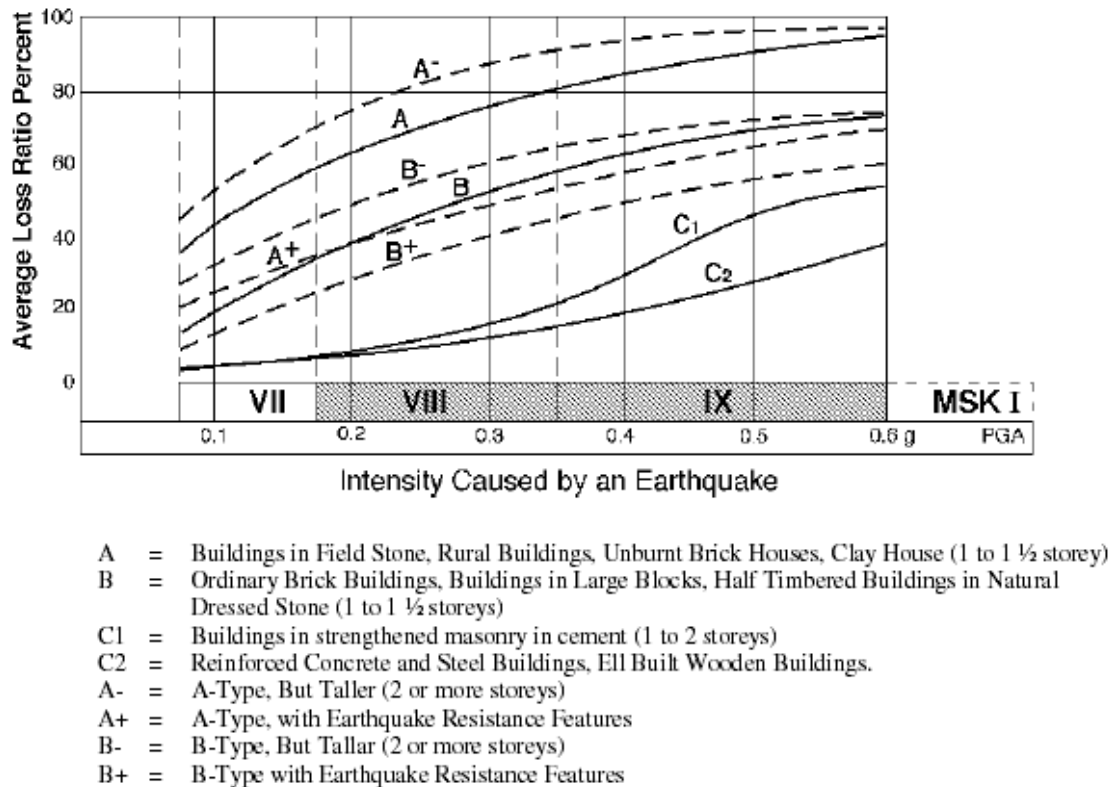
Fig. 1-15 Vulnerability functions based on the MSK seismic intensity scale. (source: Arya, 2000)

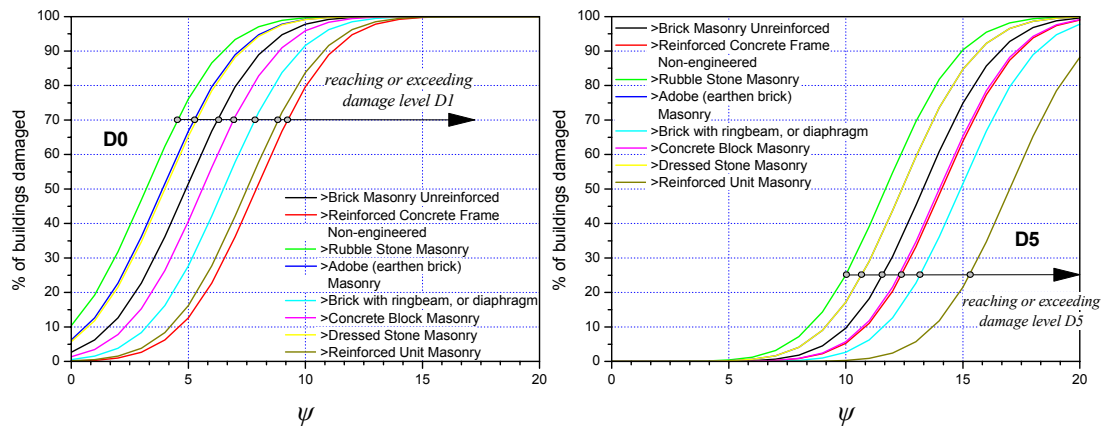
Fig. 1-17 Comparison of damage type thresholds between (a) Slight and no damage (D0-D1); (b) Total and partial collapse (D4-D5).

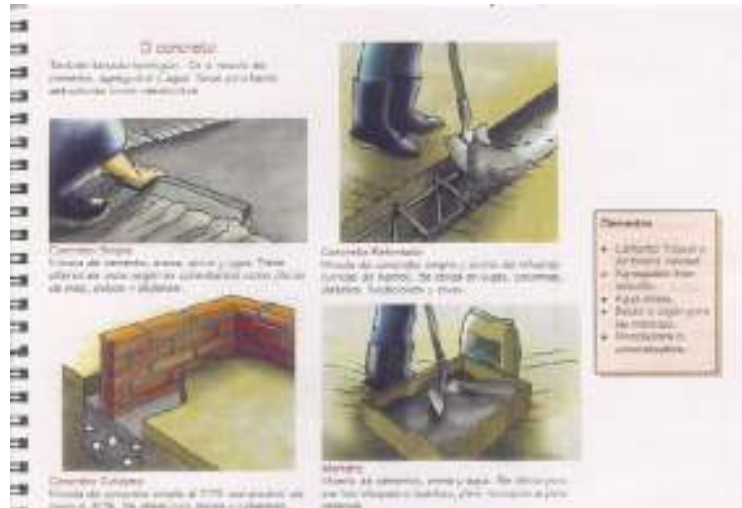
Fig. 2-3 A page from the construction manual developed for a self-help construction project in Colombia. (source: Federación Nacional de Cafeteros de Colombia. "De los corazones sismo resistentes del Quindío para Colombia: Guía práctica de construcciones sismo resistentes para viviendas de uno y dos pisos", Quindío, 1999)

To reinforce the self-help programs, the CGF published an educational guide (manual) for the construction of earthquake-resistant one- and two-storey houses. The guide, illustrated with multiple colour drawings and schemes, provided not only technical instructions but also general knowledge in a basic language appropriate for communities with little education. The guide described processes and recommendations for concrete and masonry construction (Fig. 2-3). As a complement to the same program, a second guide was provided to the community. The latter described processes and recommendations for construction of one-storey houses using traditional technologies, adopting *guadua* as the main structural material. Also in this case, colourful easy-to-read graphics were used to reach most of the population¹⁷. The actual construction was supervised by a selected group of specialists in order to guarantee the earthquake-resistance of the structures and finishing.

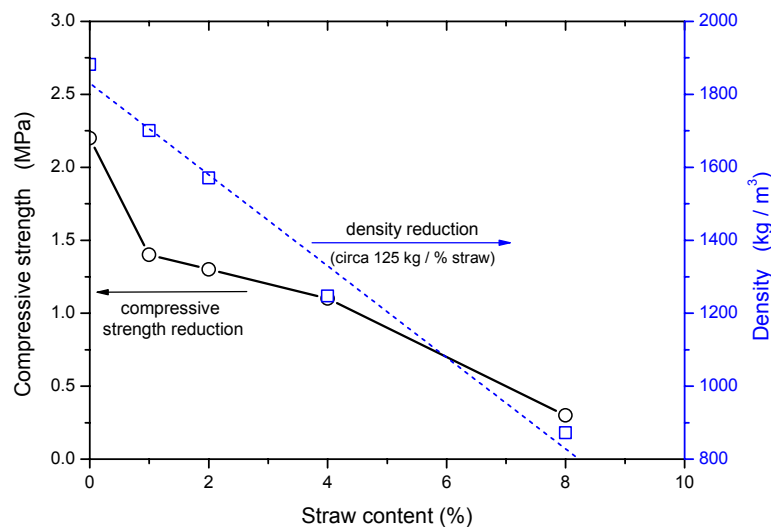
Fig. 3-6 Reduction of the compressive strength of earth mixture, by adding cut straw (50 mm in length). (source: an investigation conducted at the FEB, referenced by Minke, 2000a)

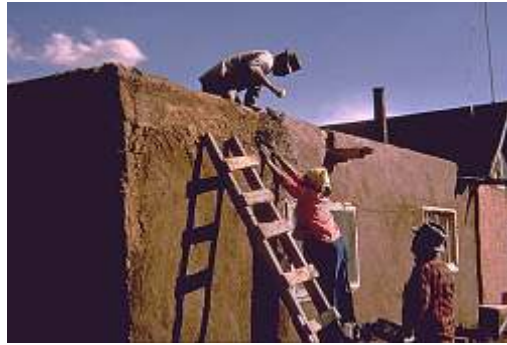
Fig. 3-7 Family plastering an adobe house.

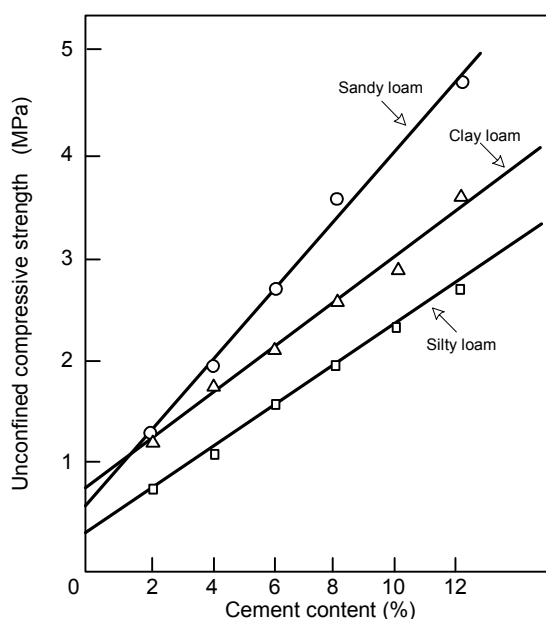
Fig. 3-9 Relationship between unconfined compressive strength and cement content.
(source: Akpokodje (1985))

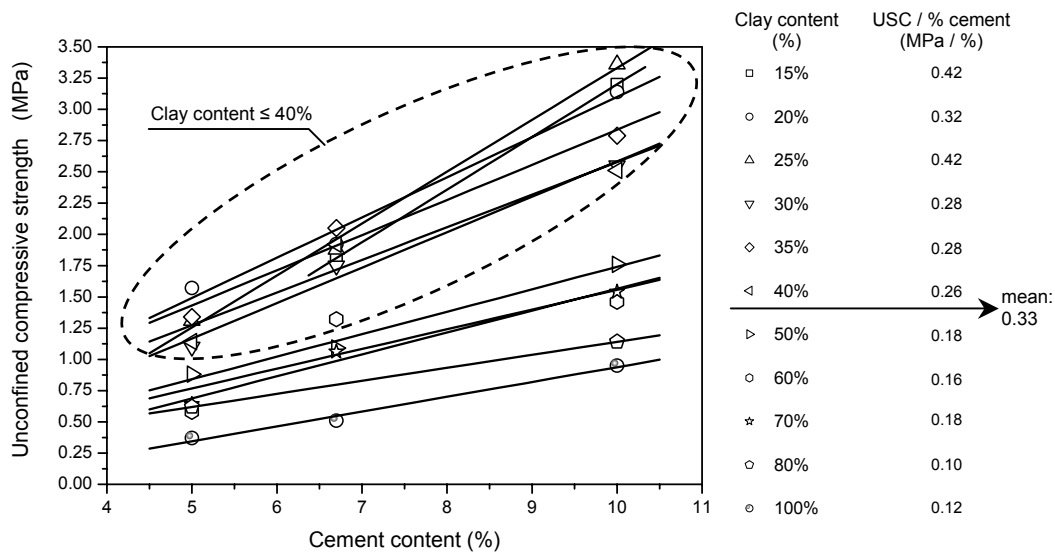
Fig. 3-10 Unconfined compressive strength versus cement content, based on data provided by Walker (1995). Linear regression results are also noted.

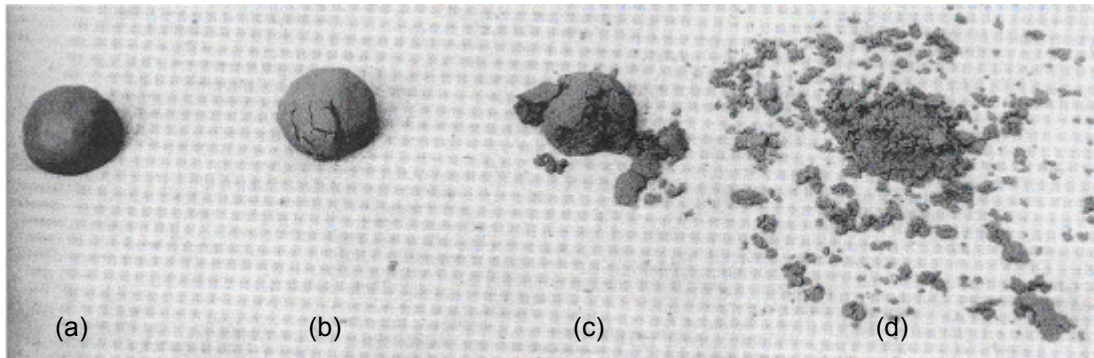
Fig. 3-12 Loam balls after the dropping test. (source: Minke, 2000a)

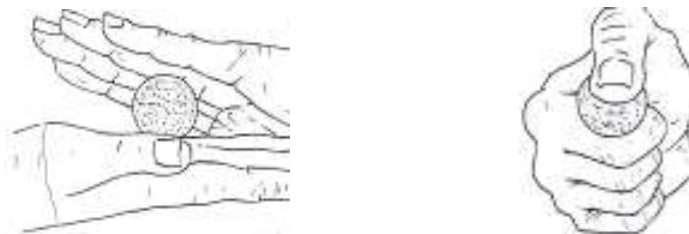
Fig. 3-13 Dry strength test of soil, as per IAEE, 1986.

- *Dry Strength Test (IAEE, 1986)*: Five or six small balls of soil of approximately 20 mm in diameter are made. Once they are dry (after 48 hours), each ball is crushed between the forefinger and the thumb (Fig. 3-13). If they are strong enough that none of them breaks, the soil has enough clay to be used in adobe construction, provided that some control over the mortar micro-fissures caused by the drying process is exercised. If some of the balls break, the soil is not considered to be adequate, because it does not have enough clay and should be discarded.

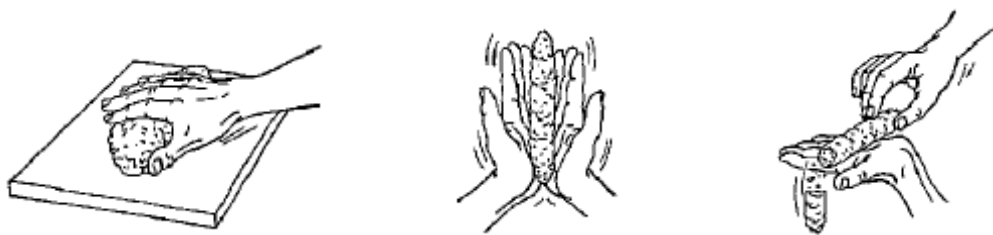
Fig. 3-14 "Cigar" test, as per CRATerre-EAG, 1995.

- *“Cigar” test (CRATerre-EAG, 1995)*: This test enables one to observe the cohesion of the soil and above all, the quantity and quality of the clays present. All gravel is firstly removed from the sample, which is then moistened and well kneaded until a smooth paste is obtained. The sample is left to stand for 30 min (or more, if possible) to allow it to become very smooth. Consequently, the loam is rolled between the hands into a cigar shape of 30 mm in diameter. The “cigar” is placed across the palm of the hand and pushed gently forward with the other hand, until a piece breaks-off (Fig. 3-14). The length of the piece that breaks-off is measured, the procedure is repeated for several times, and an average value of the measured lengths is obtained. If this length is less than 50 mm, the soil contains too much sand, or if it is found to be more than 150 mm, then the soil contains too much clay. Values between 50 and 150 mm indicate that the soil has good cohesion.

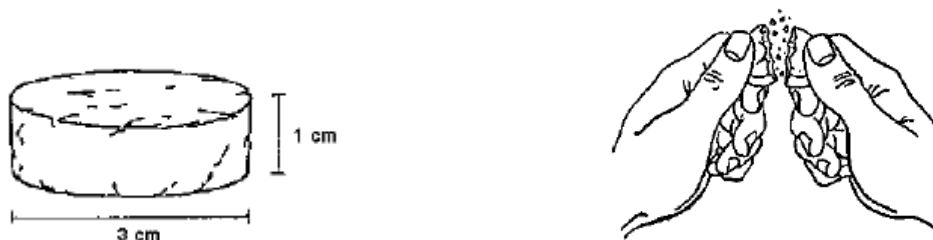
Fig. 3-15 "Biscuit" test, as per CRATerre-EAG, 1995.

- *"Biscuit" test (CRATerre-EAG, 1995)*: As in the "cigar" test, a gravel-free soil sample is moistened and well kneaded until a smooth paste is obtained. The lump is moulded into flat biscuit-shaped discs approximately 30 mm in diameter and 10 mm thick, which are left to dry. If the biscuit is cracked or if there is a clear gap between the dried sample and the sides of the mould, the soil contains too much clay. Also, if the "biscuit" is very hard to break (i.e. if it breaks with an audible crack), then the soil has a high clay content. On the contrary, if the disc is brittle, but breaks fairly easily and can be crumbled between the thumb and forefinger, the soil is classified as a good, sandy-clayey one.

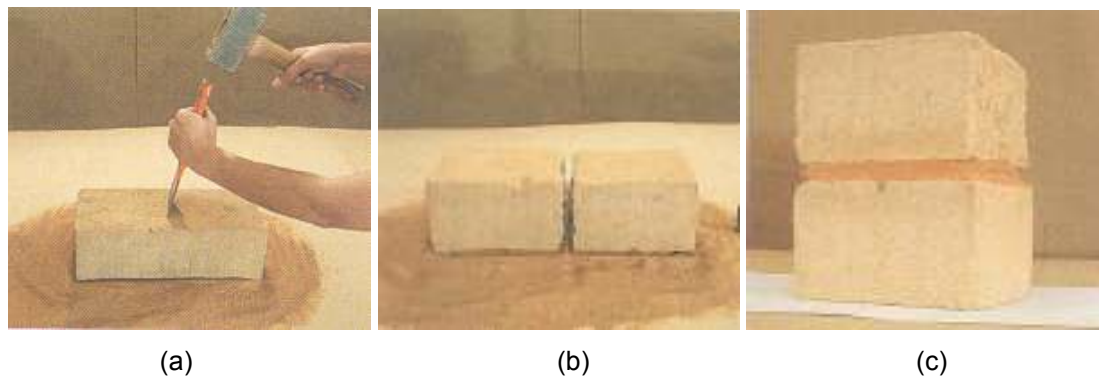
Fig. 3-18 (a) Breaking up a single brick into two pieces; (b) The two half-blocks; (c) Sample to be tested in unconfined compression.

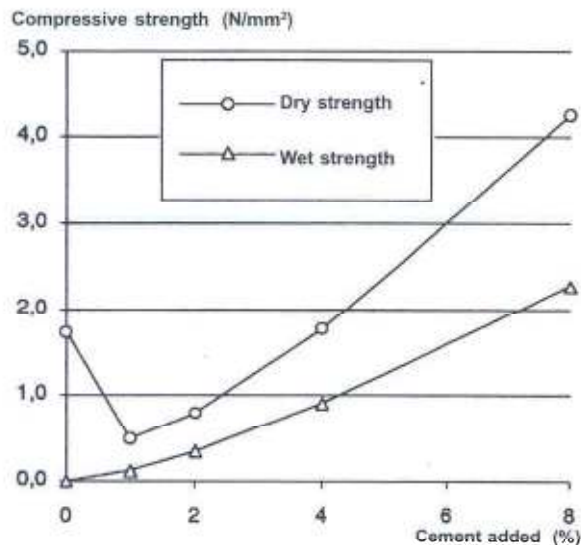
Fig. 3-19 Dry versus wet compressive strength of handmade adobes with varying contents of cement. (source: Minke, 2000a)

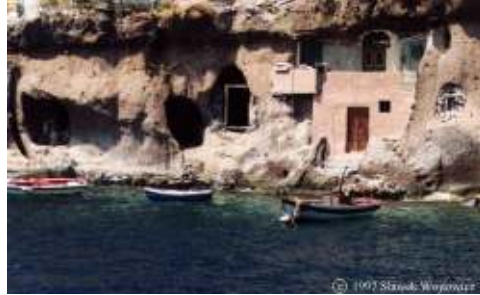
Fig. 3-24 Cave houses in Santorini.

In the Aegean island of Santorini, the slope and hardness of the ground, coupled with the need for material saving, led to the creation of vaulted caves dug into the top layer of the volcanic ash that were used as dwellings (Fig. 3-24), stables, wineries, etc. Besides the ease of construction, a major advantage of these excavated dwellings is their remarkable seismic and thermal performance (Stasinopoulos,

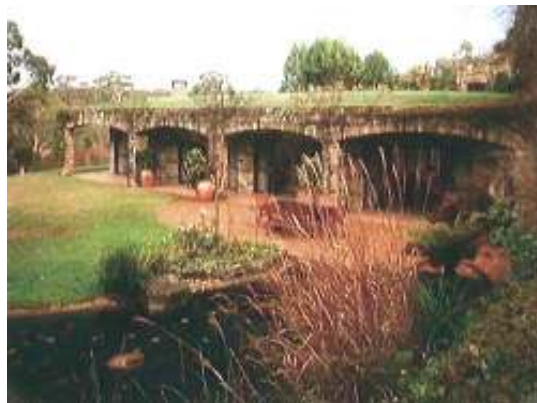
Fig. 3-25 Earth-sheltered house. (source: <http://www.paulinehurren.com.au/earth.html>)

There are two basic types of earth-sheltered housing—underground and “bermed” (or banked with earth). Certain characteristics such as the location and soil-types of the construction site, the regional climate, and the design preferences are central to which type of earth-sheltered housing is the most appropriate one. Underground housing means an entire structure built below grade or completely underground. A bermed structure may be above grade, or partially below grade, with outside earth surrounding one or more walls (see Fig. 3-25). Both types usually have earth-covered roofs, and some of the roofs may have a vegetation cover to reduce erosion (source: <http://www.eere.energy.gov/erec/factsheets/earth.pdf>).

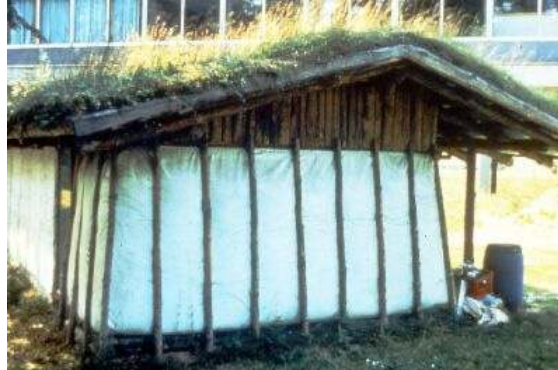
Fig. 3-26 Germany, Kassel School of Architecture. (source: Minke)

Research Institute, University of Kassel, Germany, 1978) involves the construction of walls, which are formed by two layers of jute²¹ fabric. Thin wooden posts are hammered into the ground and the fabric is fixed to these from the inside. The space between is filled with soil (Fig. 3-26). The last technique makes the use of discarded car tires in-filled with soil dug out from the foundation of the structure under construction.

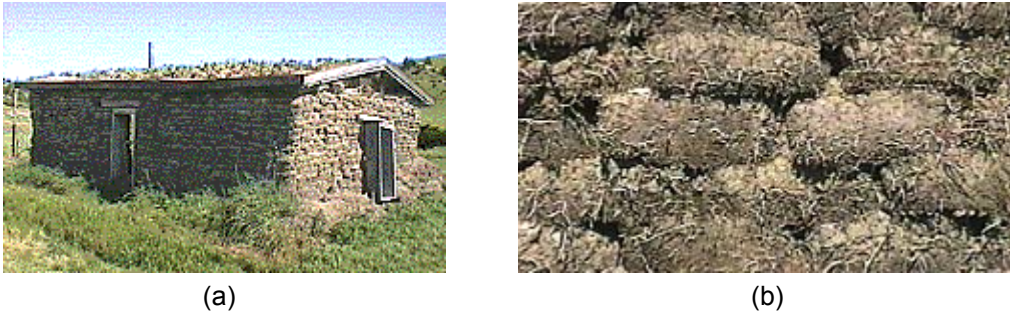
Fig. 3-27 (a) A “soddie” house; (b) Wall detail.

“Soddies” are small houses with walls built of stacked layers of uniformly cut turf (sod). The individual “bricks” of sod are held together by the thick network of roots that made preparing fields for planting so very difficult. Sod is cut with special plows, or by hand, with an axe and/or shovel. Roofs are made from timber, rough or planed, and covered with more sod. If timber is not available, roofs are built up with twigs, branches, bushes and straw. The building in Fig. 3-27 is at Ash Hollow, Nebraska, and was reconstructed in 1967 (from: <http://websteader.com/wbstdsd1.htm>).

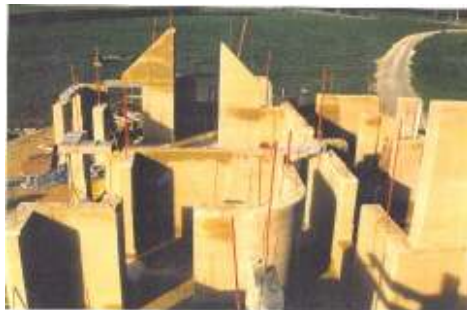
Fig. 3-28 Rammed earth house in Otorohonga, New Zealand.

Rammed earth construction (also referred to as *tapial* in Latin America, or else, *pisé de terre*, in France) is conducted by erecting wooden or metal forms for the walls and filling them with a moist cement stabilized earth mix which is compacted by pounding with hand tools (with conical or flat heads) or with a mechanical compactor. Metal rebar is often added to further increase ductility. Different kinds of earth or mineral compounds are sometimes added to each earth layer (of thicknesses ranging between 100 and 150 mm) for the sake of decoration. The finished walls are massive and monolithic (Fig. 3-28), offering high strength, high thermal mass and higher insulation value than block/brick construction. High load bearing strength allows for multi-storey structures, usually based on floor decks supported by massive wood beams. The same types of roof systems employed with adobe can be used but metal or shingle roofing with a wide overhang is more typical. No surface finishing is required except for aesthetic effect. A beeswax finish is typical for the interiors as it allows the attractive wall texture to remain visible.

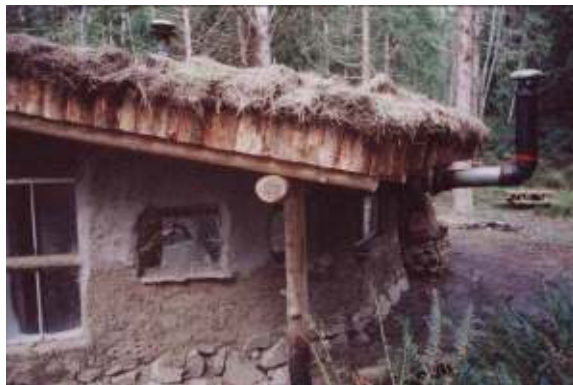
Fig. 3-30 Cob house in Mayne Island, Canada. (source: <http://www.cobworks.com/maynegallery.htm>)

Construction begins with a foundation system akin to adobe, but often much higher off the ground (Fig. 3-30), particularly where damp climate makes ground seepage a critical issue. Courses of damp cobs are stacked along wall lines with one to a couple of layers completed within a day. Modern cob construction may top the walls with a concrete bond beam, use a wooden bond beam, or a separate roof frame supported on a post and beam system (Hunting, 2003).

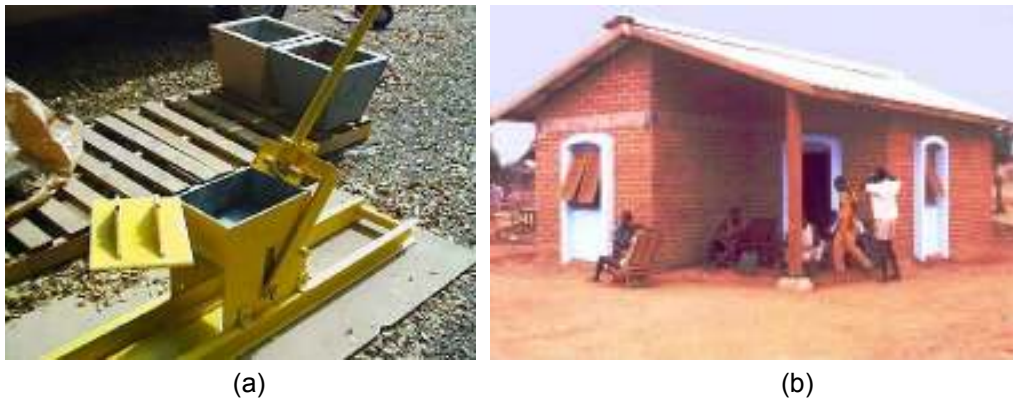
Fig. 3-31 (a) A “Cinva ram” press; (b) This house was built using compressed earth bricks in Ivory coast, within 10 days, by trainees, who were part of a local development program. [sources: (a) <http://www.northcoast.com/~tms/adobe.html>; (b) <http://www.earth-auroville.com>]

The mechanically compressed earth blocks are basically similar to the adobe ones; the main difference is in the method of block fabrication. Instead of a wet mud being loaded into moulds and air dried, this type of block uses a drier mix of earth with a stabilizer, such as cement, which is loaded by bin into a molding machine. The hand-operated press machine is commonly referred to as a "Cinva ram" (Fig. 3-3). There are several different types of presses. *Manual presses* carry out only the (static) compression and ejection of the blocks, and can be mechanical, hydraulic or both, in operation. *Motorized presses* enable higher production rates (e.g. greater than 800 blocks per day). Certain motorized presses may exert dynamic compaction. *Light mobile production units* (which are transportable) and *fixed*

production units (which are difficult to transport) are motorized, and sometimes automated. In addition to the compression and ejection of the blocks, they also carry out raw material preparation and/or removal of the products.

The compression process reduces the volume of earth and rearranges clay particles to form a more stable material matrix. Compressed earth blocks are denser (and hence, more durable) than adobe bricks, and offer a higher geometric uniformity. A comparative listing of appearance, performance and structural use of different building blocks is given in Table 3-7.

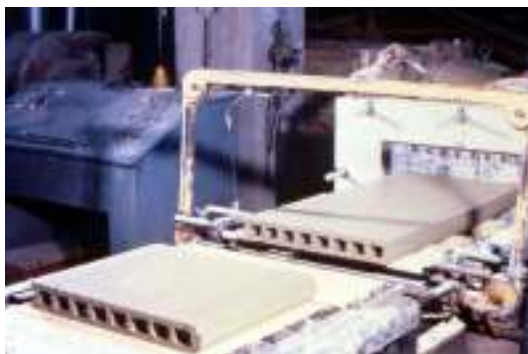
Fig. 3-32 Extruded earth profiles production line. (source: unknown)

A very clayey soil (large aggregates having been removed) is fed into a machine in the state of semi-solid paste and is extruded through it in different shapes. The blocks are often hollow (in order to reduce weight and increase thermal insulation) and are cut to the desired length, once these are on the delivery belt (Fig. 3-32); this technique was developed in the 20th century. Several companies in Germany and one in Switzerland are producing large extruded lightweight panels from earth, usually mixed with cut straw, or sawdust, or lightweight aggregates, like perlite. Their density varies from 800 to 1000 kg/m³ and they are used for non-load-bearing interior walls, or for the interior layer of exterior walls (Minke,

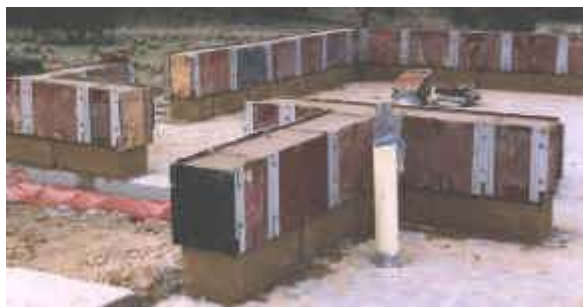
Fig. 3-33 Walls of poured earth in casting process, using the FORMBLOCK patented formwork system. (source: http://www.formblock.com.au/what_is_formblock.htm)

The technical name for poured earth is formwork cob. Like rammed earth, poured earth walls are erected between formwork (as in Fig. 3-33) using a sandy material with coarse to fine granular particles. The external walls (usually 300 mm thick) are load-bearing and can be engineered to 2-3 stories. The material usually contains 5-8% by volume of white cement at a ratio of about 20:1. Sufficient water is added to allow the mix to flow into the wall forms, which are left in position for about 12 hours. The ultimate finish can be natural - from the formwork- or sand blasted (source: <http://www.startingpoint.com.au/sppages/repe.htm>).

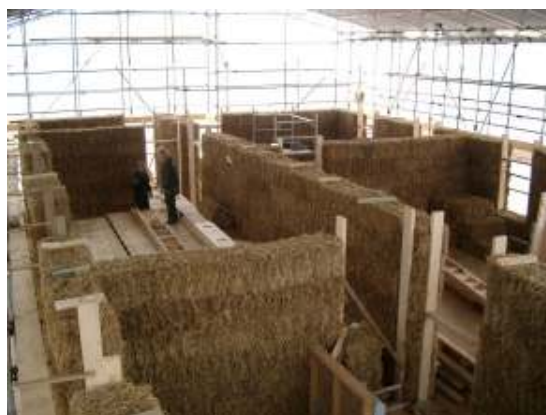
Fig. 3-34 Straw-bale house under construction.

2. *Structural bale* - The building process is akin to adobe construction, starting with the same type of foundation and using large bales of straw as “bricks” (Fig. 3-34). Automatic straw balers create tight building blocks that are stacked up to one- and one-half stories. The “straw bricks” are “nailed” in place using long metal pins (often threaded rod), tension cables or special gripping plates. The walls are then covered on both sides with a mesh lath, which is attached by wire pins on the bales, while the surfaces are plastered using a soil/straw mixture. As a load bearing wall system the bales must be topped with a bond beam of heavy lumber, steel or concrete.

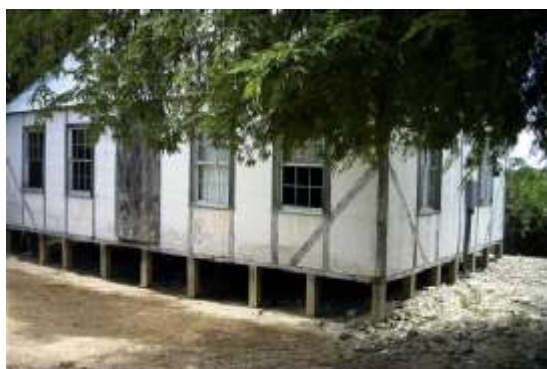
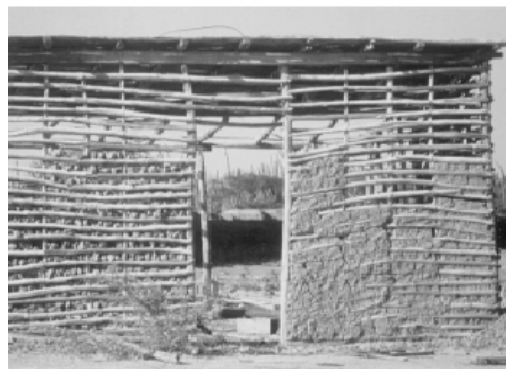
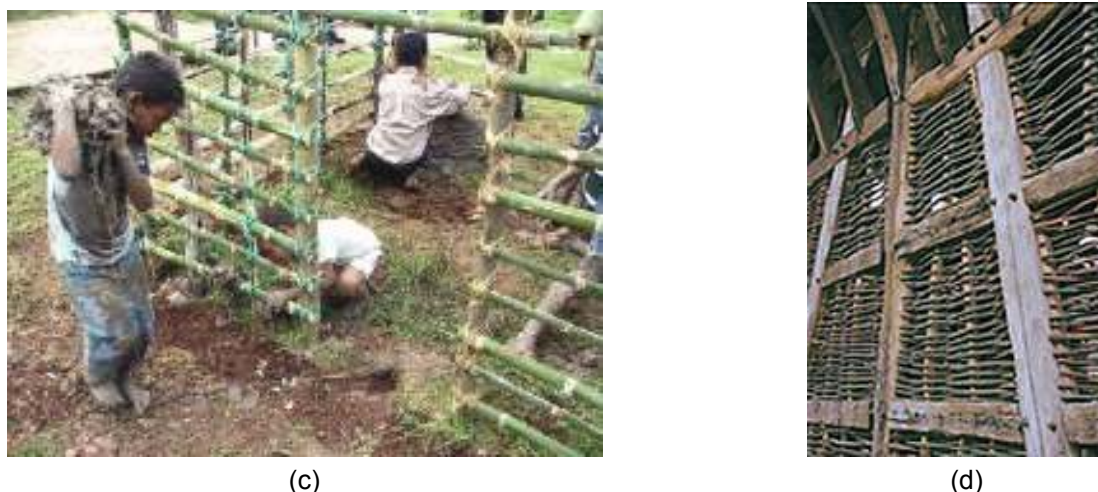
Fig. 3-35 (a) A wattle and daub building in Cayman Islands; (b) Traditional wattle and daub system, Venezuela; (c) *Quincha* building tutorial in Panama; and (d) Panel to be in-filled with earth. [sources: (a) <http://www.cayman500.ky/img/ACF14E6.pdf>]; (b) Minke, 2001; (c) photo by Barkema, D. in http://www.thepanamanews.com/pn/v_09/issue_13/community_01.html; and (d) <http://www.northcoast.com/~tms/papercrete.html>]

Typically, the technique consists in the in-fill of panels in timber framed structures (such as the one in Fig. 3-35a), comprising of vertical staves of timber (e.g. oak) or bamboo (Fig. 3-35b & c), interwoven with fine flexible branches or twigs (Fig. 3-33d), usually of hazel, of about one metre length and one centimetre diameter, and daubed with (by firmly pressing in) a mixture of mud, dung (daub) and chopped straw. These panels can be both single and double-layer grids. The resulting structural system is very light and flexible, as it is basically a timber frame structure with flexible joints and earth in-fill. The walls have neither insulation value nor thermal mass and systematic maintenance is needed, in order to compensate for the effect of weathering on the wooden or cane elements.

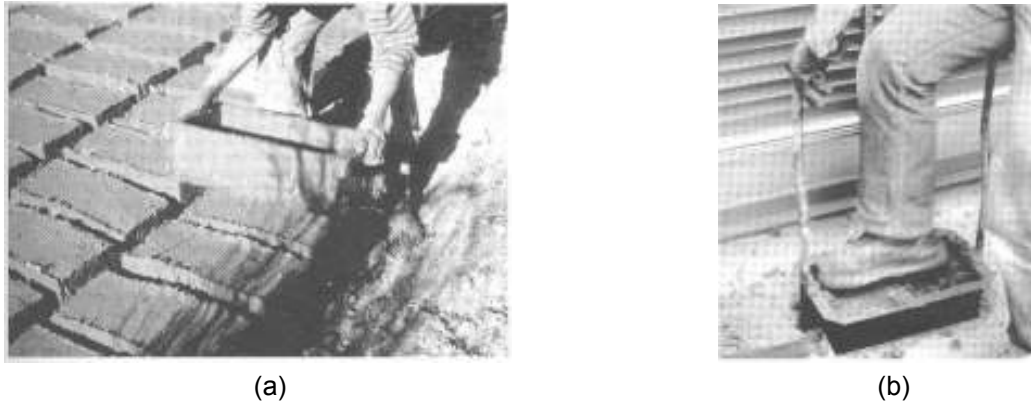
Fig. 3-36 (a) Arrayed adobe bricks, left to dry in the sun (Ecuador); (b) Releasing adobe brick off the (metal) mould. (source: Minke, 2000a)

When the bricks are stripped off the moulds, they are left to dry on a level surface covered with straw, sawdust, sand or grass to avoid any sticking (Fig. 3-36). After several days of drying, the adobe bricks are ready for air curing. This process consists of standing the bricks on the narrow edge for a period of four weeks or longer. Placing the bricks on the narrow edge minimizes the brick's exposure to the sun, slows down the drying process, and prevents cracking (Chayet et al., 1990). The drying period varies from country to country: from two weeks in Peru, to four weeks in El Salvador.

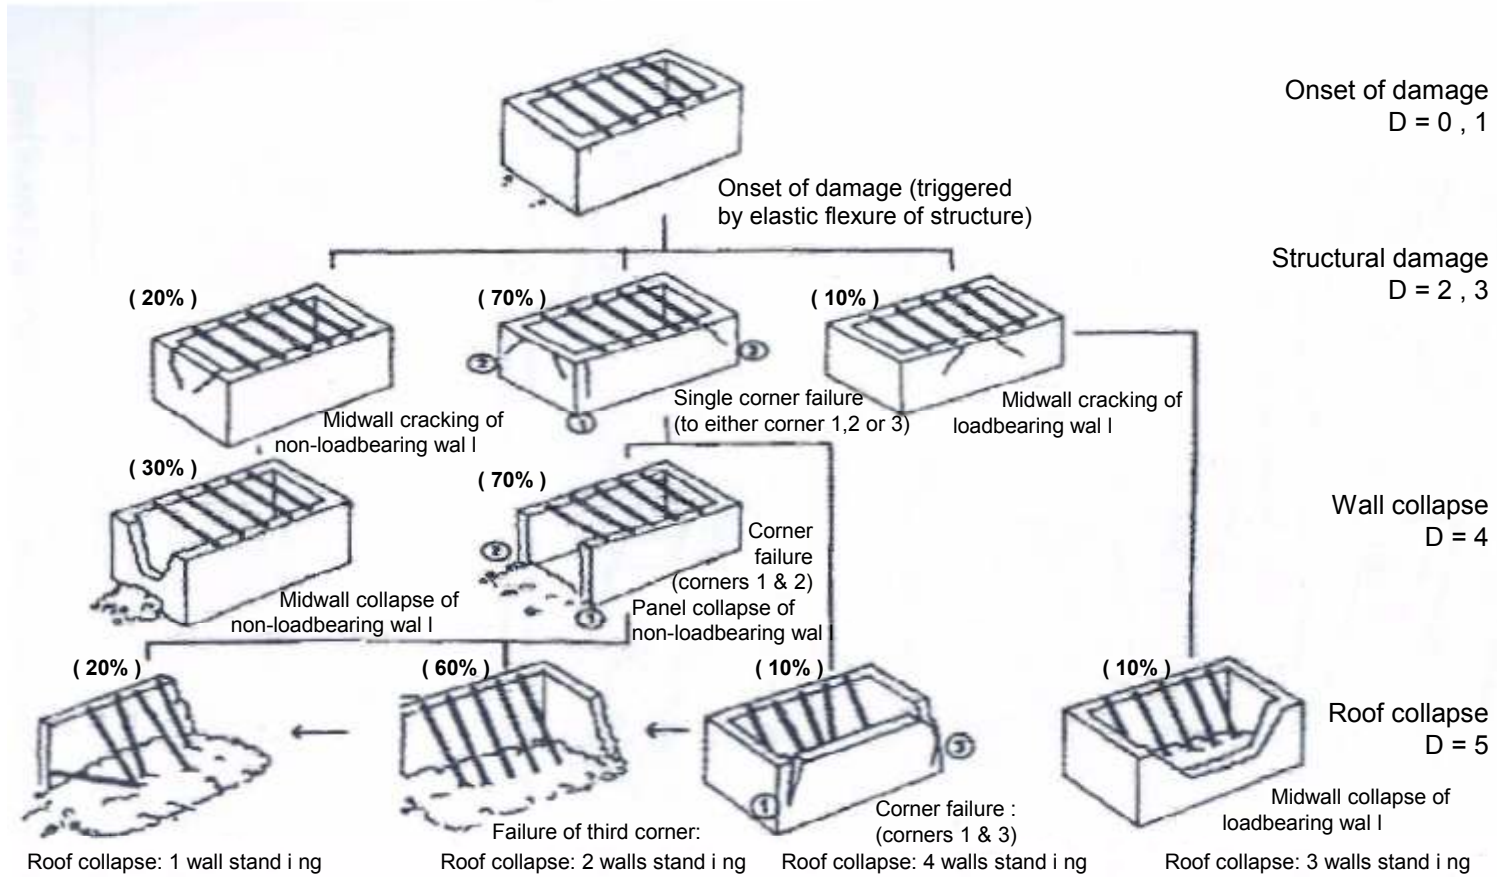
Fig. 4-2 Damage progress in weak masonry structural systems. (source: Coburn, 1986³)

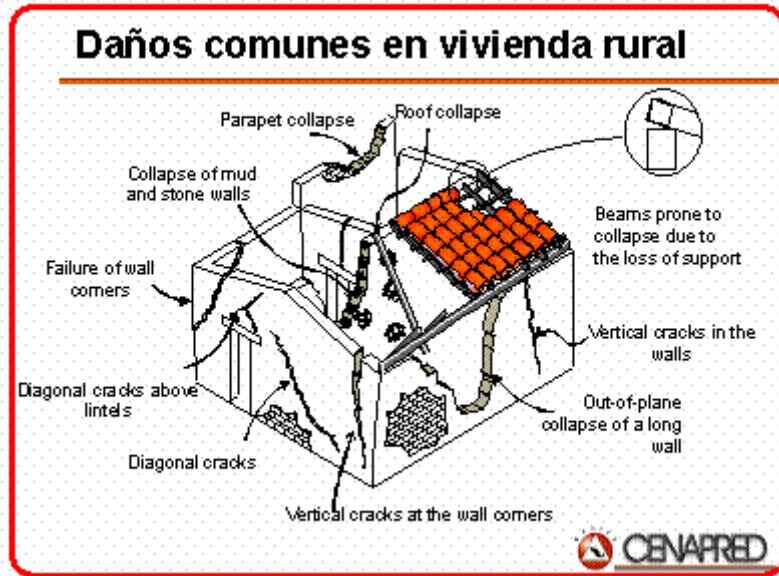
Fig. 4-3 Common earthquake-induced damages in adobe rural dwellings.
(source: CENAPRED, 2000)

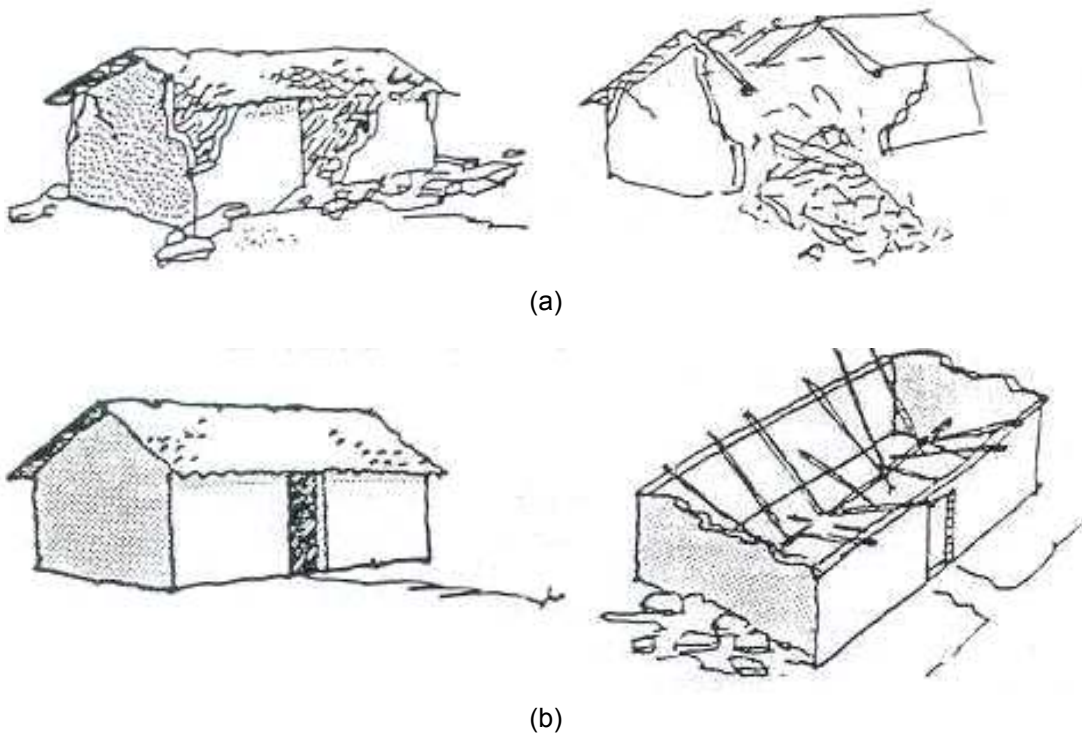
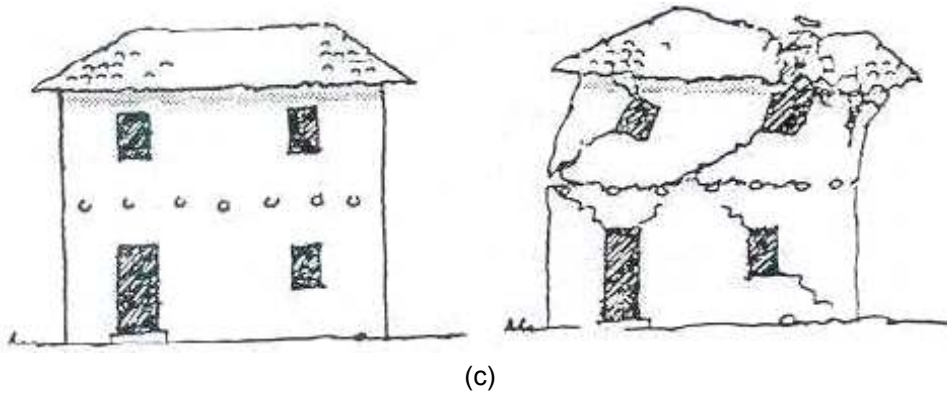
Fig. 4-4 (a) Corner failure and out-of-plane collapse of walls; (b) Effect of gables' collapse; and, (c) Two-storey house damage/collapse. (source: IAEE, 1986)

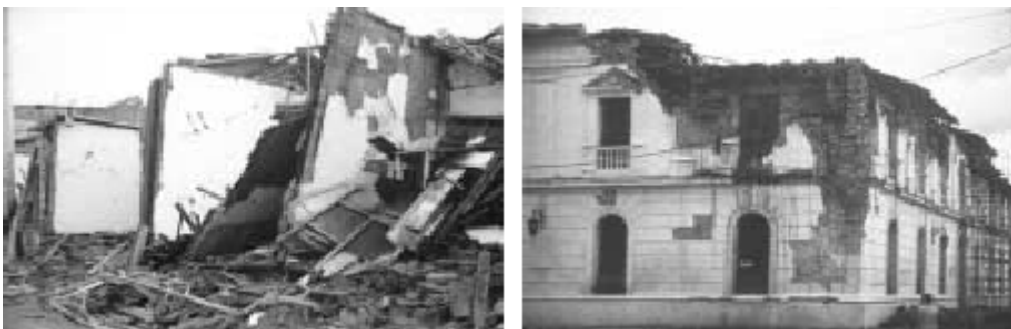
Fig. 4-6 Severely damaged rammed earth (“*tapiá*”) and *bahareque* dwellings. (source: AIS, 2002)

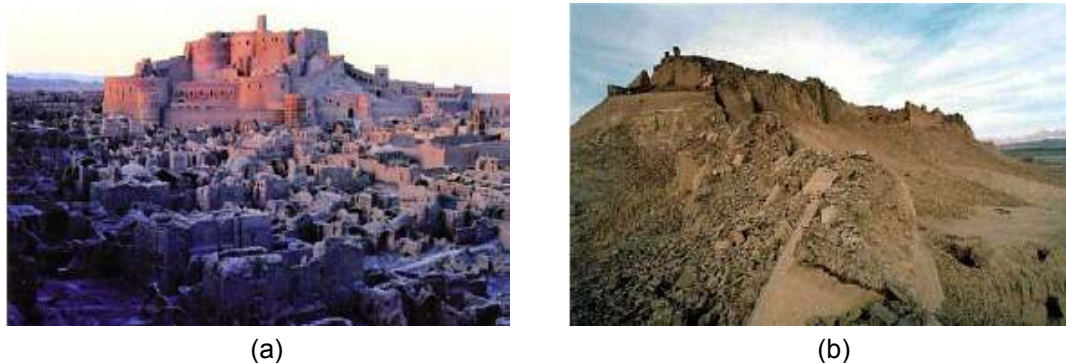
Fig. 4-8 The citadel in Bam: (a) before and (b) after the earthquake of December 2003. (source: Schroeder, 2004, "Building with Earth in Iran", available in: http://www.dachverband-lehm.de/pdf/DVL_terra2003_bam_gb.pdf)

In the light of the 2004 Bam earthquake in Iran⁵, resulting into a devastating death-toll and extensive damage to one of the world's most famous historical earthen monuments, the citadel of *Arg-e-Bam*⁶, more attention is expected to be paid by the academia to the issue of earthen structures in seismic prone areas in the immediate future⁷.

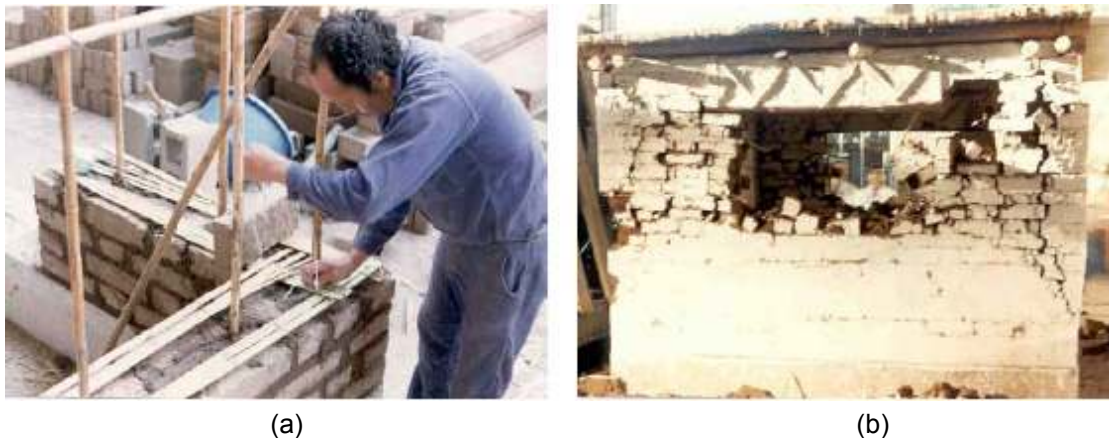
Fig. 4-11 (a) Cane reinforcement; (b) Reinforced module after a seismic test.

The main conclusions obtained were that improvements in the construction technique (the quality of materials and labour) by itself increased the resistance and stiffness of the uncracked walls, but had negligible influence after the occurrence of significant cracking. The horizontal and vertical cane reinforcement (Fig. 4-11a), combined with a solid collar beam can prevent the separation of the walls in the corners due to strong earth motion, and thus, can maintain the structure's integrity after the walls fail (Fig. 4-11b, Otazzi et al,

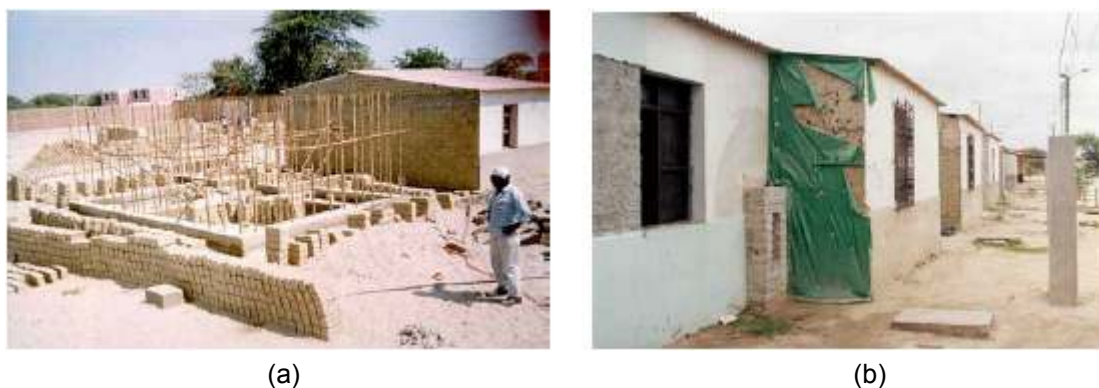
Fig. 4-13 (a) Cane reinforcement; (b) Finished dwellings after El Niño.

A project was then initiated for the sale of adobe dwellings through bank loans (Zegarra et al., 2004), as another attempt to disseminate the new technology among middle class urban dwellers. This project took place in the urban zone of the city of Piura, and was funded by the IDRC. Sixteen dwellings, 50 m² each, with a simple but well-completed finish, were built and sold. The cost per dwelling was approximately US \$ 5,000, financed through a ten-year loan. After the publicity campaign to let the population know of this project and to bring about the settlers' participation, it was clear that demand was much higher than supply, showing that the solution was attractive to middle class settlers. The houses were finished before the El Niño phenomenon of 1998 and they suffered little damage from the heavy rains. This shows that, with adequate protection, reinforced adobe dwellings are capable of resisting torrential rains (Figs. 4.13a & b).
