Review of Non-Engineered Houses in Latin America with Reference to Building Practices and Self- Construction Projects

Aikaterini Papanikolaou, Fabio Taucer

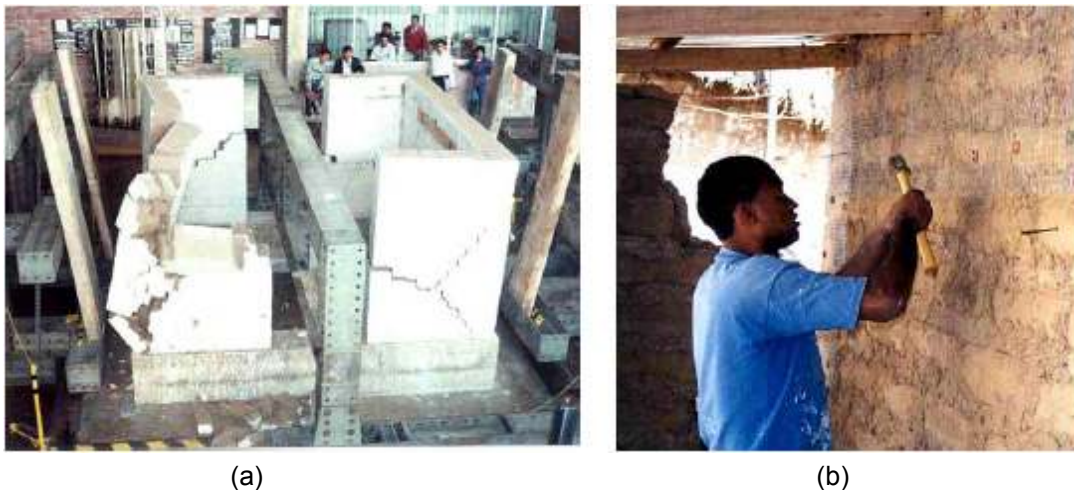
Fig. 4-14 (a) U Walls with and without mesh; (b) Wall wire mesh reinforcement.

Different reinforcement materials were tested, like wooden boards, ½-inch ropes, chicken wire mesh and steel welded meshes. Seismic simulation tests were performed on “U”-shaped walls, with and without reinforcement (Fig. 4-14a). The most efficient type of reinforcement, in terms of delaying the collapse of the structure, consisted of a welded mesh (1 mm wires spaced at ¾ inches), nailed with metallic bottle caps against the adobe (Fig. 4-14b, also see Chapter 5). The mesh was placed in horizontal and vertical strips simulating beams and columns, and was covered with mortar made with cement and sand. The strengthening method has been adopted by other Latin American countries, such as in Ecuador (see: Aguiar Falconí,

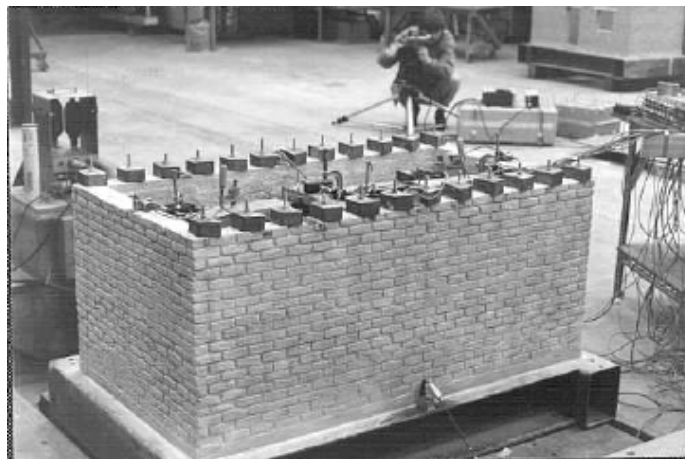
Fig. 4-15 One of the model adobe houses tested by Tolles. The roof is simulated through the addition of weights on the long walls. (source: Tolles and Krawinkler, 1990)

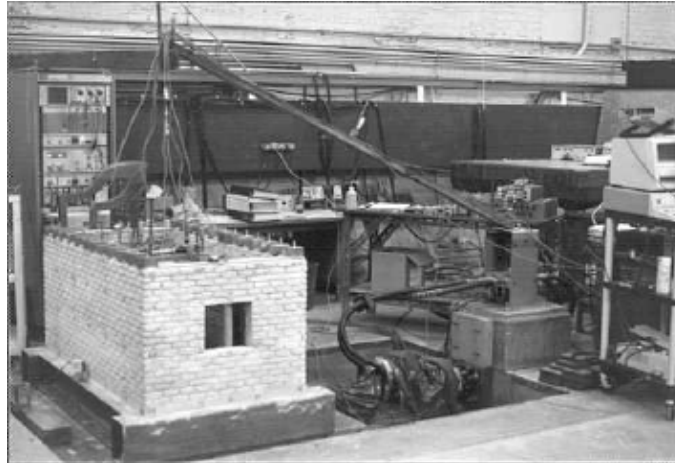
Fig. 4-17 Specimen mounted on the seismic table.

The schematics of every specimen used in the experimental program are given in Fig. 4-16. The shaking table tests (see Fig. 4-17 for the set-up configuration) provided basic information on the extent of damage and the types of failure that occur in adobe buildings during major seismic events. Wall overturning was the most often observed mode of failure. A lighter roof delayed initial structural damage but had negligible effect on the model's resistance to collapse. Both anchored roof beams and bond beams tied the walls together, helped prevent wall overturning, and increased the model's resistance to collapse. Figure 4-5 provides a summary of damages induced to the model houses through simulated shocks of increasing intensity.

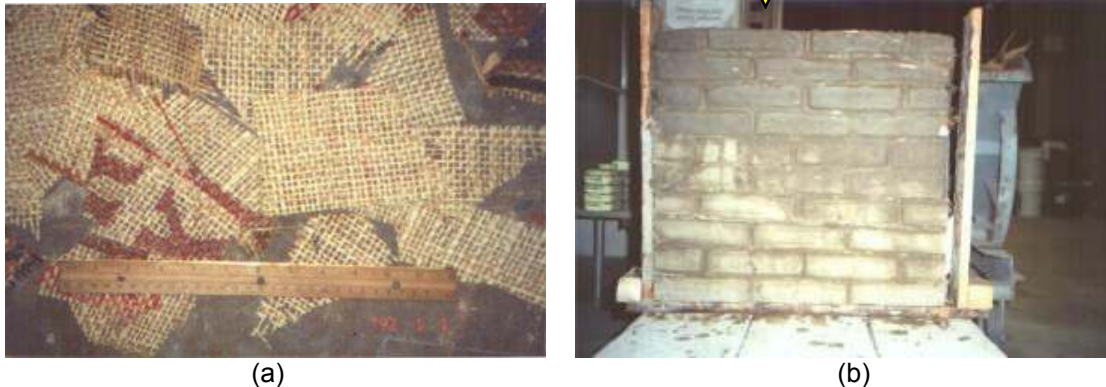
Fig. 4-18 (a) Burlap pieces cut from coffee bags; (b) Control specimen in the process of drying. (source: <http://www.engineering4theworld.org/adobe.html>)

Taking into consideration that the target population in the regions of interest would have difficulty finding entire sheets of burlap sufficient for constructing a house, two methods of layering burlap in the mortar were tested through diagonal compression tests: 1) a continuous, uncut horizontal layer and 2) a layer of overlapping pieces cut to lengths from 100 to 130 mm and to a width that matches the depth of the wall unit (100 mm, see Fig. 4-18a). The third wall unit was a control specimen containing no burlap¹⁶.

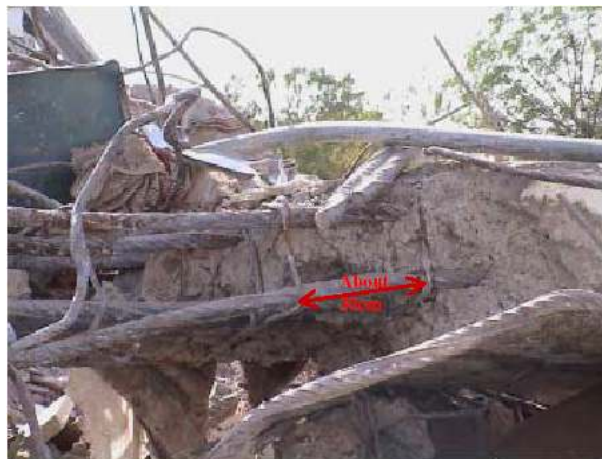
Fig. 4-20 Close-up view of the rubble from a damaged multi-storey building in Ahmedabad (namely the Manasi complex), after the Gujarat (western India) earthquake of 26 January, 2001; the photo shows the reinforcement arrangement and the quality of concrete used in the columns.¹⁹ (source: Karkee and Itagaki,

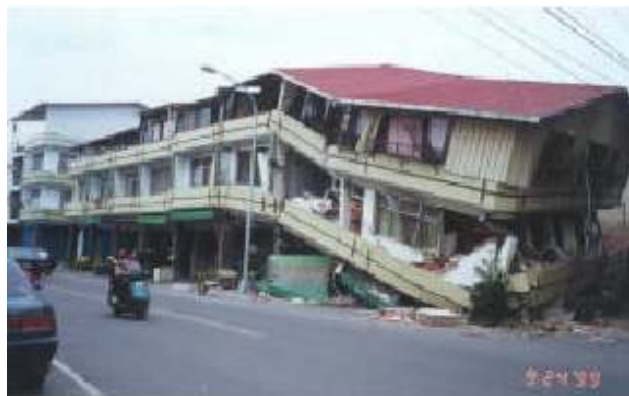
Fig. 4-21 Collapse of a building with an open front (a pedestrian corridor), following the 1999 earthquake in Central Taiwan (also known as the 921 Chi-Chi earthquake)²⁰. (source: Tsai et al.,

ground floor of buildings, is attributed to the development of a “soft-storey” mechanism, and takes place in stories of relative lower strength and stiffness that experience most of the displacement demand imposed by the earthquake. These soft stories experience large, uncontrolled deformations that result in partial or total collapse. Soft stories are usually developed in the presence of large openings, such as windows, pedestrian corridors, garages and open fronts used as windows for commercial purposes (Fig. 4-21). These openings are usually located asymmetrically through the plan of the building, causing further problems related to torsion.

after the main shock. The 921 Chi-Chi earthquake caused collapses or damages of various degrees to approximately 9,000 buildings. A large percentage of buildings that collapsed were un-reinforced clay block masonry houses and non-engineered one-to-three stories reinforced concrete frame structures, with brick infill partitions and exterior walls. Although the authors do not specifically identify the building shown in Fig. 21 as a non-engineered one, this photo successfully illustrates the “soft-storey” type of failure, which is common in many non-engineered RC structures.

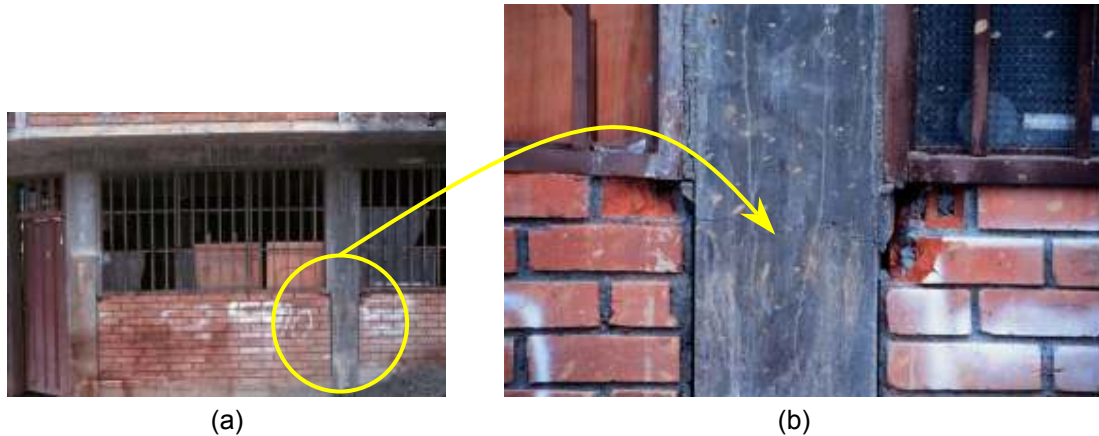
Fig. 4-22 (a) A Colombian self-built RC structure, featuring “short” columns; (b) Close-up of a short column (adjacent to two mid-height infill walls) that failed in shear. (source: Taucer, 1999)

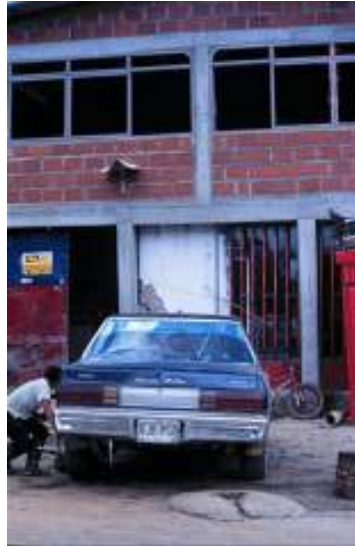
Fig. 4-23 Lack of vertical continuity of columns in a Colombian self-built RC structure.

- Lack of vertical continuity of columns (i.e. the new columns are supported on beams of the lower storey - see Fig. 4-23, or they just rest on the concrete slab), resulting into excessive stress concentrations on the supporting elements (large bending moments induced on the supporting beams, or punching shear on the slab);

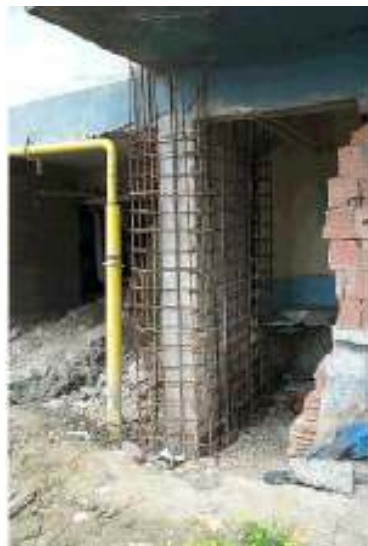
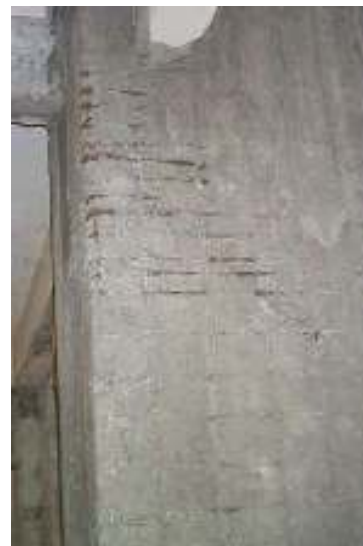
Fig. 4-24 Non-engineered retrofitting interventions after the 1999 Kocaeli earthquake: (a) Additional external reinforcement around a column to be jacketed: the longitudinal reinforcement is not properly anchored into the joint; (b) Insufficient concrete cover on a recently retrofitted column. (source: Caicedo et al., [redacted])

The vulnerability associated to these structural defects is greatly aggravated when the existing “core” house has suffered severe damage, due to previous earthquakes. Similar exacerbating effects are introduced when the owners undertake structural rehabilitation and strengthening works without the supervision of an engineer. In this case, some structural deficiencies that result from poor workmanship and lack of knowledge include: discontinuity of the additional reinforcement (e.g. the additional longitudinal reinforcement used for a column’s jacket may not be anchored to the foundation and/or to the successive columns by means of sufficiently long development lengths or bends – see Fig. 4-24a), inadequate concrete cover (Fig. 4-24b) and asymmetrically distributed structural mass and/or stiffness. A common mistake is found when the section of a member (especially in columns) is increased without providing adequate detailing for an effective transfer of stresses to the original structure, with the result that the now stiffer element attracts higher forces that are not corresponded with an equal increase in strength and ductility.

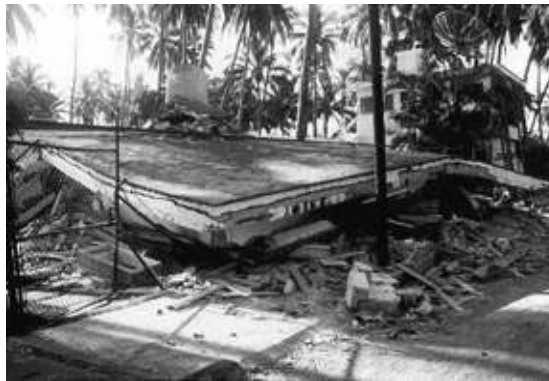
Fig. 4-25 This two-story home in Manzanillo collapsed due to a heavy roof and inadequate walls. (source: EERI, 1995)

Most of the damage occurred in non-engineered masonry constructions. The damage observed after the earthquake indicated that the use of concrete columns and beams can greatly enhance the performance of these buildings. Among the non-engineered buildings of vernacular unreinforced masonry construction, those with short storey heights (about 2.5 m) performed better than those with higher storeys. The use of mid-storey concrete beams (*dalas*) was associated with better performance, apparently limiting out-of-plane failures. Shear failures in concrete column boundary elements (*castillos*) were frequently observed; however, buildings with these elements generally performed better than those without them. In the non-engineered low-rise masonry buildings, diagonal cracks between openings were common in both brick and block walls. Shear failure of the vertical lightly reinforced concrete members was common through many buildings. In the collapse of a two-storey police station, insufficient continuity of the framing elements appeared to have caused the damage. Complete collapses occurred in many of the simple masonry buildings that did not make use of supplementary horizontal and vertical concrete elements (Fig. 4-25). Much of these constructions were built with clay tile roofs; the tiles were often shaken loose²¹.

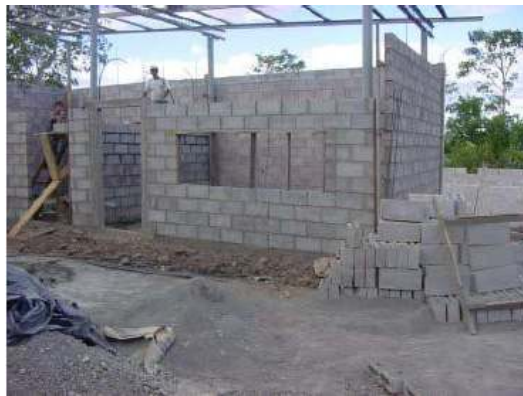
Fig. 4-26 Reinforced masonry house with concrete blocks under construction.

Reinforced masonry construction is popular in El Salvador. The use of concrete blocks is more extended than the use of clay bricks, as the latter are not widely available in the market. Fig. 4-26 shows a typical reinforced masonry building under construction. In 1994, the Ministry of Public Works published the “Guidelines for the Design and Construction of Masonry”. This document establishes the minimum requirements for the design, construction and supervision of the construction of these structures. In general, it was observed that modern buildings, presumably built under this regulation, did not suffer much damage.

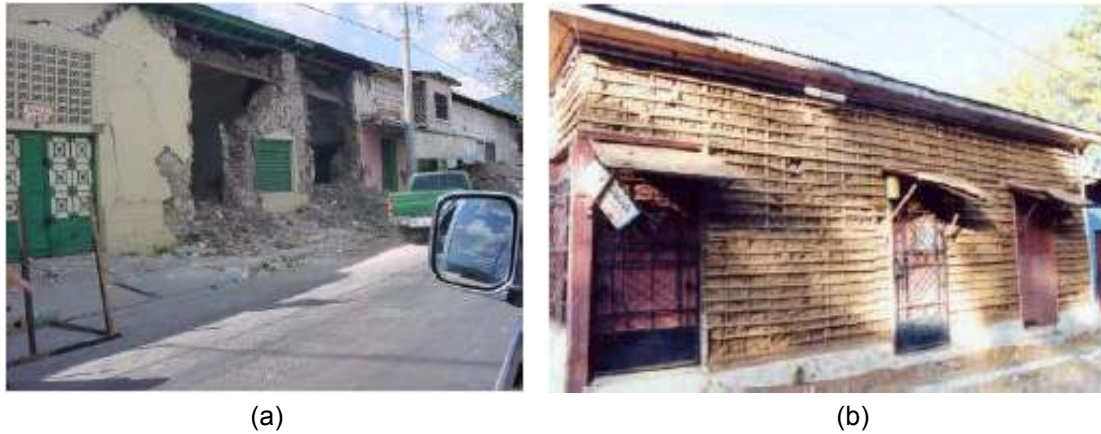
Fig. 4-31 (a) Typical adobe house damaged by the earthquake; (b) *Bahareque* structure, which suffered mud cover spalling. (source: JSCE, 2001)

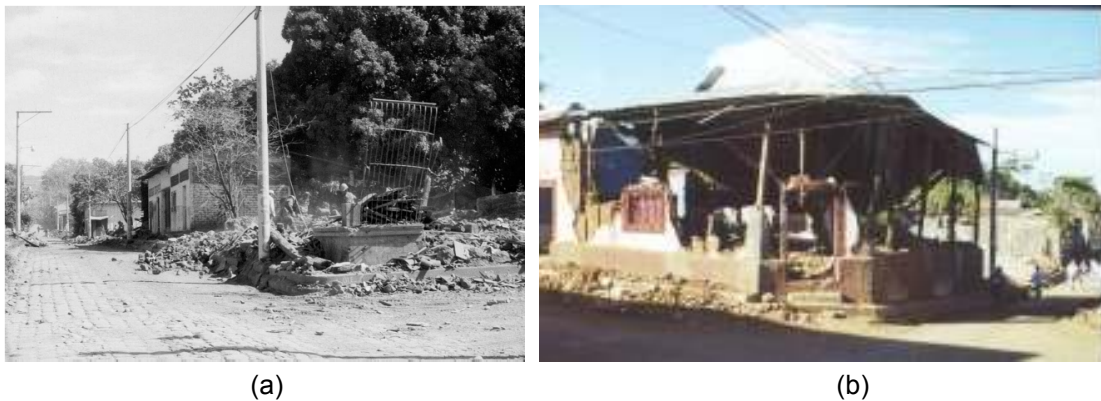
Fig. 4-32 (a) Collapsed adobe house in San Agustín, of which only the door remains standing after the 13 January earthquake; behind are houses of *mixto* and *lámina*, which have survived the earthquake (source: Bommer et al., 2002); (b) Damaged adobe house in Santiago de María. (source: photo by Julian Bommer – annotated picture from EERI special newsletter report on the El Salvador earthquakes of 13 January and 13 February, 2001)

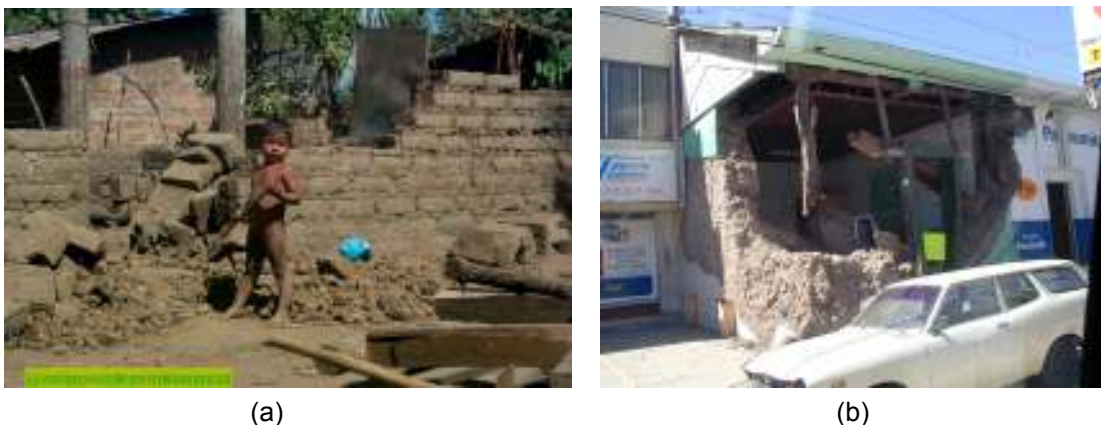
Fig. 4-33 (a) Collapsed adobe house in Canto La Concordia, near Jiquilisco [source: Salvadorean Programme for Research on Development and Environment (PRISMA)]; (b) Near-collapse of an older adobe structure in Santa Tecla. (source: photo by Conrad Paulson and Larry Hultengren – annotated picture from EERI special newsletter report on the El Salvador earthquakes of 13 January and 13 February, 2001)

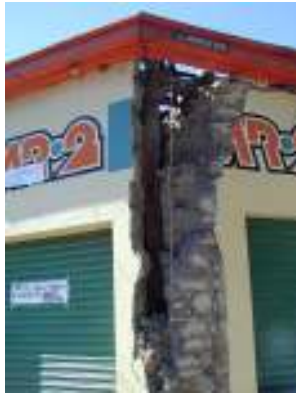
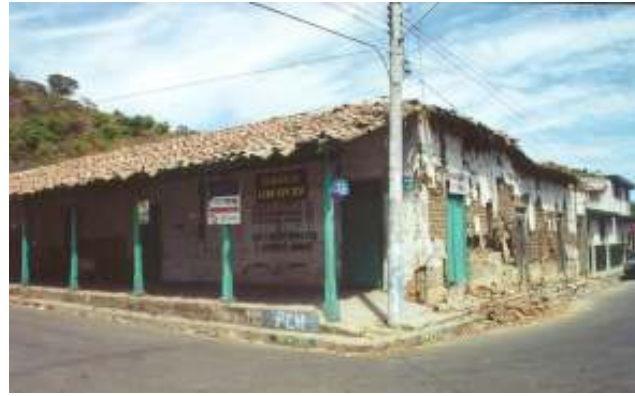
Fig. 4-34 (a) Older adobe structure in Santa Tecla. Note the loss of roof tiles and damage at the corner of the structure (source: photo by Conrad Paulson and Larry Hultengren – annotated picture from EERI special newsletter report on the El Salvador earthquakes of January 13th and February 13th, 2001); (b) View of a *bahareque* (made from timber vertical members, bamboo horizontal, infilled with mud and covered with stucco) house in Apastepeque. (source: photo by Manuel López Menjivar, University of El Salvador – annotated picture from EERI special newsletter report on the El Salvador earthquakes of 13 January and 13 February, 2001)

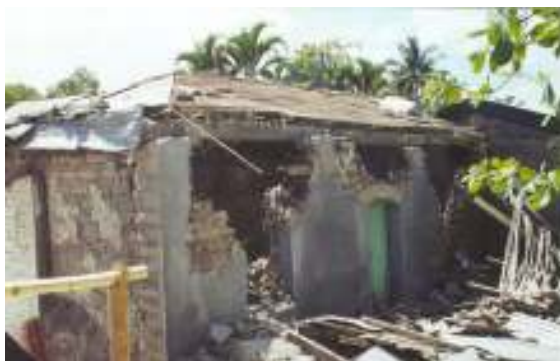
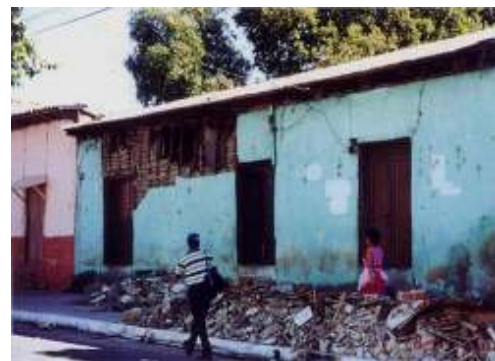
Fig. 4-35 (a) View of a destroyed adobe house in Candelaria (source: photo by Manuel López Menjivar, University of El Salvador – annotated picture from EERI special newsletter report on the El Salvador earthquakes of 13 January and 13 February, 2001); (b) A typical *bahareque* house in Santa Tecla. (source: annotated photo by Seo and Salazar

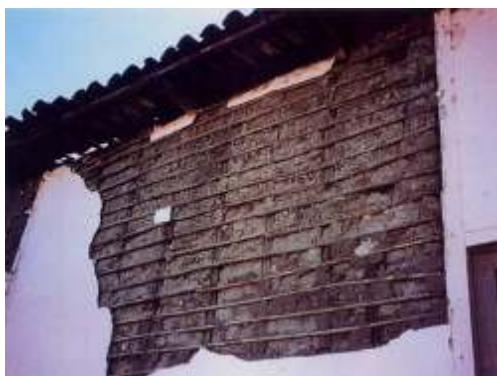
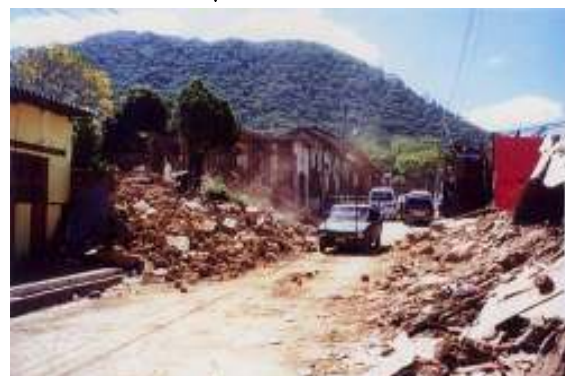
Fig. 4-36 (a) *Bahareque* wall in detail. The frame was made of vertical elements in wood and horizontal elements in bamboo; (b) Damage of adobe houses in Santiago de María, Usulután. (source: annotated photos by Seo and Salazar

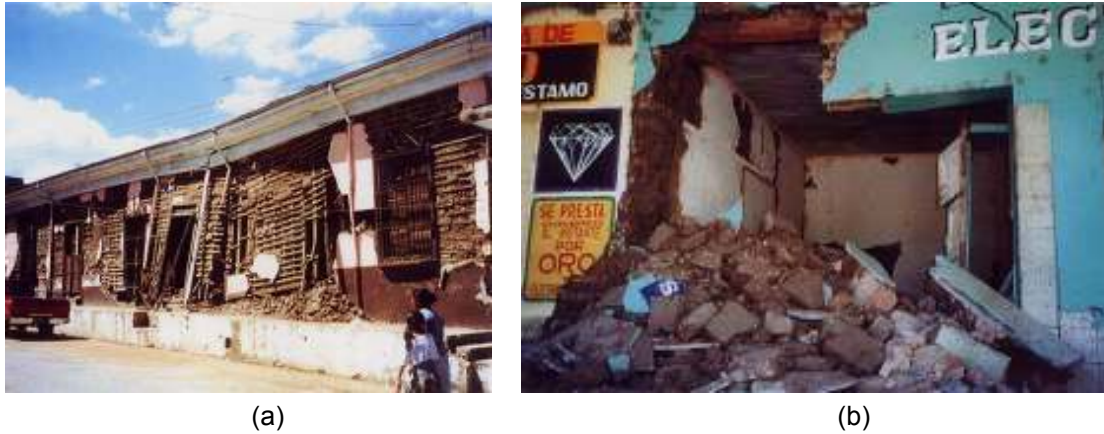
Fig. 4-37 (a) *Bahareque* houses in Santiago de María: these performed much better than adobe houses from the earthquake engineering point of view; (b) A typical adobe structure: wooden columns and beams prevented the total collapse of the building. (source: annotated photo by Seo and Salazar

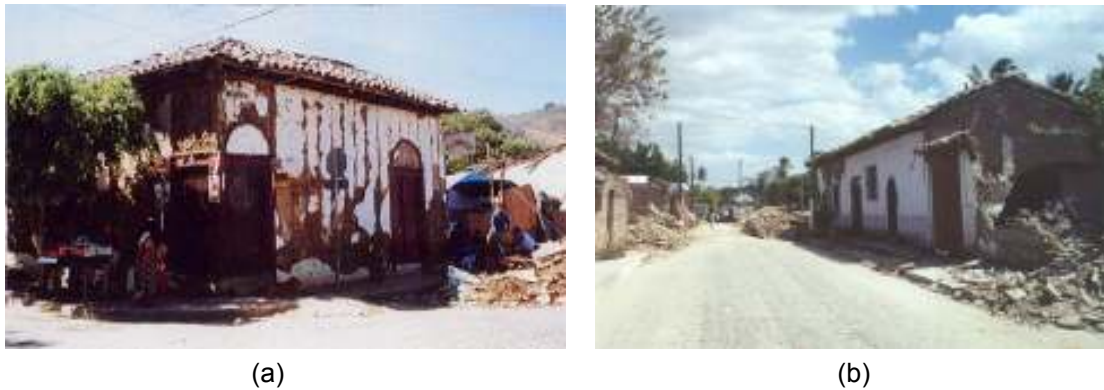
Fig. 4-38 (a) A typical *bahareque* structure: the roof triangle was made of wood (source: annotated photo Seo and Salazar

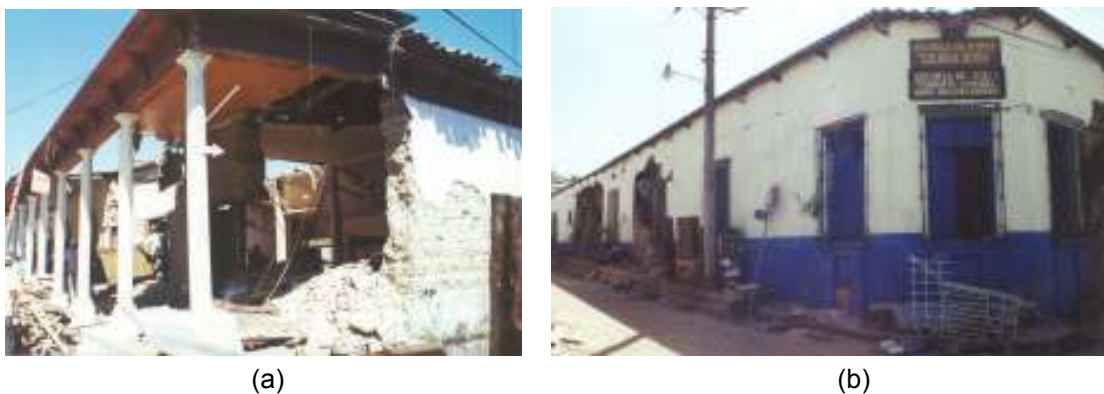
Fig. 4-39 (a) Destruction of an adobe portal in Cojutepeque; (b) A severely damaged adobe school in Cojutepeque where some students were killed. (source: photo by Manuel López Menjivar, University of El Salvador – annotated picture from EERI special newsletter report on the El Salvador earthquakes of 13 January and 13 February, 2001)

- Fig. 4-39** (a) Destruction of an adobe portal in Cojutepeque; (b) A severely damaged adobe school in Cojutepeque where some students were killed. (source: photo by Manuel López Menjívar, University of El Salvador – annotated picture from EERI special newsletter report on the El Salvador earthquakes of 13 January and 13 February, 2001) 122

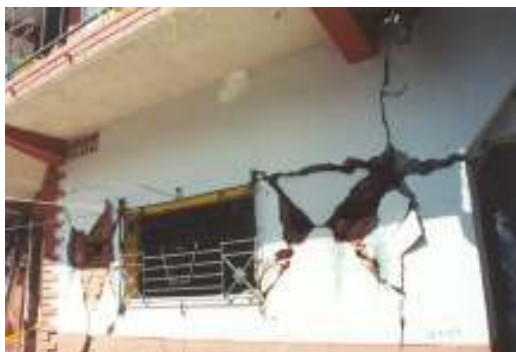
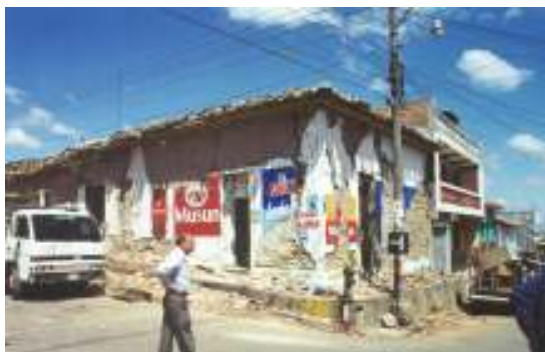
Fig. 4-40 (a) Shear failure in *mixto* walls in Cojutepeque; (b) Damaged adobe house in Cojutepeque. (source: photo by Manuel López Menjívar, University of El Salvador – annotated picture from EERI special newsletter report on the El Salvador earthquakes of 13 January and 13 February, 2001)

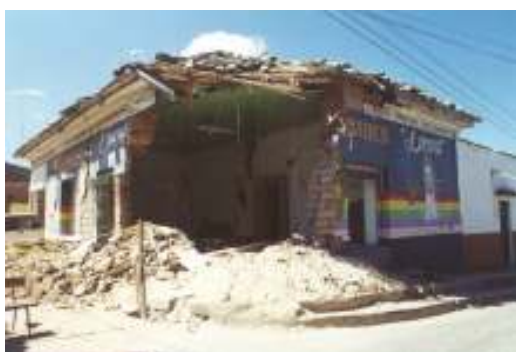
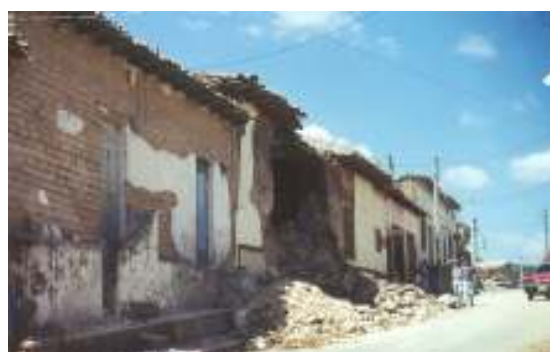
Fig. 4-41 (a) Severely damaged adobe house in Cojutepeque; (b) Damage to an adobe structure in Cojutepeque. (source: photo by Manuel López Menjívar, University of El Salvador – annotated picture from EERI special newsletter report on the El Salvador earthquakes of 13 January and 13 February, 2001)

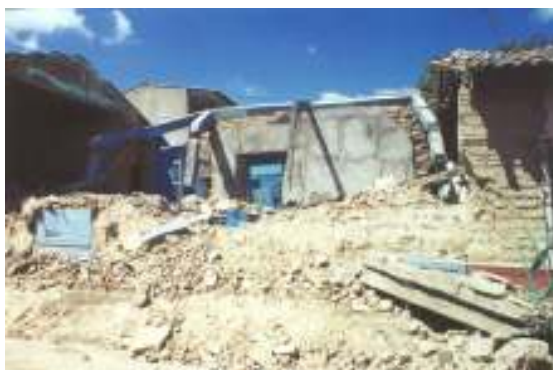
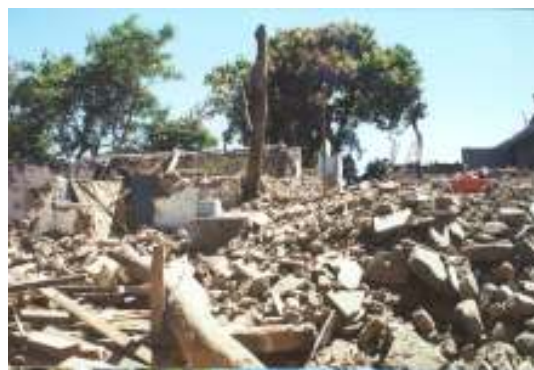
Fig. 4-42 (a) Destruction of an adobe house with some concrete elements in Cojutepeque (source: P3); (b) Total collapse of adobe houses in El Carmen county. (source: photo by Manuel López Menjívar, University of El Salvador – annotated picture from EERI special newsletter report on the El Salvador earthquakes of 13 January and 13 February, 2001)

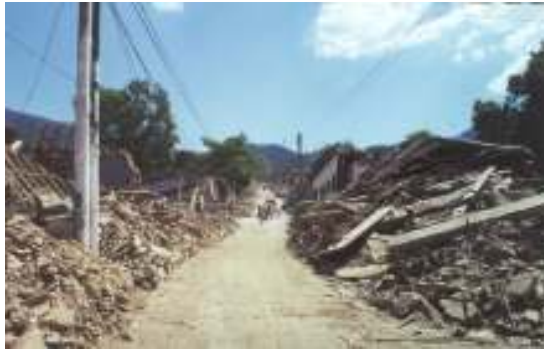
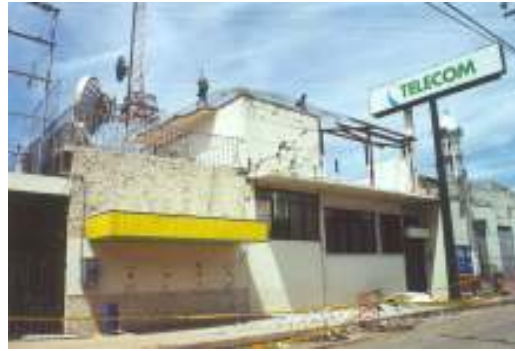
Fig. 4-43 (a) Total destruction of adobe and *bahareque* dwellings in Guadalupe; (b) Damage to *mixto* construction in San Vicente. (source: photo by Manuel López Menjívar, University of El Salvador – annotated picture from EERI special newsletter report on the El Salvador earthquakes of 13 January and February 13, 2001)

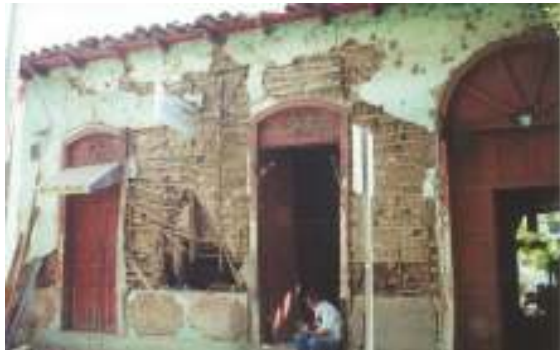
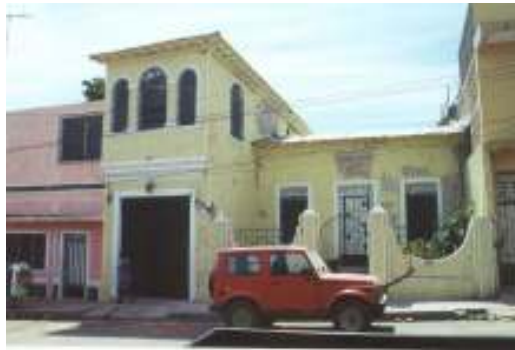
Fig. 4-44 (a) Damage to a *bahareque* construction in San Vicente; (b) Moderate damage to an adobe construction. (source: photo by Manuel López Menjívar, University of El Salvador – annotated picture from EERI special newsletter report on the El Salvador earthquakes of 13 January and 13 February, 2001)

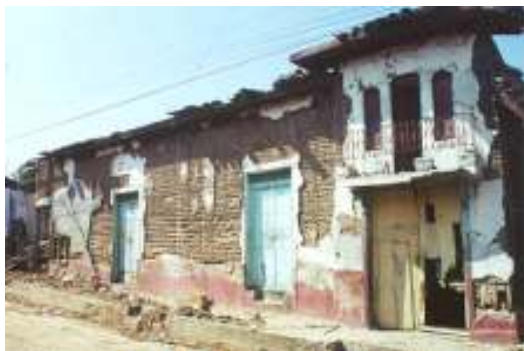
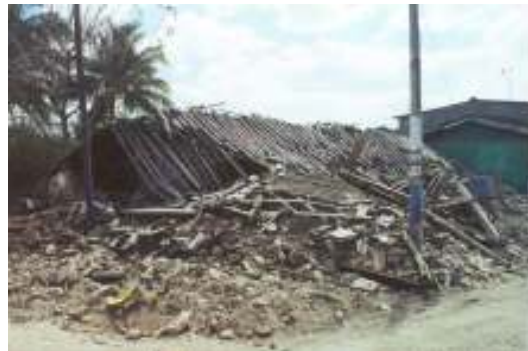
Fig. 4-45 (a) Damaged *bahareque* house in San Vicente; (b) Adobe construction in total ruins. (source: photo by Manuel López Menjívar, University of El Salvador – annotated picture from EERI special newsletter report on the El Salvador earthquakes of 13 January and 13 February, 2001)

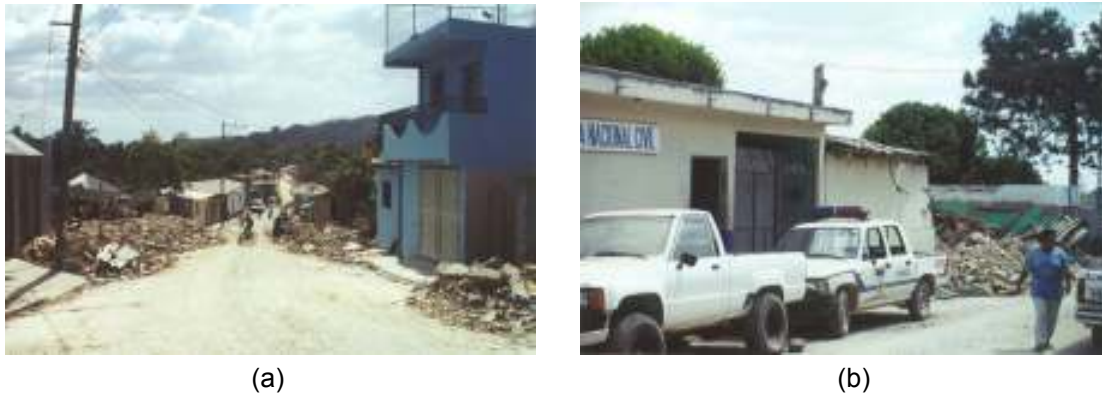
Fig. 4-46 (a) *Mixto* construction in the town of Santa Cruz Analquito still standing, but surrounding a destroyed adobe construction; (b) House of *mixto* construction in Santa Cruz Analquito still standing next to an adobe house turned into rubble. (source: photo by Manuel López Menjívar, University of El Salvador – annotated picture from EERI special newsletter report on the El Salvador earthquakes of 13 January and 13 February, 2001)

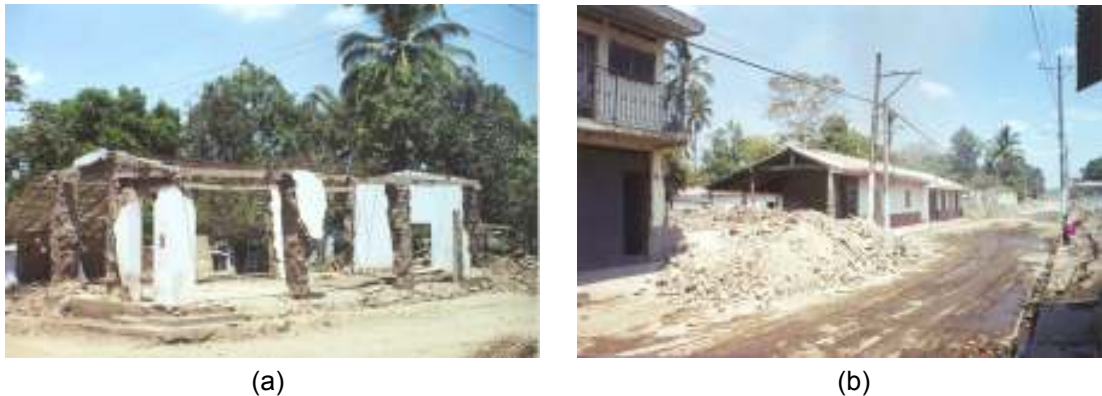
Fig. 4-47 (a) Adobe house with columns still standing in Verapaz; (b) *Mixto* house in Verapaz still standing next to an adobe house in total ruins. (source: photo by Manuel López Menjívar, University of El Salvador – annotated picture from EERI special newsletter report on the El Salvador earthquakes of 13 January and 13 February, 2001)

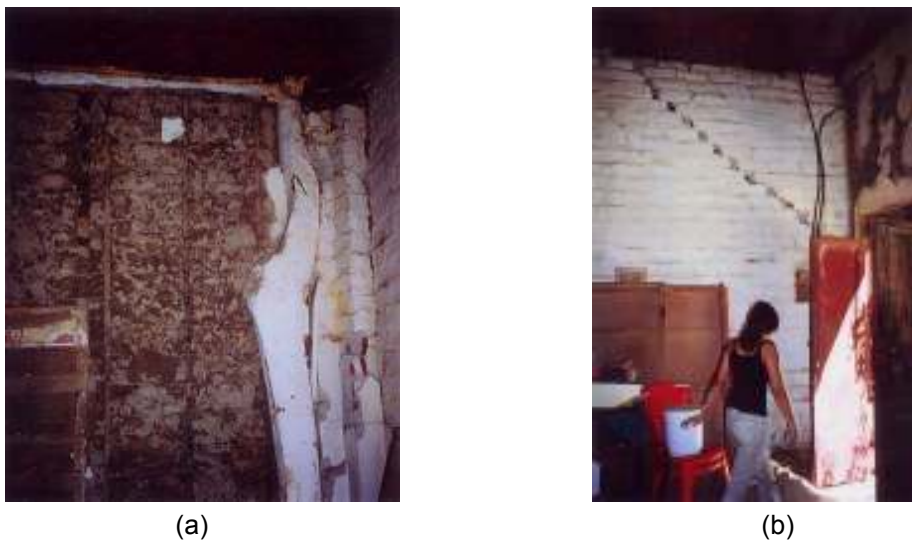
Fig. 4-48 (a) Inner view of a *bahareque* house where a tree trunk was used as a column; (b) Inner view of the same house showing a brick wall with no reinforcement. (source: annotated photo by Seo and Salazar

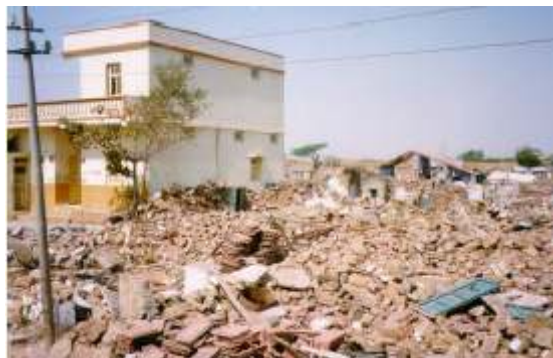
Fig. 4-50 Residential building constructed using brick masonry with lintel band survived at Ratnal. (source: IITB and EDM/NIED, 2001)

In the epicentral region, almost all non-engineered structures and a large proportion of poorly constructed engineered ones suffered major damage or collapsed. It is interesting to note that several properly constructed engineered and non-engineered structures in the epicentral region escaped with only minor damage. This clearly demonstrates the importance of proper construction practice for seismic safety of buildings. Fig. 4-50 shows a masonry building with earthquake-resistant features (lintel bands) in Ratnal that escaped with minor damage while all adjoining non-engineered structures suffered total collapse.

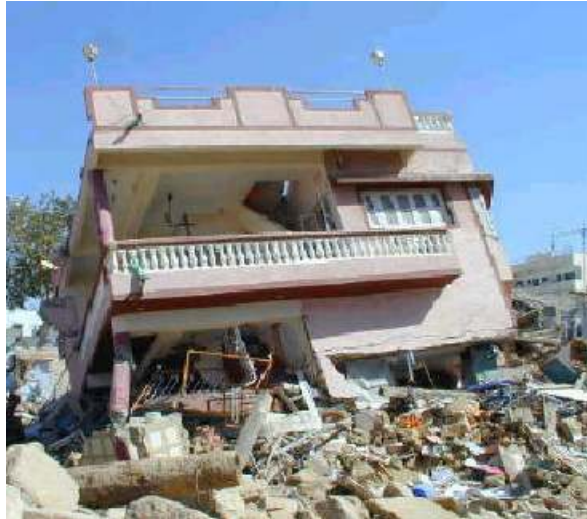
Fig. 4-51 Typical soft storey and torsion collapse in Bhuj. (source: Gujarat Relief Engineering Advice Team - GREAT, 2001)

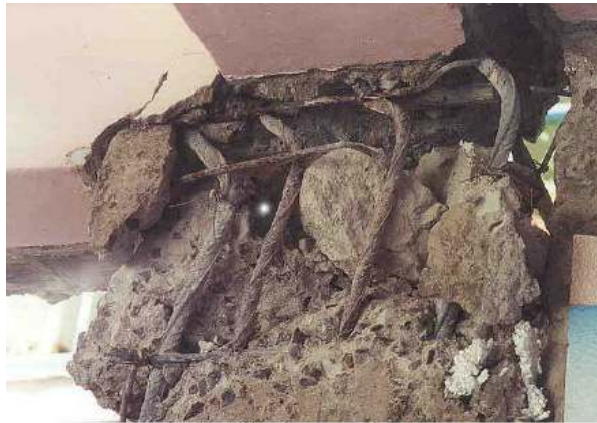
Fig. 4-52 Heavy compressive stresses and large deformations caused total destruction of the column head; heavily bent longitudinal reinforcement is shown. The large spacing of stirrups did not provide effective confinement of the concrete core. (source: Gujarat Relief Engineering Advice Team - GREAT, 2001)

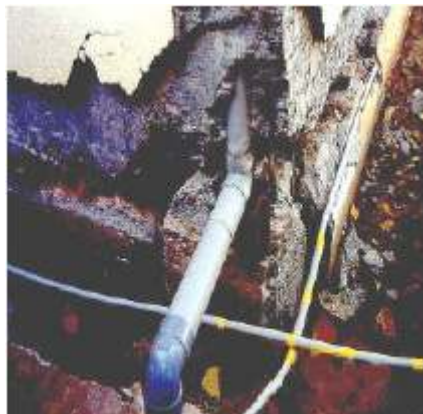
Fig. 4-53 Separation between the ground beam and the column junction caused by crushing of the concrete (city of Sukhpur). The damage worsened by the presence of a plastic pipe within the column. (source: Gujarat Relief Engineering Advice Team - GREAT, 2001)

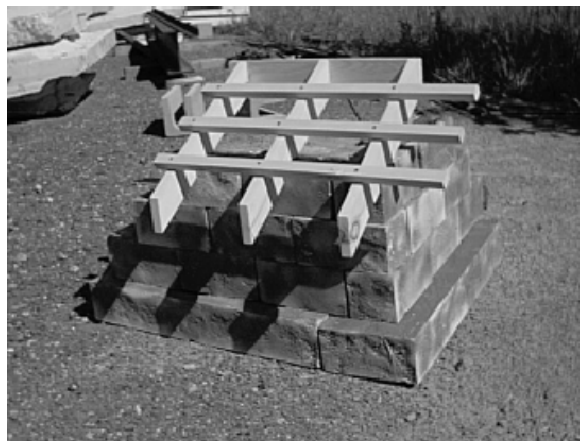
Fig. 5-2 A mock-up of wall to roof connection. [source: Mincks et al. (2001) “Reforzar y conectar para proteger - Un manual de capacitación para la construcción de casas resistentes a desastres”, published by NAHB and HUD²]

- *Prototypes & mock-ups*: In the case of large-scale housing projects, one or more full-scale model houses (prototypes) are constructed under the guidance and supervision of engineers and/or skilled builders. The future self-builders are trained by participating to the construction phase. After the completion of the prototype(s) these “experienced” builders pass-on their knowledge to the rest of the community. In some cases, simple mock-ups are also used to better visualize the principles of the construction method to be used (Fig. 5-2).

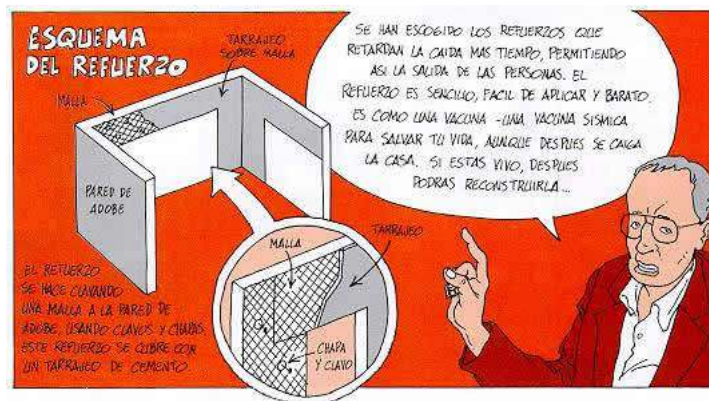
Fig. 5-3 Part of the four-pages publication of CERESIS, communicating the need for the reinforcement of adobe houses, based on the recommendations made by the Pontifical Catholic University of Peru. (source: <http://www.banmat.org.pe/Terremoto.htm>)

- **Cartoons:** This means of communication is very appealing, due to its entertaining character. The risk is to distract the reader from the technical contents of the illustrations. In Fig. 5-3, part of a four-page cartoon-like document published by CERESIS (Centro Regional de Sismología para América del Sur) is shown (the whole document is found in Appendix E), whereas Fig. 5-4 presents one of the best cartoons used for the purposes of a self-construction manual. This is a fairly recent manual ("*La casa de adobe sismorresistente*", 2001), published by two Salvadoran organizations (*Equipo Maíz* and *UNES* UNIÓN ECOLÓGICA SALVADOREÑA - SALVADORAN ECOLOGICAL UNION).

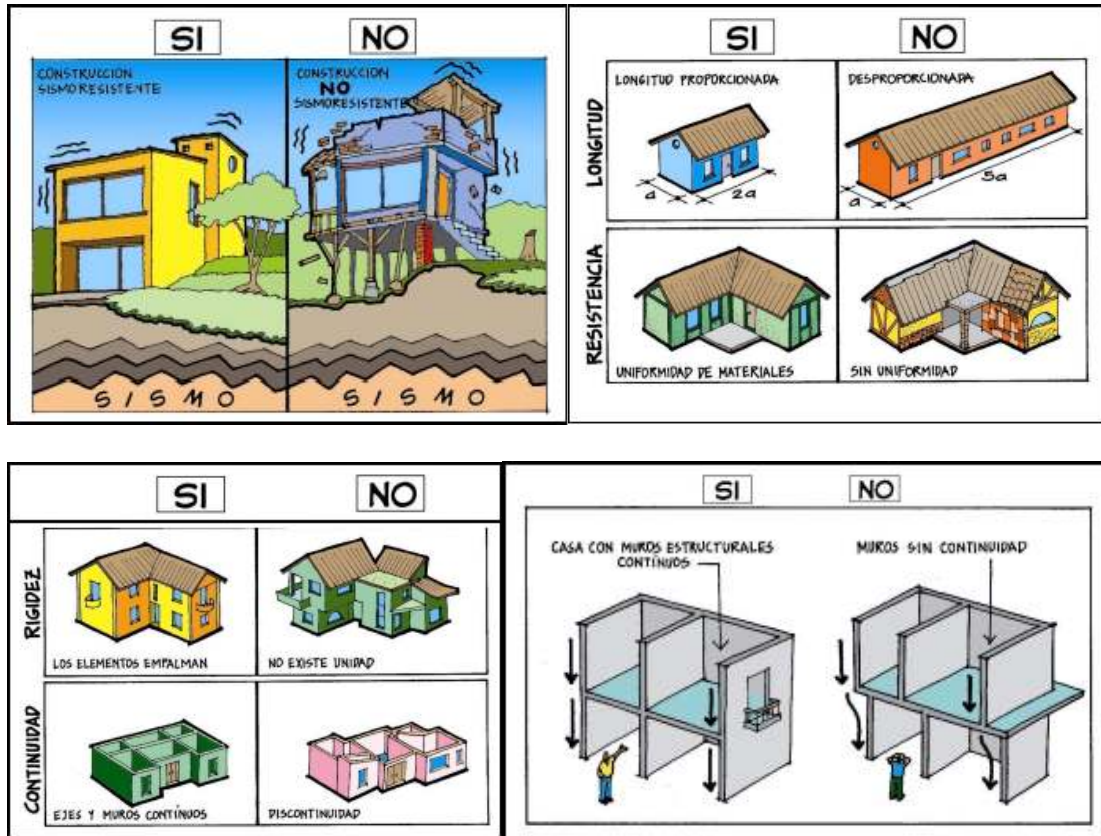
Fig. 5-9 Illustrations of “wrong” and “correct” structural configurations. (source: “Manual de Construcción, Evaluación y Rehabilitación sismo resistente de viviendas de mampostería”, La Red de Estudios Sociales en prevención de desastres en América Latina, Asociación Colombiana de Ingeniería Sísmica – AIS, 2001)

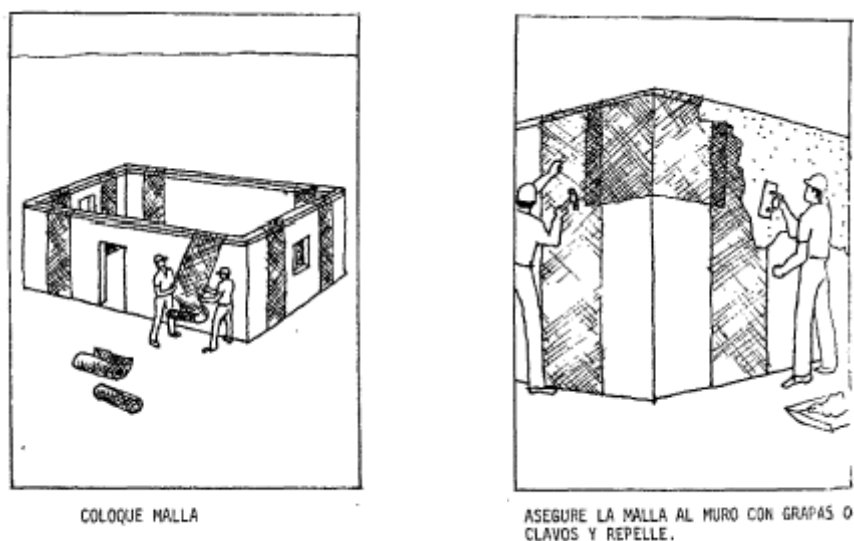
Fig. 5-15 Application of the steel wire mesh.

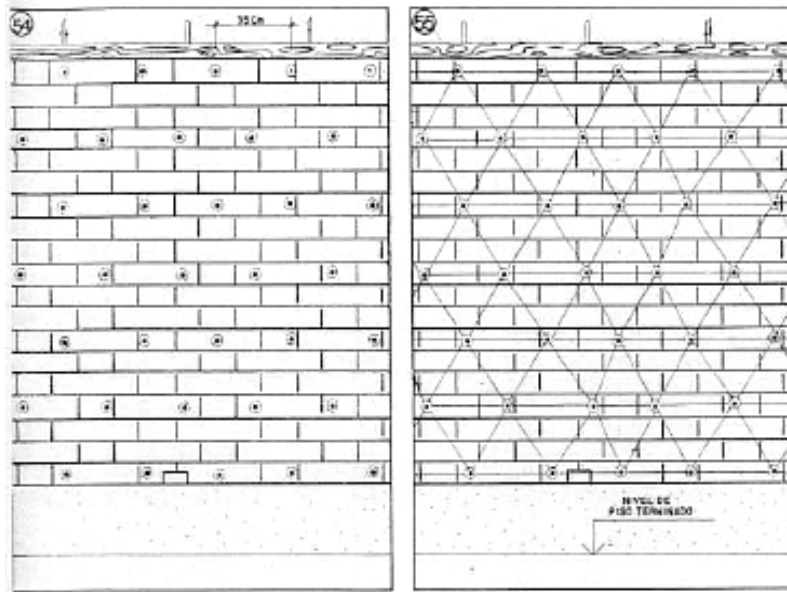
Fig. 5-16 Application of the steel wire on the walls following a rhomboid pattern.

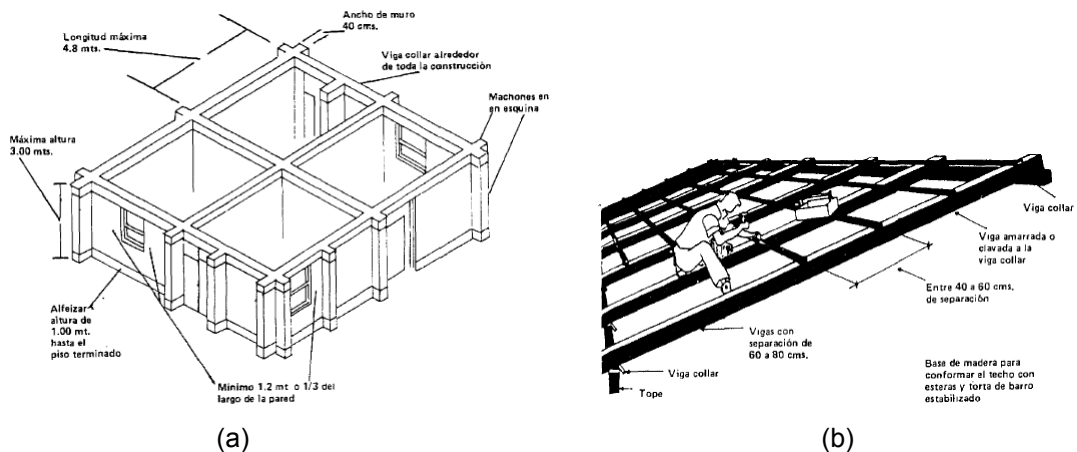
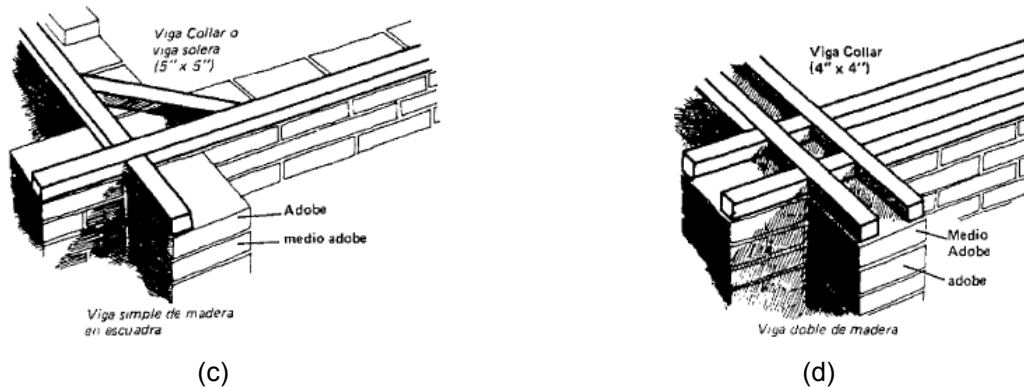
Fig. 5-17 Graphics from the manual “*El Adobe estabilizado - Construcción de una vivienda económica en adobe estabilizado*”, illustrating: (a) the general plan layout; (b) the roof; and (c) & (d) alternative construction methods for the collar beam.

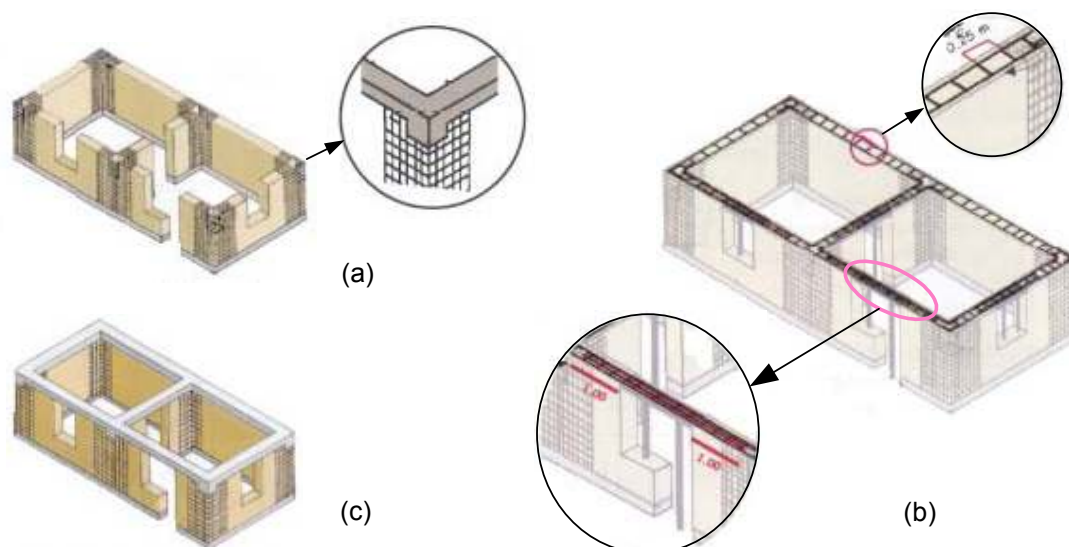
Fig. 5-20 (a) Reinforcement with the steel wire mesh and corner detail; (b) reinforcement arrangement of the collar beam and details for stirrups (not closed) and openings (two additional rods, extending for 1 m on both sides of the opening); and (c) casting of the collar beam (the “sockets” at the top level of the walls’ intersections can be clearly seen).

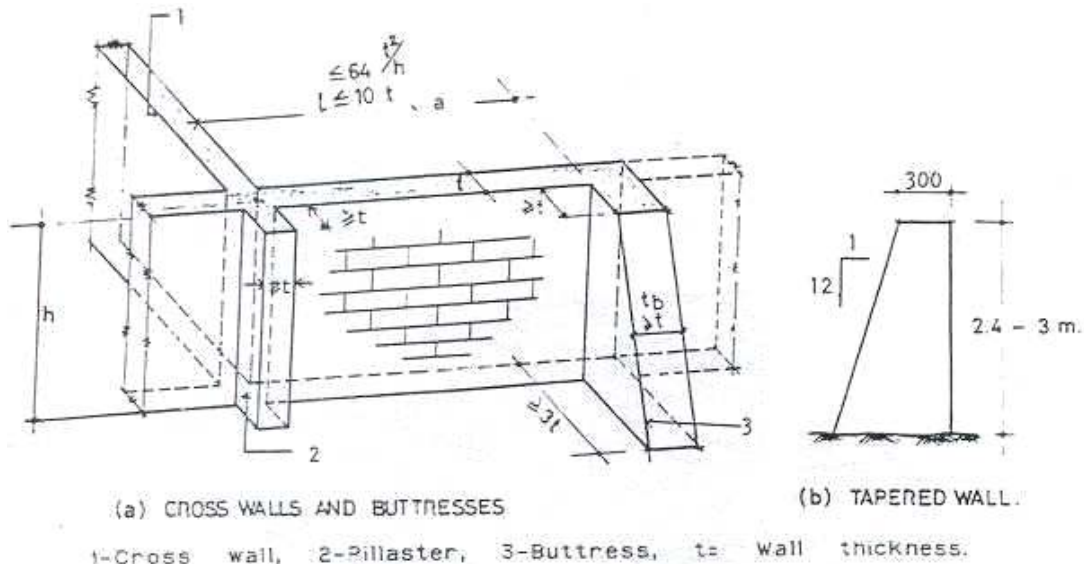
Fig. 5-22 A very useful figure showing the recommended relative wall dimensions.

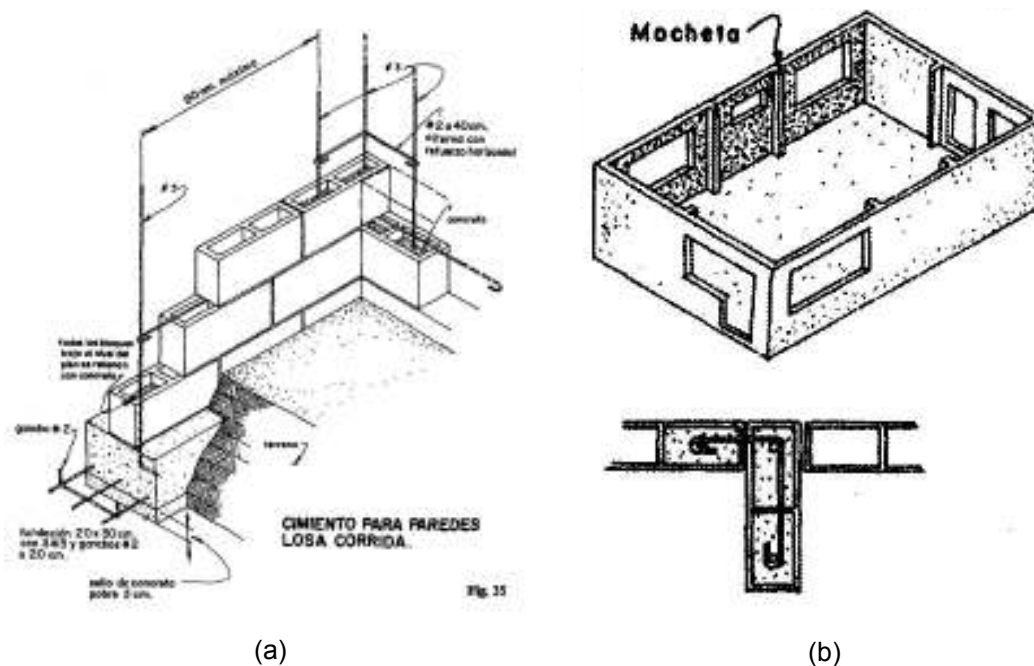
Fig. 5-24 Extract from “Manual para la construcción de viviendas de un piso con bloques de concreto”: (a) Foundation detail for continuous walls (Fig. 35, p. 28); (b) Buttress detail (*mocheta integral*) (Fig. 15, p. 14).
