Review of Non-Engineered Houses in Latin America with Reference to Building Practices and Self- Construction Projects

Aikaterini Papanikolaou, Fabio Taucer

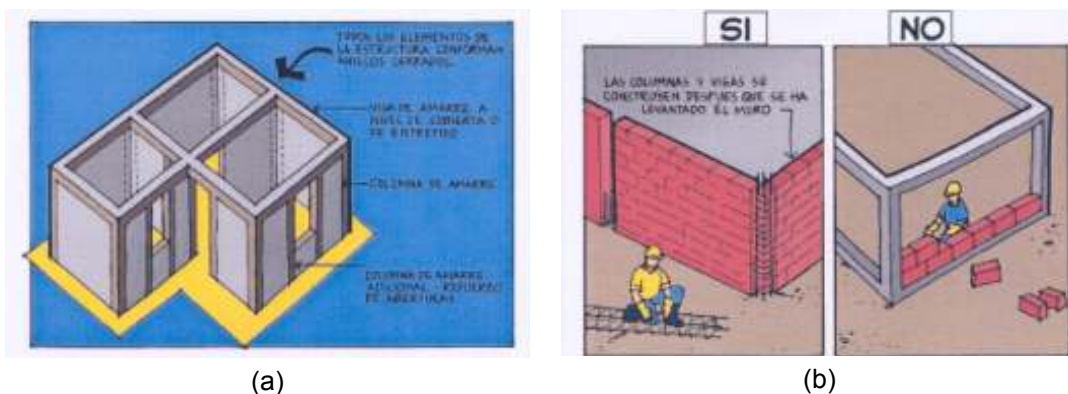
Fig. 5-26 Extract from “Manual de Construcción, Evaluación y Rehabilitación sismo resistente de viviendas de mampostería”: (a) Distribution of column and beam confinement elements (p. 1-30); (b) Construction procedure of confinement elements (p. 1-30).

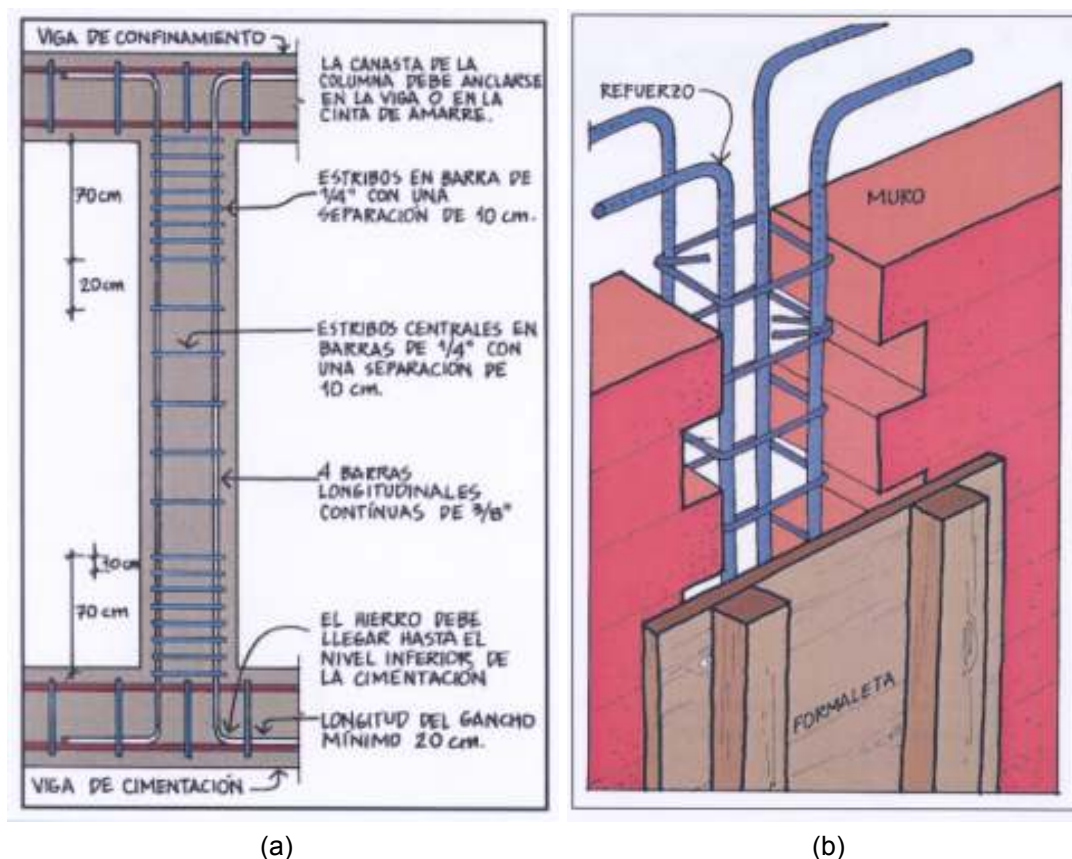
Fig. 5-27 Extract from “Manual de Construcción, Evaluación y Rehabilitación sísmo resistente de viviendas de mampostería”: (a) Steel reinforcement detail of confinement column (p. 1-32); (b) Detail of formwork and placement of steel reinforcement (p. 1-35).

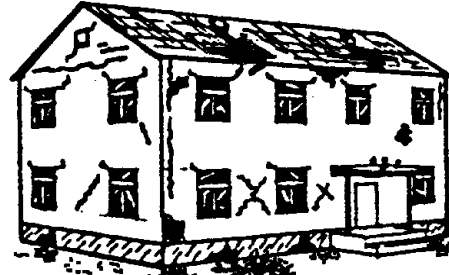
<p>Grade 3: Substantial to heavy damage</p> <p>(moderate structural damage, heavy non-structural damage)</p> <ul style="list-style-type: none"> ▪ Large and extensive cracks in most walls. ▪ Roof tiles detach. Chimneys fracture at the roofline; failure of individual non-structural elements (partitions, gable walls).

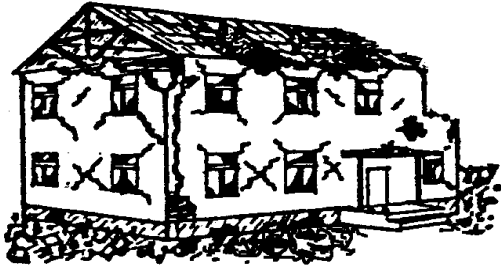
<p>Grade 4: Very heavy damage</p> <p>(heavy structural damage, very heavy non-structural damage)</p> <ul style="list-style-type: none"> ▪ Serious failure of walls; partial structural failure of roofs and floors.

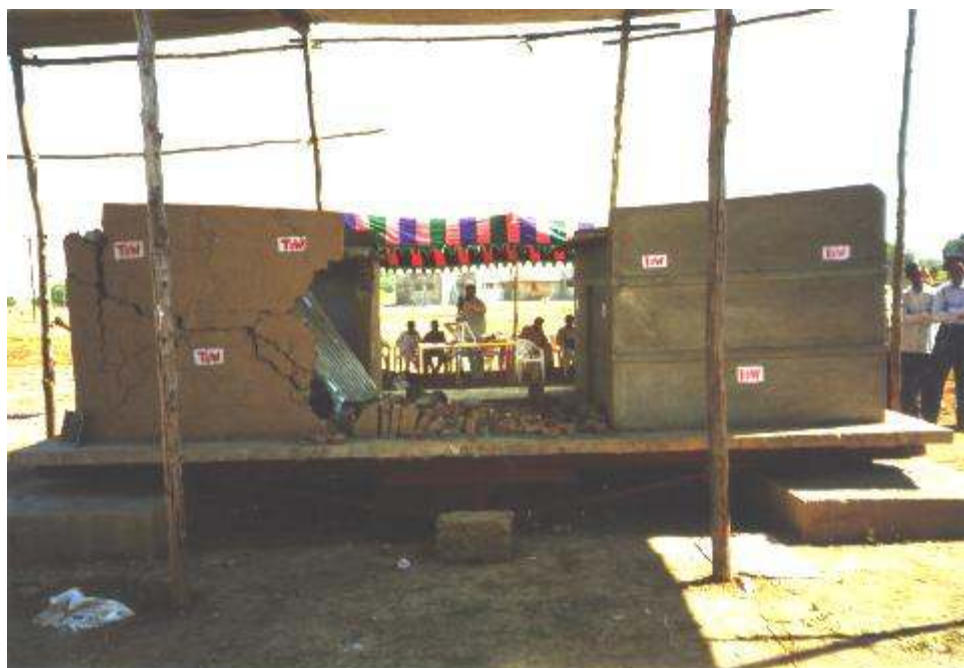
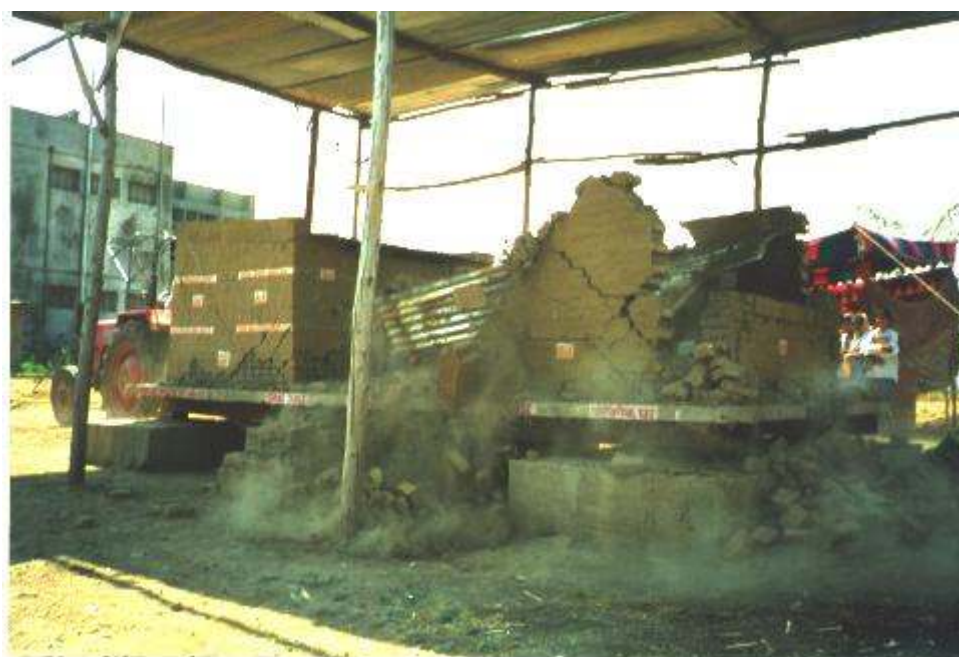
Fig. D-1 (a) Conventional building on the left, shortly before total collapse; (b) Improved building on the left, conventional building on the right at collapse. (source: <http://www.ehc.arch.vuw.ac.nz/newsletters/oct99/page4.htm>)
