SEISLINES

**Experimental Investigation of the Behaviour of
Undeteriorated and Deteriorated Asbestos Cement Pipes
under Seismic Loads
(Task 5)**

Final Report

P. Negro, D. Tirelli, J. Molina, G. Magonette, V. Vidal, G. Saldarini

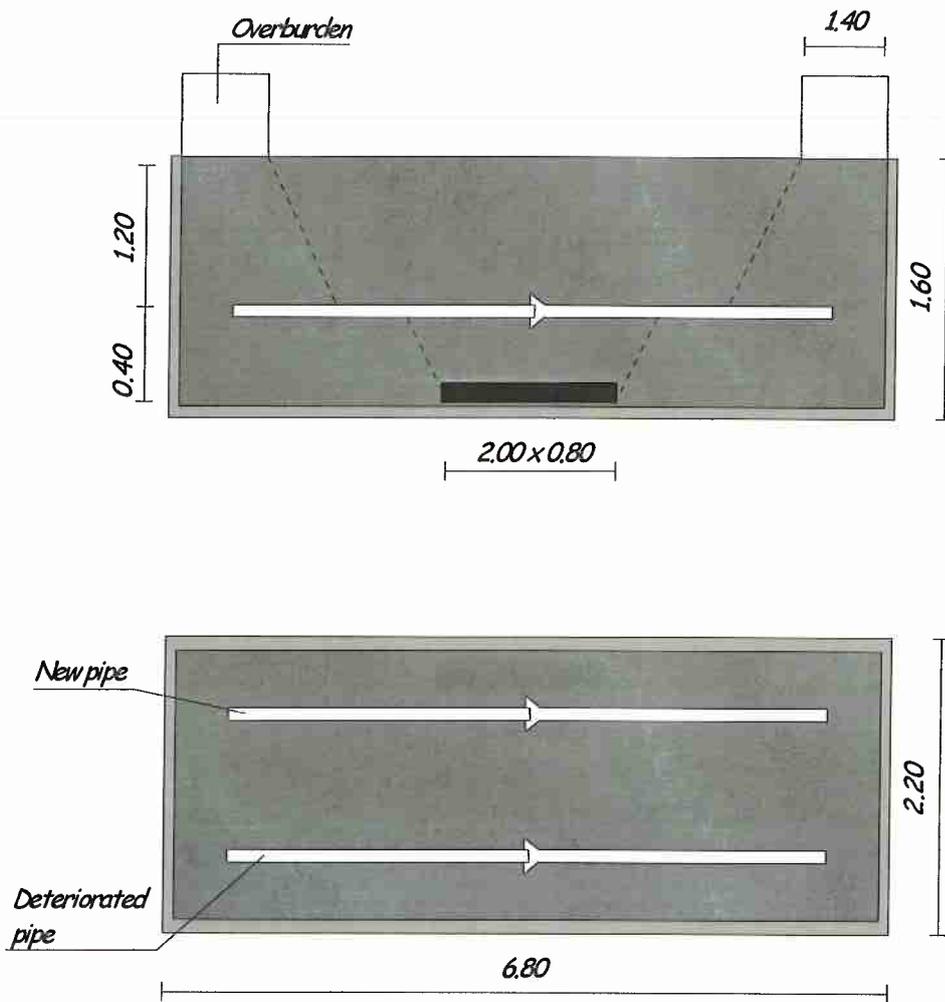
Fig. 1: Scheme of the experimental set-up for the seismic tests.

The experimental set-up was defined (Figure 1) as a volume of dry sand of uniform and well-known mechanical properties, in which two pairs of pipe segments (one undeteriorated and one artificially corroded) were embedded. A steel caisson with dimensions 6.8 m x 2.2 m x 1.6 m (dept) was used (Figure 2). The sand used in an experimental activity previously carried out at ELSA was used, and the deposition technique was aimed at obtaining a uniform relative density.

The loading system was based on steel plates, controlled by hydraulic actuators underneath, to impose increasing upward distortion to the sand below the pipe, in correspondence to the joint.

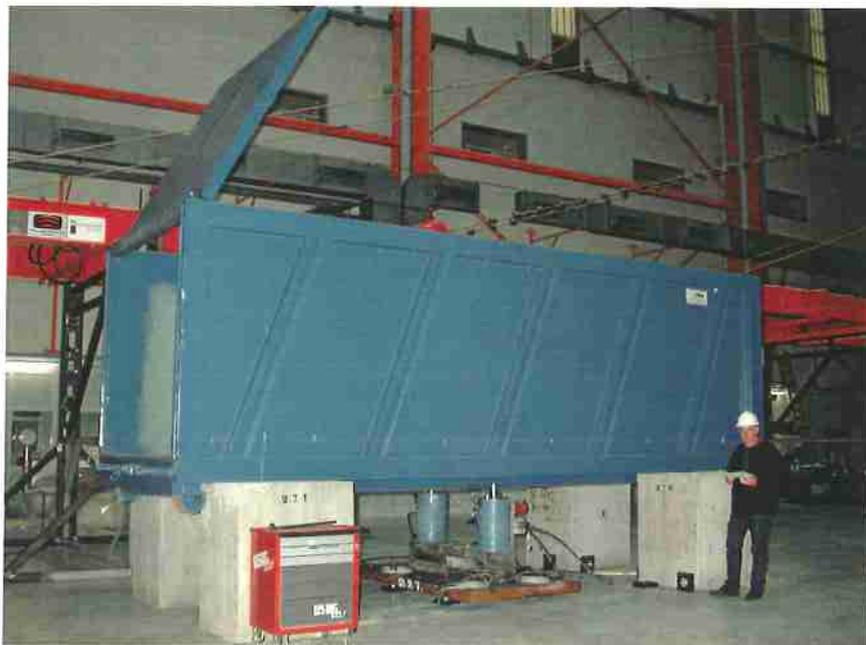
Fig. 2: Scheme of the experimental set-up for the seismic tests.

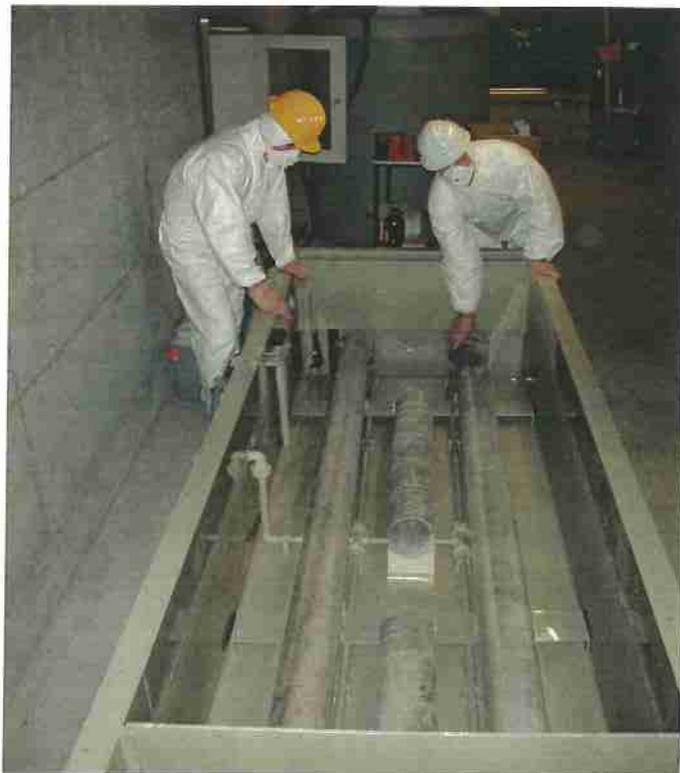
Fig. 3: View of the apparatus for the artificial corrosion.

1. a specimen tank consisting in a prismatic plastic container, 3.2 m long, 1 m wide and 0.5 m high, provided with a removable airtight cover;
2. a secondary tank with 1500 litres capacity for storing the solution during the dry cycles;

3. electric pumps to fill and empty the specimen tank;
4. pH regulating apparatus, to automatically correct the pH in the range 7 +/- 0.1;
5. a warm air generator, with the necessary filters;
6. a programmable control system.

The apparatus is shown in the Figure 3.

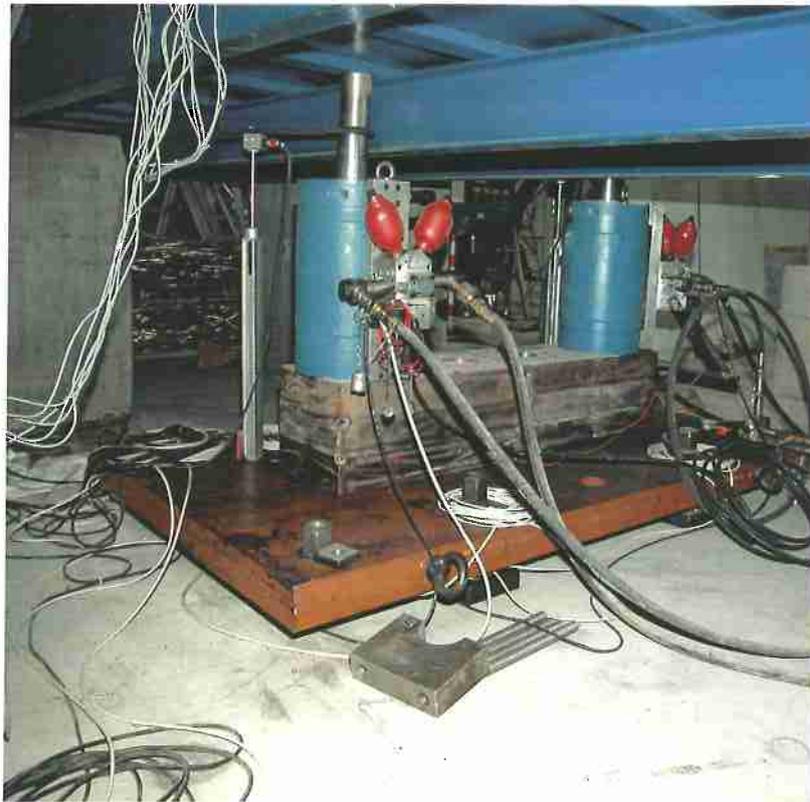
Fig. 4:View of the loading apparatus.

Based on the definition of the experimental setup, the construction of the model was carried out. Two holes were cut in the floor of the caisson, and the loading apparatus was placed, as it is shown in Figure 4. A pneumatic ring tube was placed between the caisson floor and the steel loading plate, to prevent the sand from flowing underneath the plate when it moved upwards.

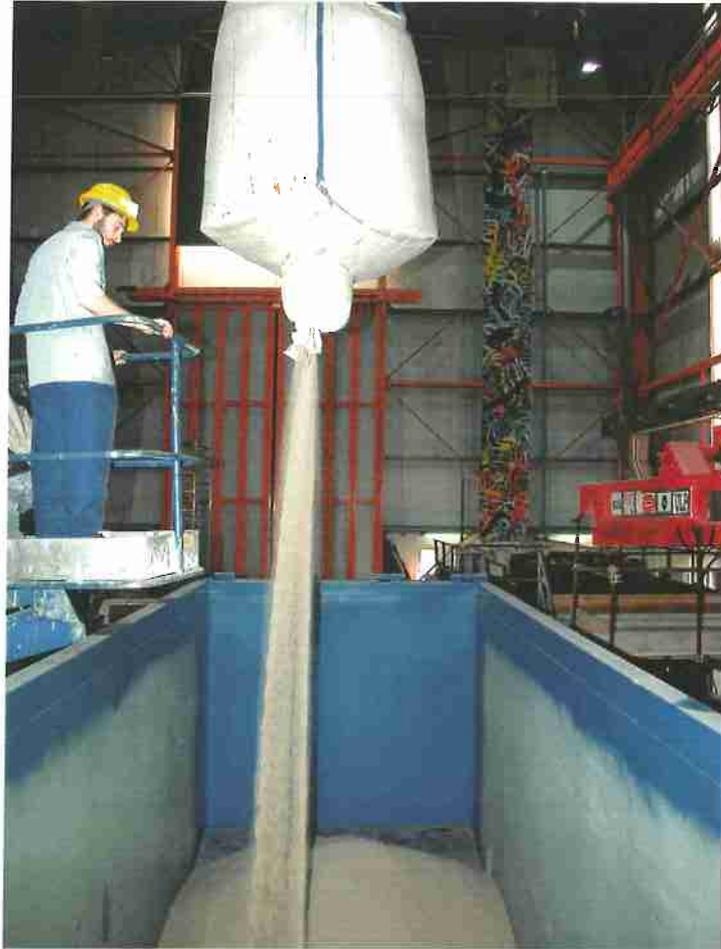
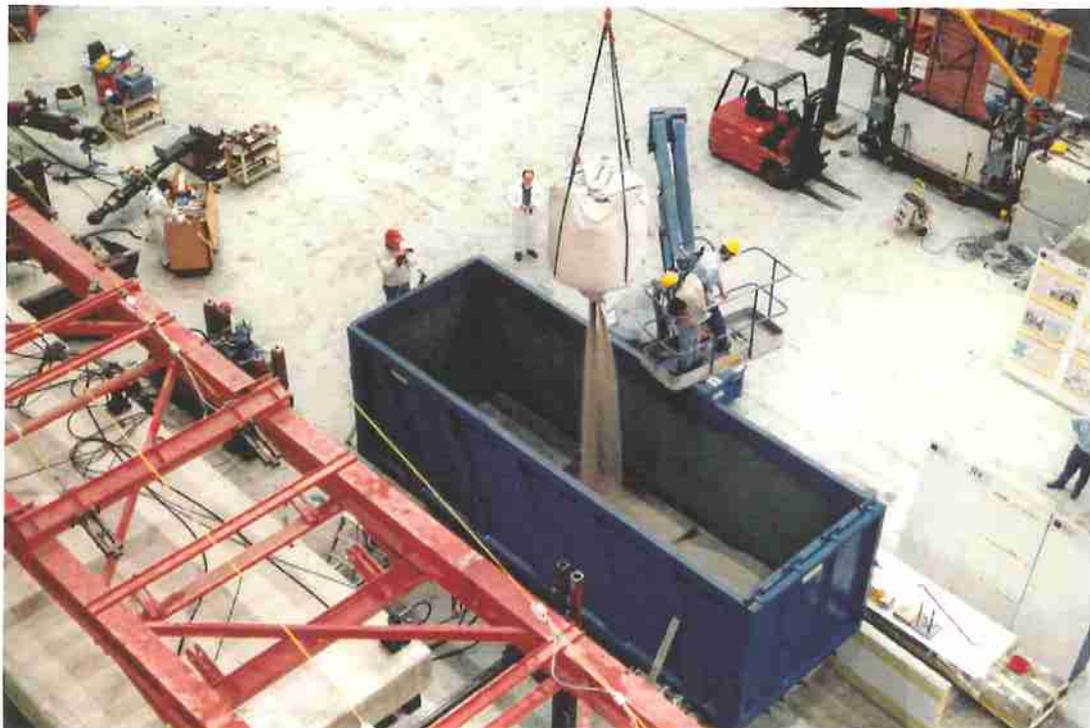
Fig. 5:Deposition of the sand.

The first layer of sand was placed. Sand of well known mechanical properties was adopted. A comprehensive description of both chemical and mechanical properties of the sand is provided in Appendix B. The sand was placed by letting it fall from a narrow orifice from a constant height (Figure 5). This procedure was adopted in other experimental activities (Faccioli et al., 1999; Negro et al., 2000), and is known to result into uniform relative density (Jamiolkowski, 1999). No particular value of the target density was selected, instead, four moulds of known volume were placed. The resulting relative density was found to be substantially uniform, with a mean value of 38%.

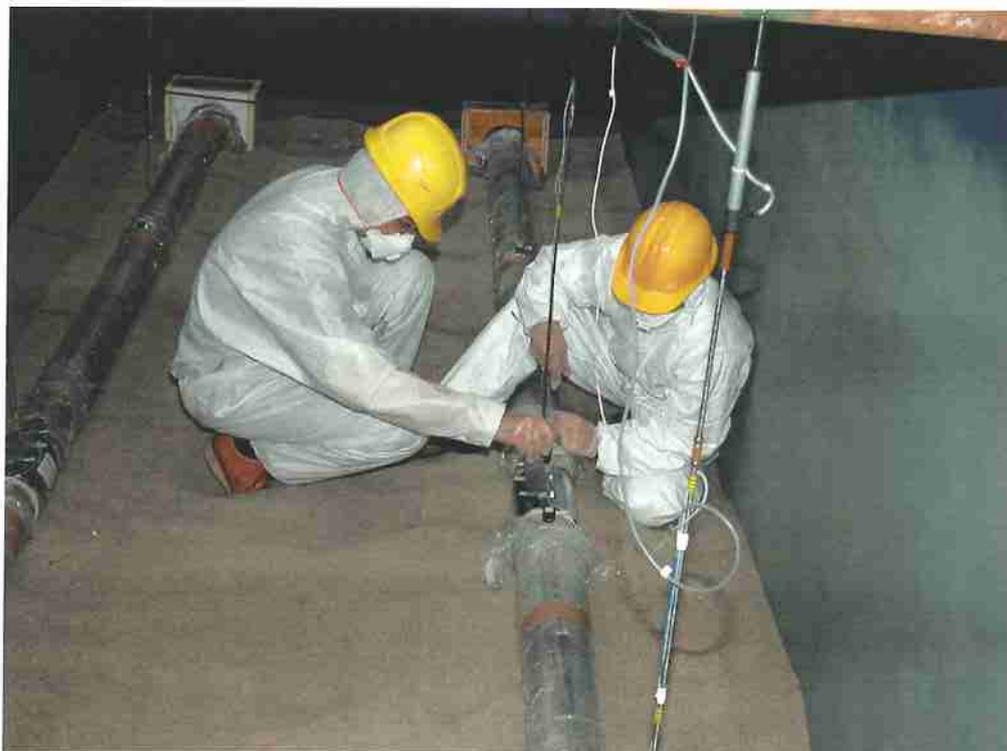
Fig. 6:Placement of the steel joint.

After the first layer of sand had been positioned, the pipe segments were placed. The steel joints were mounted, and sealing blocks were placed at the ends of the segments. The tubes for filling the pipes with water were connected and the steel rods for measuring the vertical displacement were placed. A water pressure of 1.5 m was applied. A number of micro-inclinometers were glued to the surfaces of the pipes.

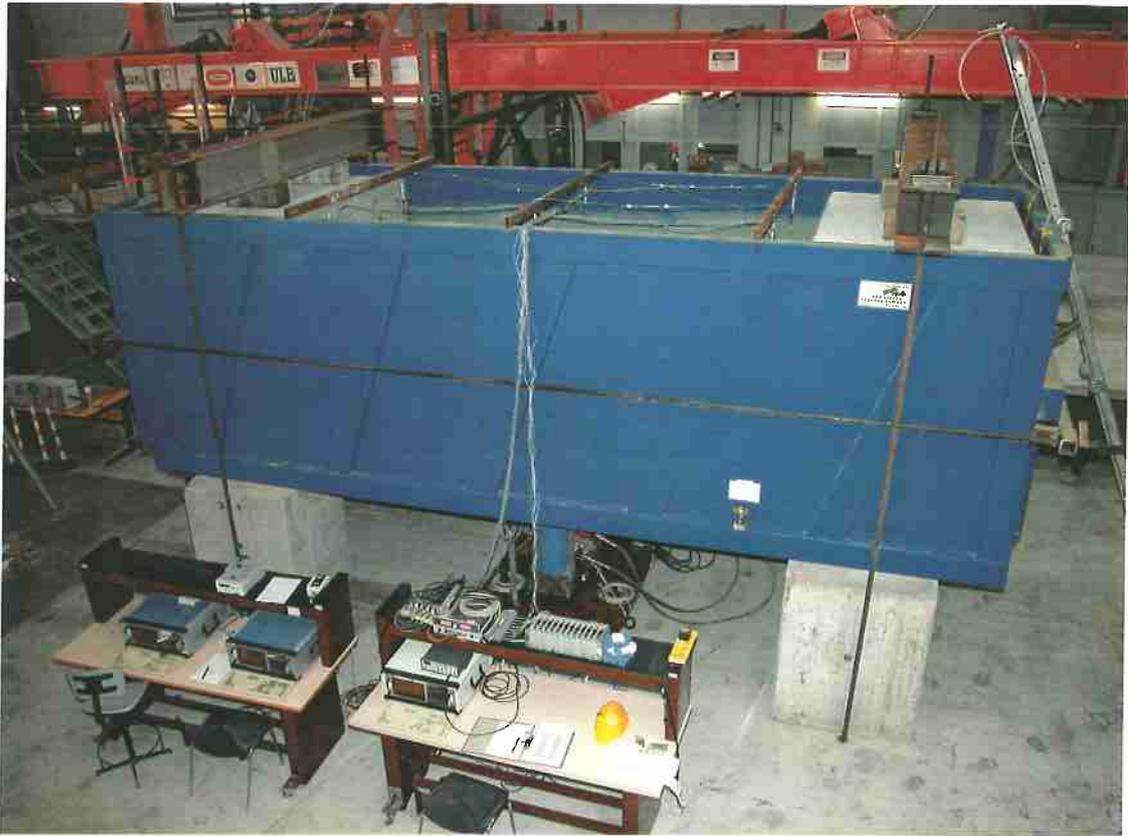
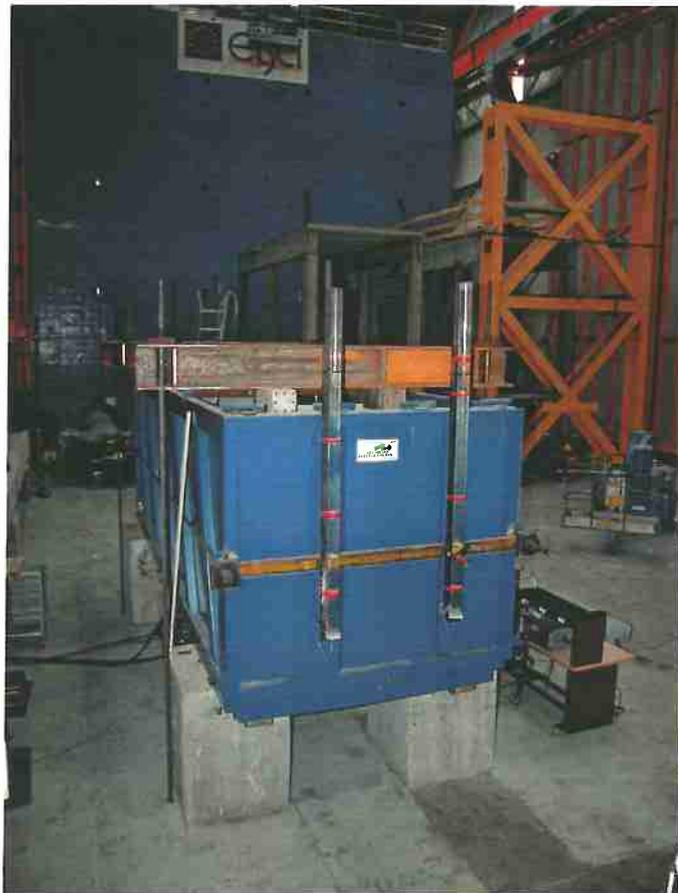
Fig. 7:General views of the experimental setup.

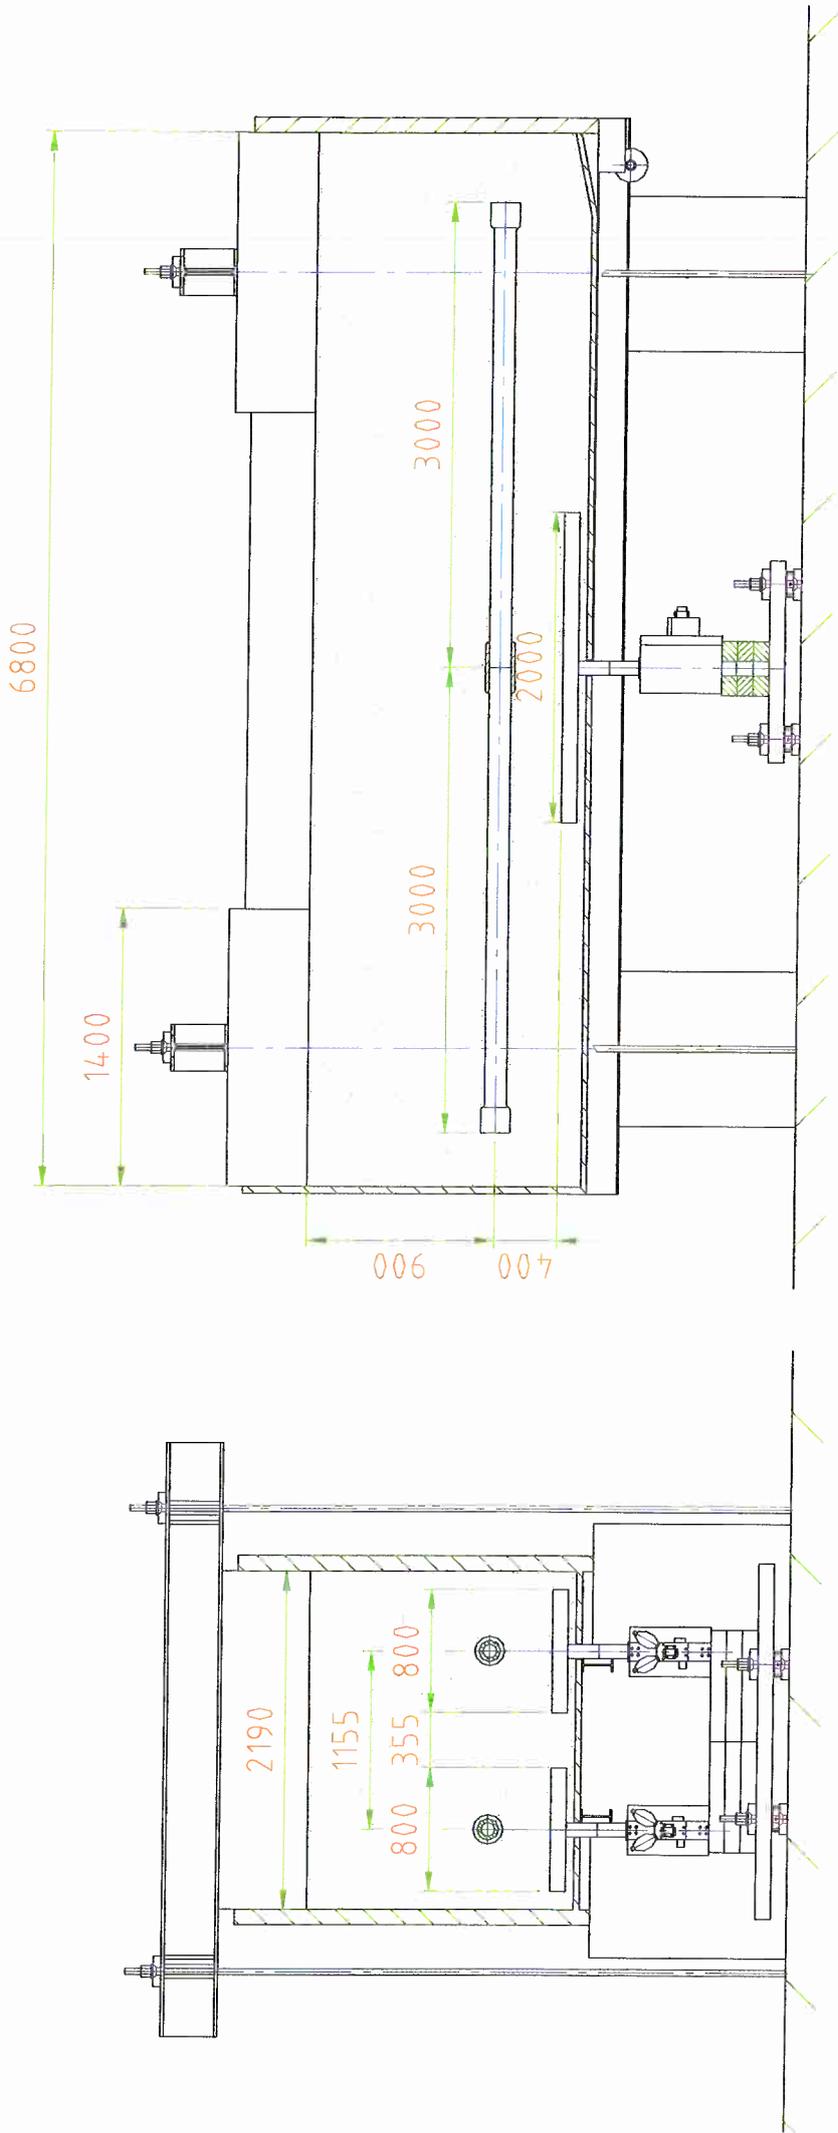
Fig. 8: Scheme of the experimental setup.

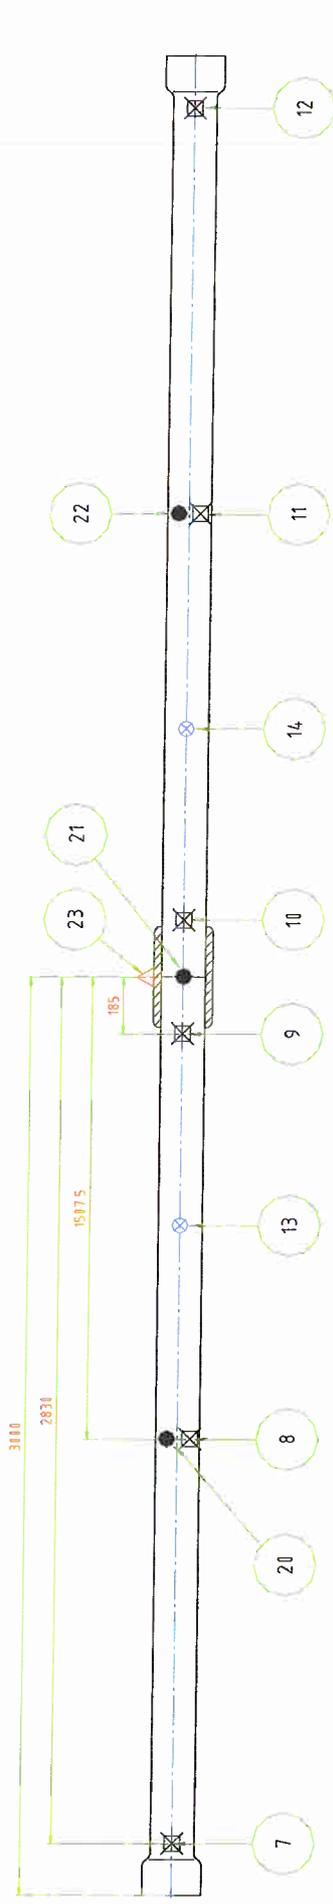
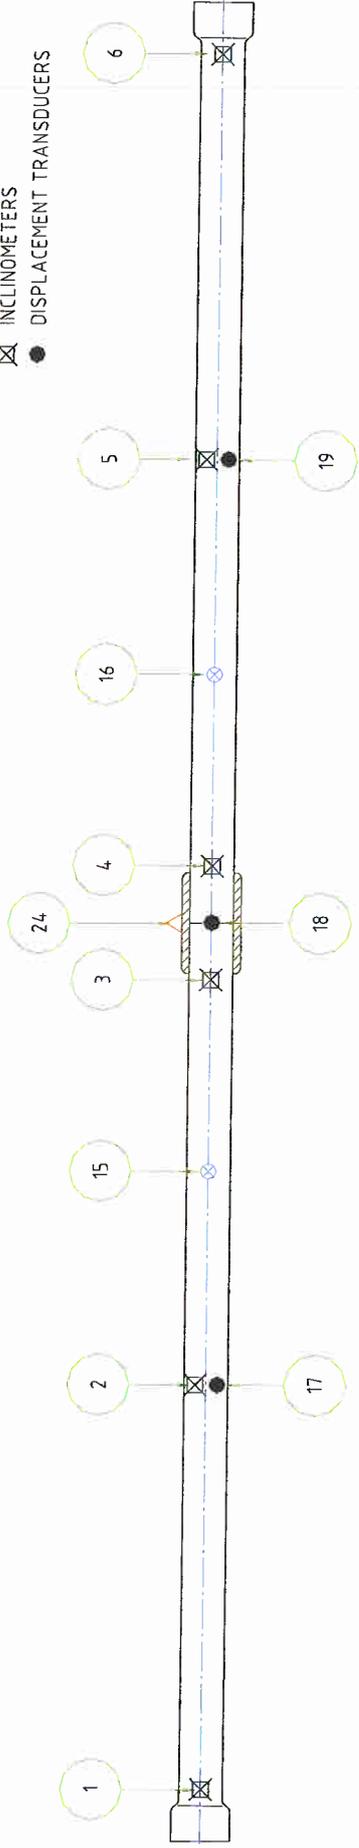
- ▲ ACTUATOR DISPLACEMENT TRANSDUCERS
- ⊗ LOAD CELLS ABOVE PLATE
- ⊠ INCLINOMETERS
- DISPLACEMENT TRANSDUCERS

Fig. 9: Scheme of the instrumentation.

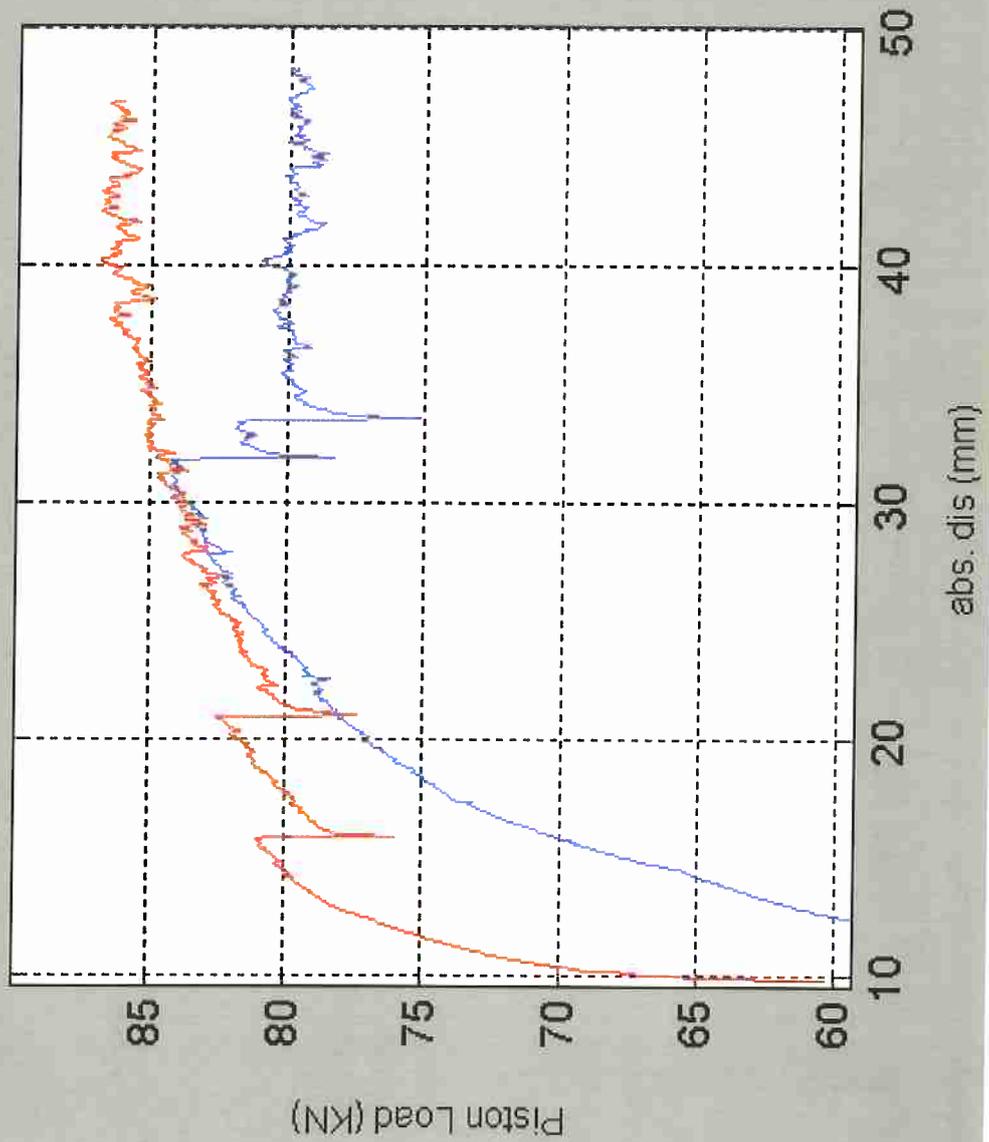
Fig. 10: Measured monotonic force-displacement diagrams.

The results are presented in the following figures. The possibly most important piece of results is the comparison of the global force-displacement diagram for the two segments (Figure 10). The graph starts at a value of the load of 60 kN for the reasons explained in the previous paragraph. The corroded segment, represented by the red curve, breaks at a displacement of about 15 mm, much smaller than the displacement at which the virgin segment, represented by the blue curve, does (about 32 mm). However, these displacements could have been affected by the disturbance introduced by the first loading phase, which was asynchronous. This statement is supported by the fact that the loads at which the two segments broke are rather similar (81 kN for the corroded segment, 84 kN for the virgin segment). From this graph, no major differences in the behaviour of the two segments could be inferred, thus confirming the findings of the artificial corrosion.

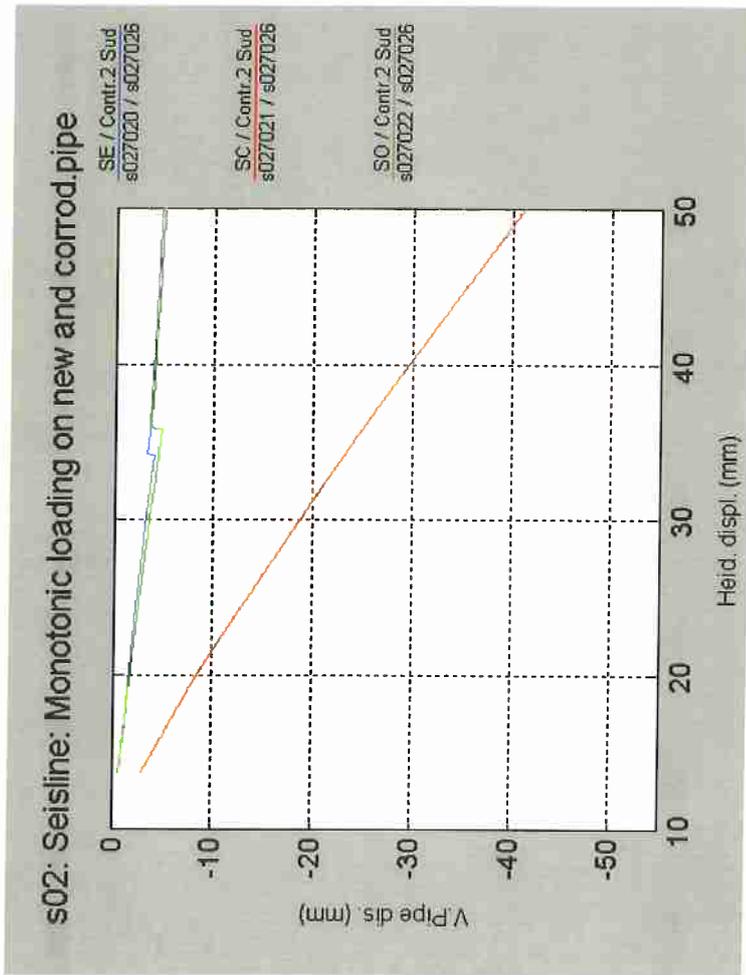
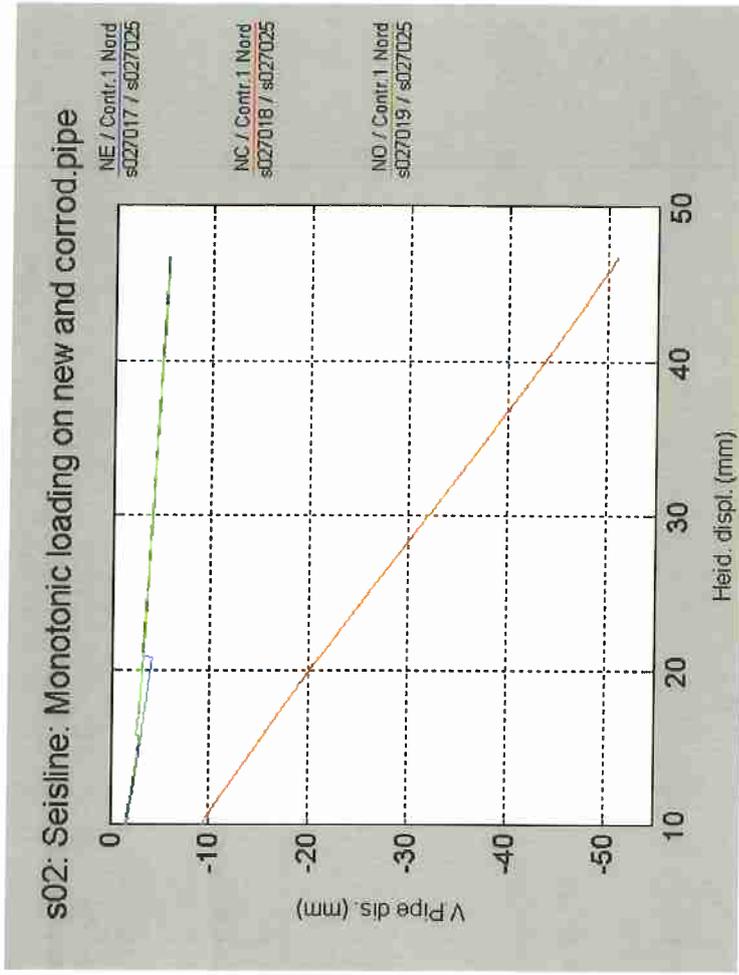
Fig. 11: Measured distributions of vertical deformation along the pipes.

In Figure 11 the vertical displacements measured at different positions along the segments are given as a function of the imposed displacement. The graph on the right hand side refers to the virgin (undeteriorated) segment, the other to the corroded one. One should refer to Figure 9 to identify each curve: the number in the scheme corresponds to the last two digits in the label. The behaviours of the two segments are similar, and most of the vertical deformation took place at the joint, thus demonstrating that the ends of the segments were adequately restrained, a condition which was requested for the test setup to be representative of the seismic behaviour of a real aqueduct line. The vertical displacements of the segments at failure (about 20 mm for the virgin segment and 15 mm for the corroded one) are much closer apart than the corresponding displacements imposed at the level of the loading plate. This is further evidence that the behaviours of the virgin and corroded segments were similar.

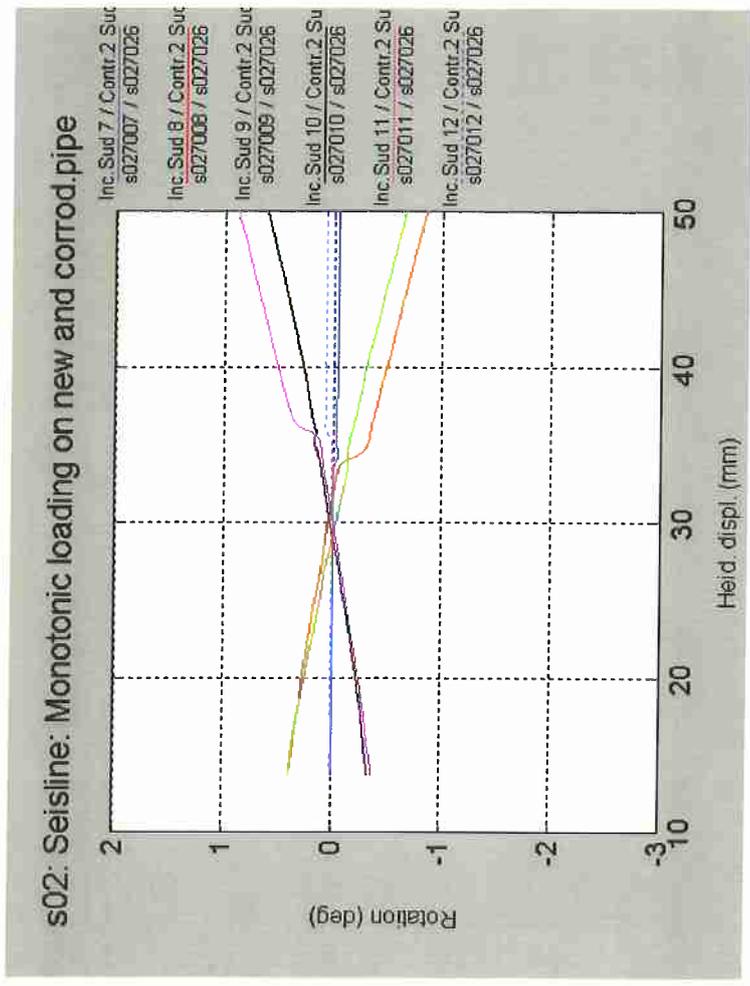
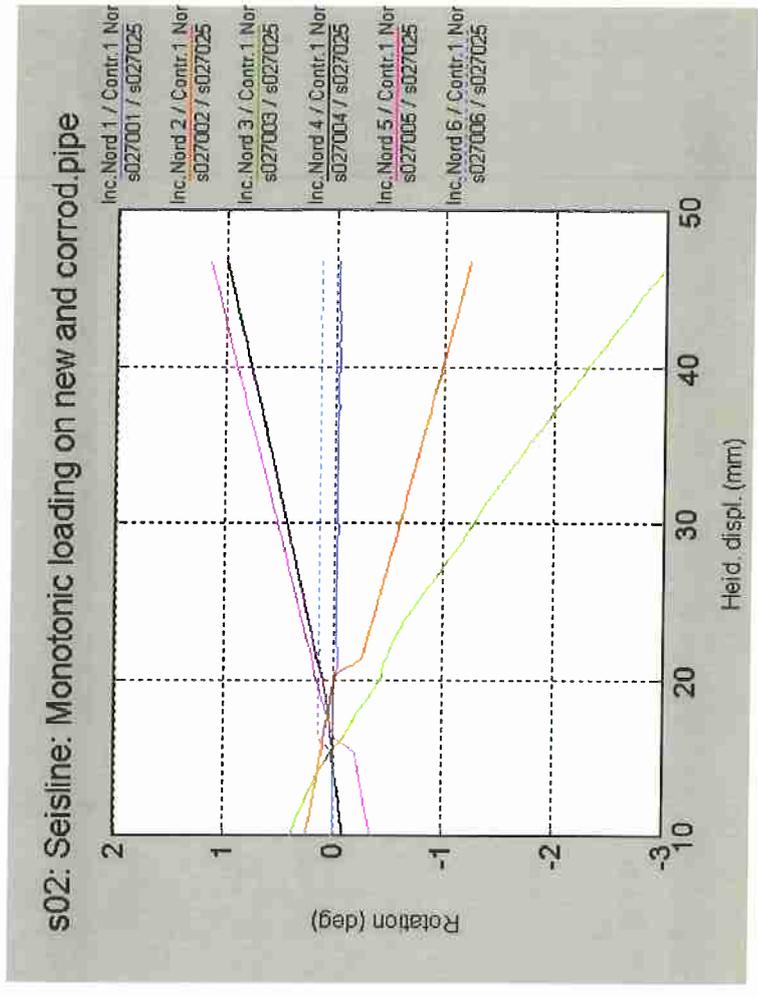
Fig. 12: Measured distributions of rotation along the pipes.

In Figure 12 the measurement of the inclinometers are depicted as a function of the imposed displacement. The graph on the right hand side refers to the virgin (undeteriorated) segment, the other to the corroded one. Again, one should refer to Figure 9 to identify the position of each sensor. No major differences between the behaviour of the virgin and deteriorated segments are visible. The point corresponding to the first rupture is clearly identifiable in the graphs, and by identifying the curves in which the drop takes place, one can conclude that the rupture took place in the vicinity of the joint.

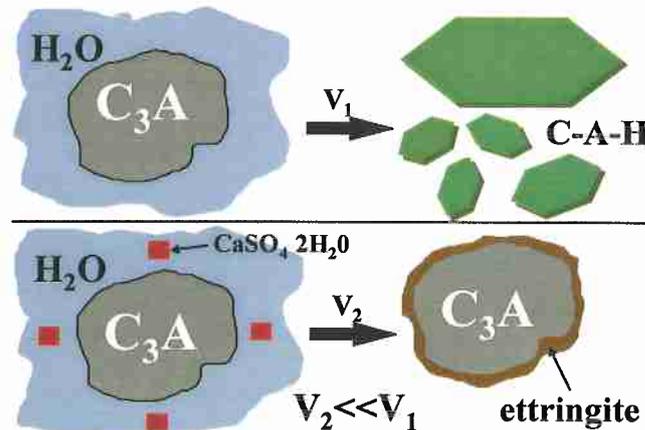
Fig. 1 – The hydration of C_3A in the absence (above) and in presence of gypsum (below).

Sulphate, in form of gypsum ($CaSO_4 \cdot 2H_2O$) is already present in the cement (about 5%) in order to regulate the setting of cement. In the absence of gypsum there is quick set due to a very rapid reaction of calcium alluminate (C_3A) and water producing hexagonal crystals of hydrated calcium alluminate C-A-H (Fig. 1, above).

In the presence of gypsum, water and C_3A react to produce "**primary**" ettringite immediately (*EEF*) in form of a coating around the C_3A grains (Fig. 1, below). Due to the ettringite coating the rate of C_3A hydration (V_2) is much lower than that (V_1) which occurs in the absence of gypsum. For this reason gypsum plays an important role in the cement hydration as set regulator through the early ettringite formation according to this chemical reaction.

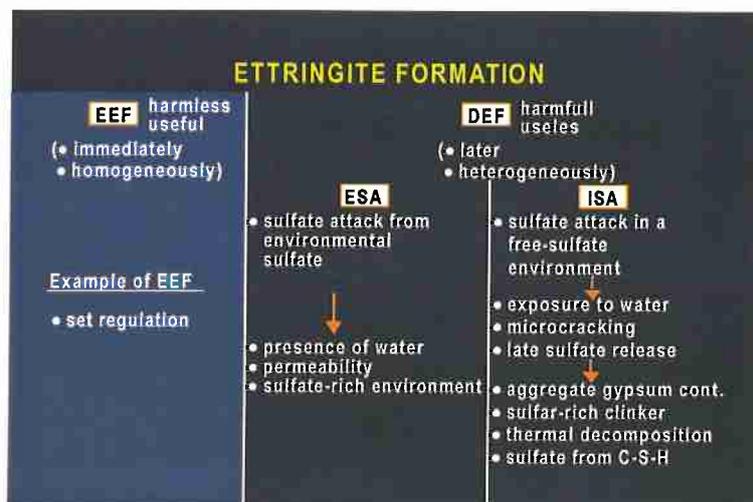
Fig. 2 – Schematic representation of *EEF* and *DEF*.

Figure 2 shows schematically the main differences between *EEF* and *DEF*, as well as the two type of *DEF*: *ESA* (External Sulphate Attack) and *ISA* (Internal Sulphate Attack). The type of *DEF* for the cement-based structures embedded in a soil is related to the sulphate attack from the environment, that is the sulphate present in the soil. Therefore, this is considered to be an *ESA* type of *DEF* with formation of “secondary” ettringite which must be distinguished from “primary” ettringite formed earlier in the setting period of cement.

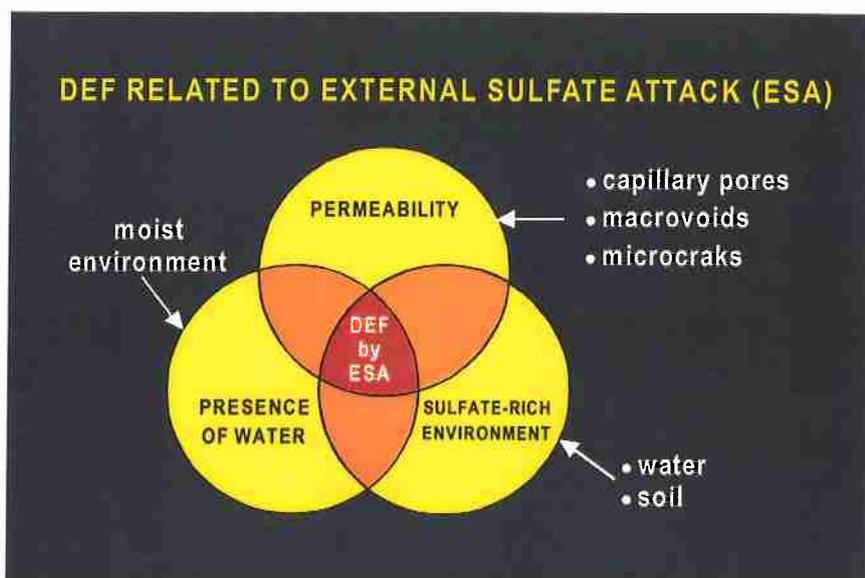
Fig. 3 – The coexistence of permeability, presence of water and sulphate rich environment is needed for the Delayed Ettringite Formation (*DEF*) caused by External Sulphate Attack (*ESA*).

Figure 3 schematically shows the three factors needed for the Delayed Ettringite Formation (*DEF*) caused by External Sulphate Attack (*ESA*); they are the permeability of the cement based material, the presence of water and sulphate rich environment. In the absence of one of these factors the *ESA* cannot occur. For instance if the cement-based structure is crack-free and is made by a very dense material with low capillary porosity (low permeability) the sulphate ions cannot diffuse from the environment through the water filling the capillary pores or the cracks. On the other hand, a permeable cement-based structure cannot be penetrated by sulphate ions in a dry soil since, in the absence of water, sulphate ions cannot migrate through the cement matrix. Finally it is trivial that, in the absence of sulphate in the environment any sulphate attack cannot occur.

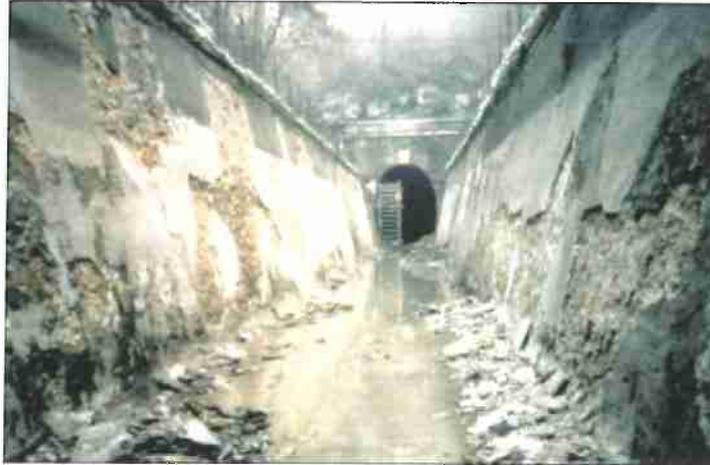
Fig. 4 – Typical external sulphate attack (ESA) occurring on the surface of the concrete of a canal in contact with a sulphate rich water. After removing water, deterioration by ESA can be observed.

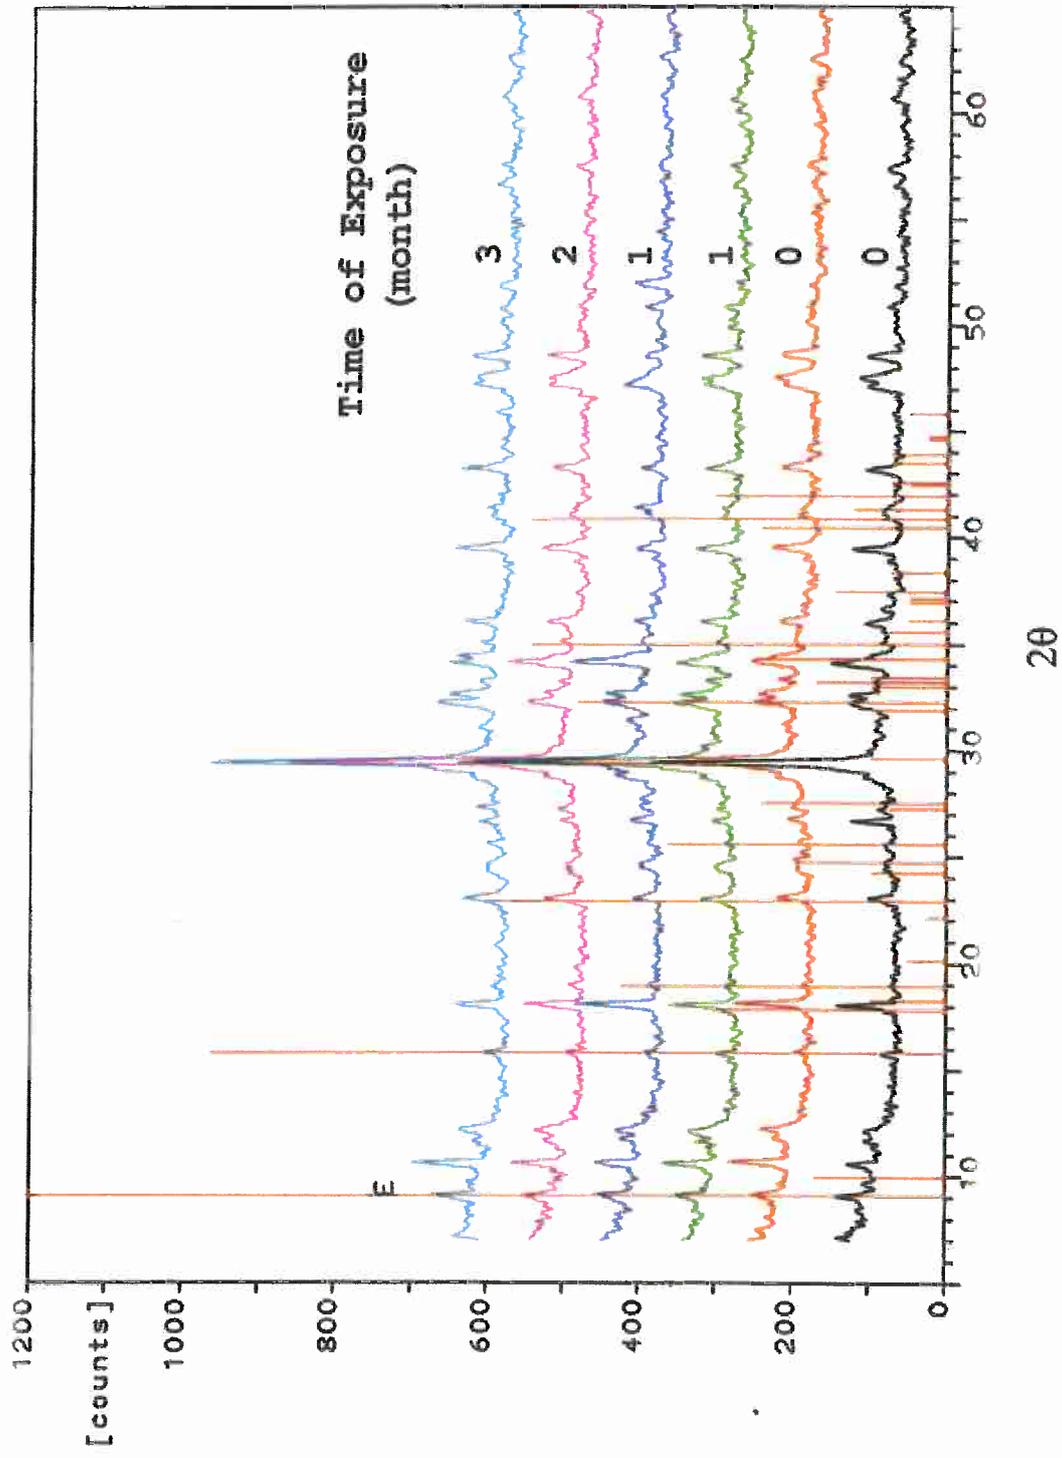
Fig. 5 – XRD patterns of specimens exposed to sulphate for different times.

The specimens of pipes were finally ground and subjected to X-Ray Diffraction (*XRD*) analysis.

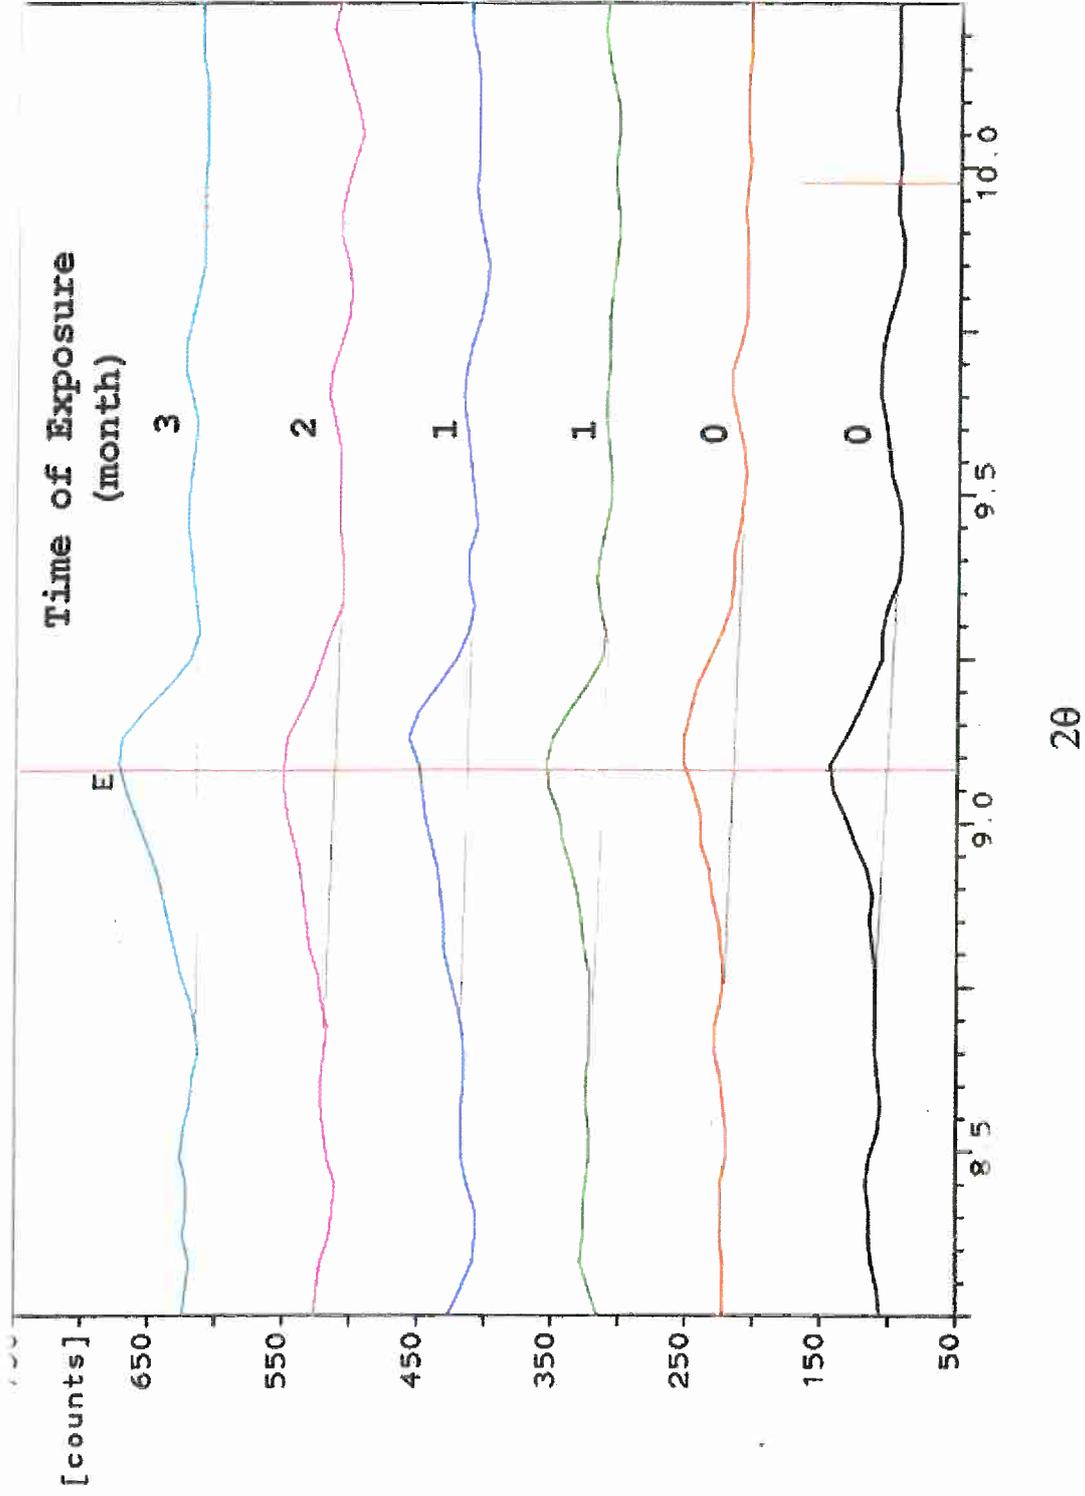
Fig. 6 – Details of XRD main peak of ettringite at 9.08 as a function of the time exposure to sulphate environment.

Figure 6 shows the enlarged ettringite peak at 9.08°. The area under the peak is proportional to the amount of ettringite. Again no significant change is observed in the area under the peak at 9.08° by increasing the exposure time to sulphate.

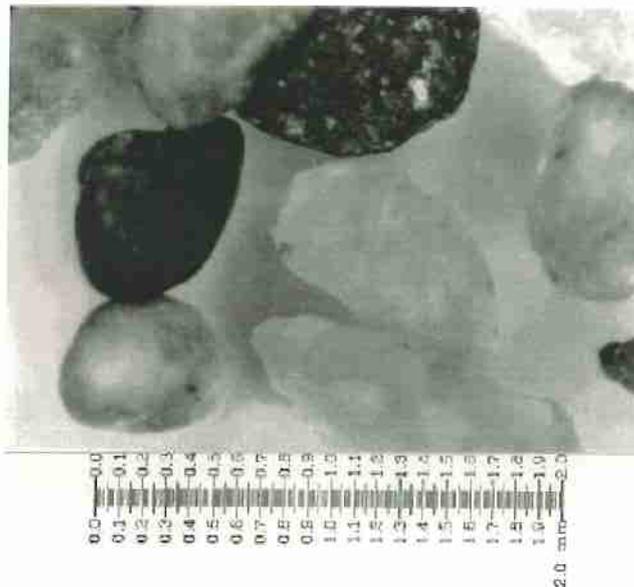
Fig. B.2: Ticino sand particles grains magnified by a factor of 40 (Rondena 1984)

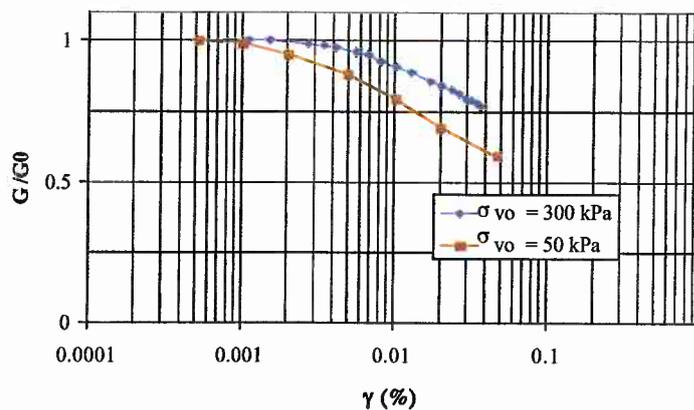
Fig. B.3: Cyclic shear modulus decay of Ticino - Resonant column results

Fig. B.3 illustrates the experimental decay of shear modulus as a function of cyclic shear strain amplitude observed in resonant column results on TIS for different levels of confining pressure. The decay does not depend upon the relative density of the sand.
