NEDIES PROJECT

Lessons Learnt from Maritime Disasters

EUR 20409 EN

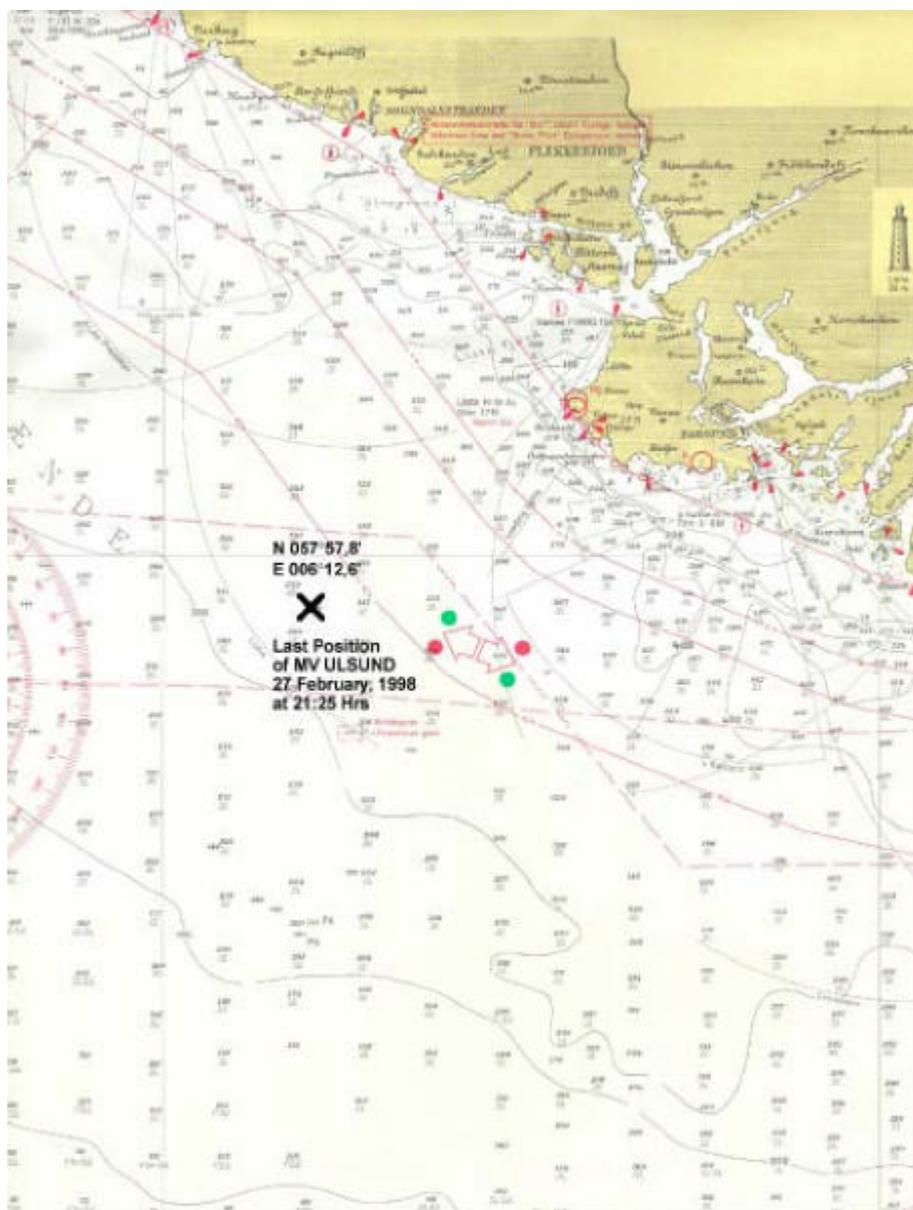
*Figure 2.3.b– Last position of MV Ulsund.
© Accident Investigation Board Finland*

In the afternoon of 25 February 1998, the voyage to Høyanger continued. In the Skagerrak, the ship encountered SW/W winds, varying between near gale and gale, and heavy sea, 5 to 6 m. The ship's speed was reduced to 3 to 4 knots. The master called the shipping company in Finland both on 26 February and on 27 February 1998 without giving any information about problems related to the seaworthiness of the ship. On 27 February 1998 at 21.25 hrs the ship transmitted the distress alert MAYDAY on VHF radio channel 16 from the position N 57.00-57.80 and E 06.00-12.60 (see Figure 2.3.b) Farsund Radio answered the ship immediately and after roughly 70 seconds the captain told them that:

- a) the ship made water,
- b) its port bulwark and deck were submerged,
- c) it listed approx. 6 degrees (to port),
- d) they were trying to pump,
- e) they needed immediate assistance,
- f) there were 7 people on board.

It is assumed that the ship went down in the course of about 10 to 15 minutes, as no other vessel observed any clear radar echo in the indicated casualty position. The first vessel reached the indicated casualty position about one hour later, at which time there was only wreckage left.
