The L'Aquila (Italy) earthquake of 6 April 2009: report and analysis from a field mission

Anna Bosi, Francesco Marazzi, Artur Pinto

European Commission, Joint Research Centre, IPSC, ELSA, via E. Fermi 2749, TP 480, I-21027 Ispra (VA), Italy

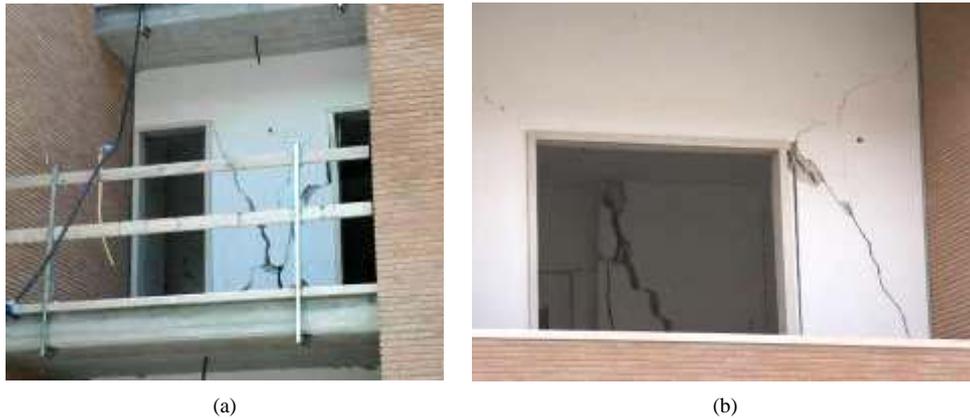
Figure 3.7: Damage of masonry infills

The overall performance of new reinforced concrete buildings was superior to that of older ones. None of the new reinforced concrete buildings that were visited during the field mission had collapsed. Extensive damage of the masonry infills and very limited, if any, damage of load-bearing elements was observed. Figure 3.7 shows typical diagonal cracking of internal and external infills of a building under construction. Such damage, which requires costly repair, was observed in the majority of the new reinforced concrete buildings. The fact that this type of damage occurred to such extent in new buildings calls for a better consideration of the non-structural elements in the design and construction procedure.

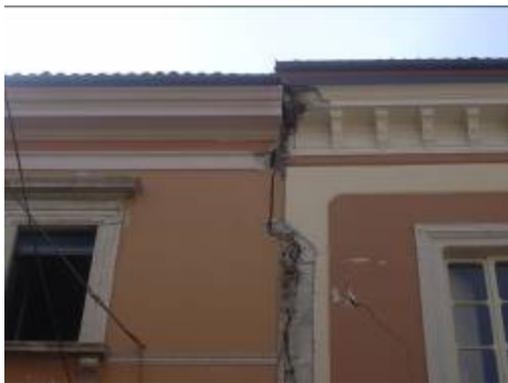
Figure 4.1a shows the pounding among two adjacent buildings. The earthquake has revealed the discontinuity between the two structures. Because of their continuous façade, in fact, before the earthquake they should appear as a whole construction.

(a) pounding between buildings

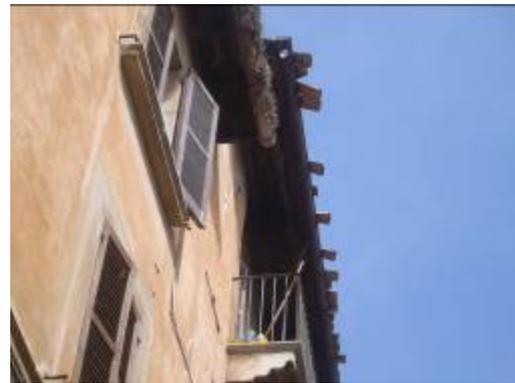
(b) tiles

Non-structural damages have also an important role in the safety issue. Figure 4.2 shows some examples of danger for pedestrians. In Figure 4.2a the balcony has partially collapsed and the shutter leaning against it is in a very unsafe equilibrium. Figure 4.2b shows the tiles of an old roof: they have slid and are now leaning around the very margin. Therefore, at the time of the visit, not only the risk of total collapse of buildings, but also risks due to non-structural damage made the centre of the city of L'Aquila not accessible if not assisted by the Fire Brigades.

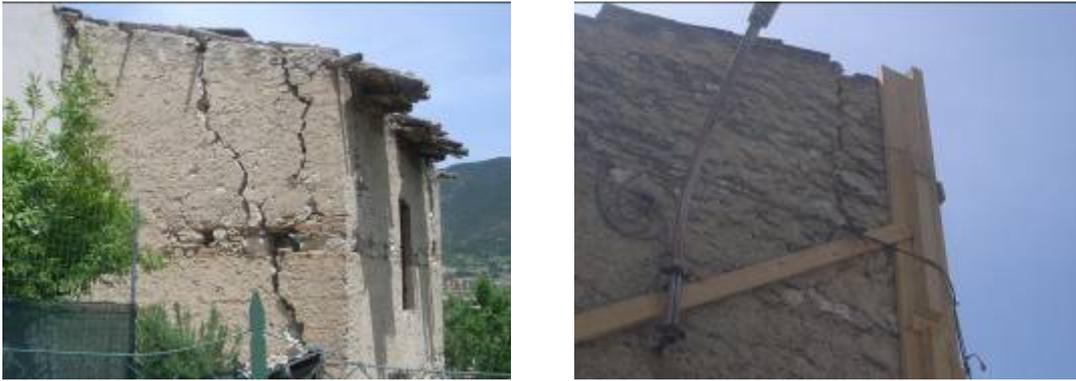
The small village of Coppito stands some kilometres far from L'Aquila. Its origin is much more modest than the city of L'Aquila and this reflects in the type and quality of buildings. There are mainly old masonry buildings, usually with 2 or 3 floors, sometimes restored and often in a quite bad conservation state. Examples of the worst cases are shown in Figure 4.3.

Figure 4.3: Coppito – Very poor quality of masonry

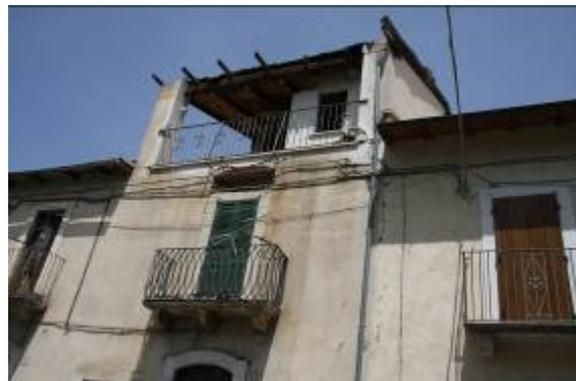
(b) collapsed arch

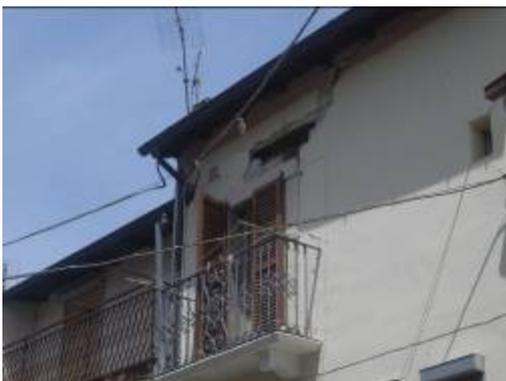
(c) not properly connected corners

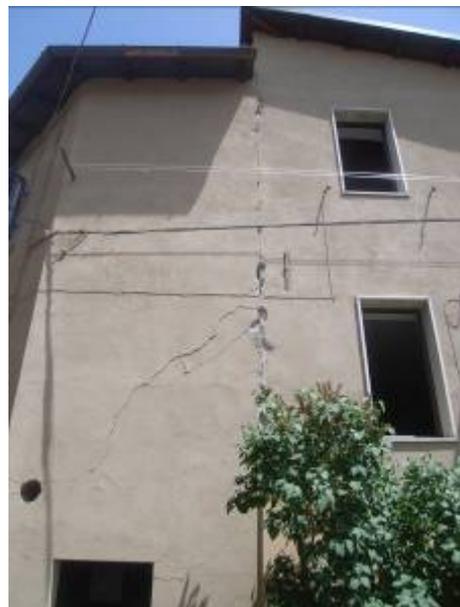
(d) not properly connected buildings

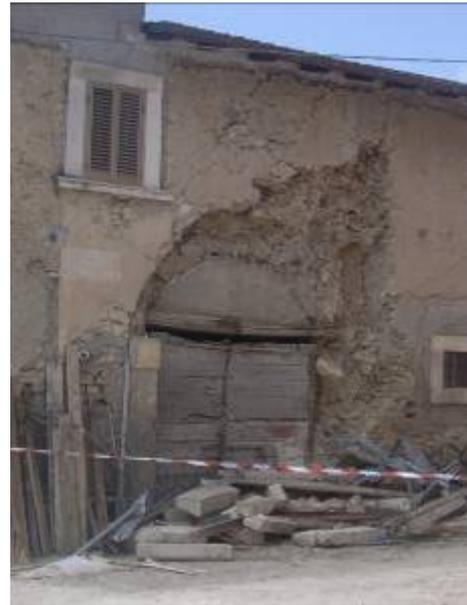
the complete destruction of the structural wall of the building. The bad quality of masonry can be seen in Figure 4.6b, where an entrance arch partially collapsed.

(b) bad masonry quality

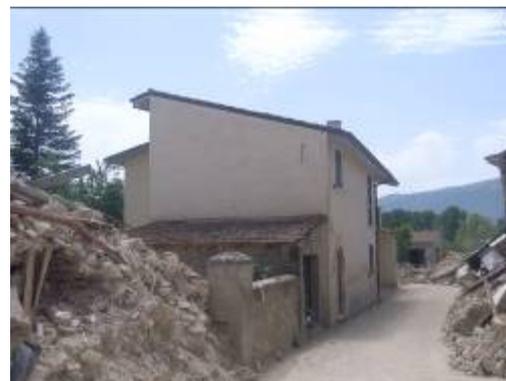
(d) collapsed and undamaged buildings

Some recent buildings resisted very well to the earthquake. Figure 4.6d gives an indubitable example of how damage is related to both the earthquake intensity and the building vulnerability: the building on the left completely collapsed, while the house in the centre of the photo has resisted very well to the earthquake.

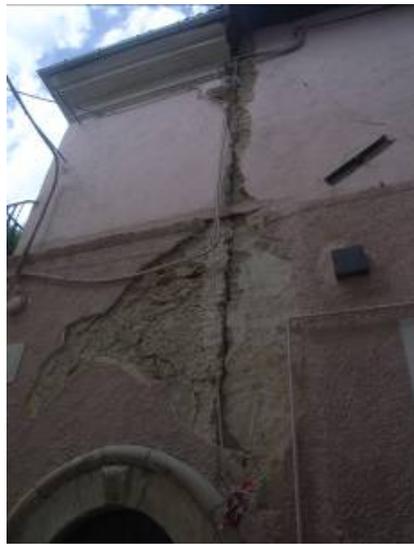
Masonry is also the material of the churches. In general the quality of masonry buildings is poor even for restored ones. Several buildings present traces of additions (Figure 4.7a) and recently-constructed heavy concrete roofs (Figure 4.7b).

(a) addition without proper anchorage

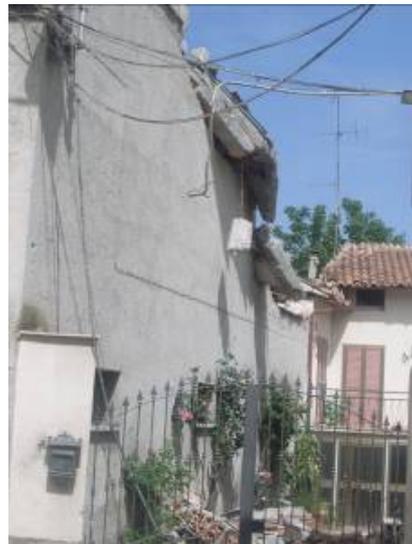
(b) heavy concrete roof

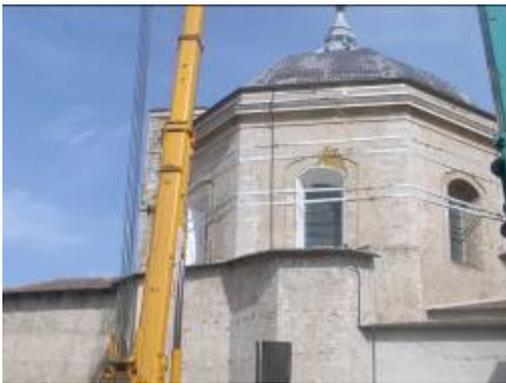
(c) San Bernardino (drum)

The church of Sant'Agostino (Figure 4.9a) suffered the collapse of the bell tower and severe damages at the drum. The church of San Francesco di Paola (Figure 4.9b) has the upper part of the façade destroyed and damages to the roof. The church of San Bernardino (Figure 4.9c) had the façade completely saved, but its drum suffered extensive cracks. The church of Santa Maria Paganica (Figure 4.9d) had the roof of the nave completely collapsed together with its apse. The Cathedral of L'Aquila (Duomo, Figure 4.9e and 4.9f) had the drum almost collapsed and the façade heavily damaged.

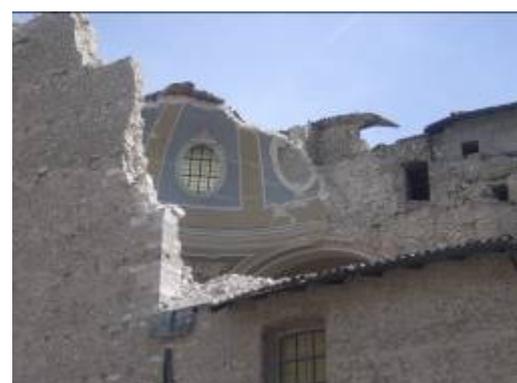
(d) Santa Maria Paganica

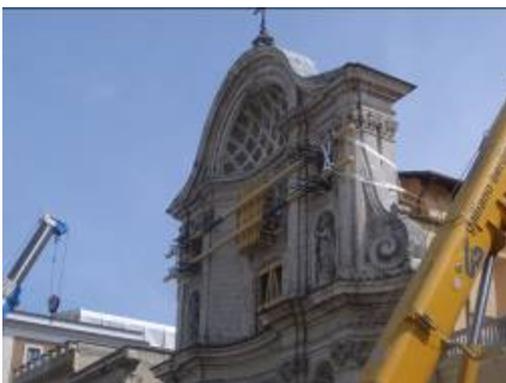
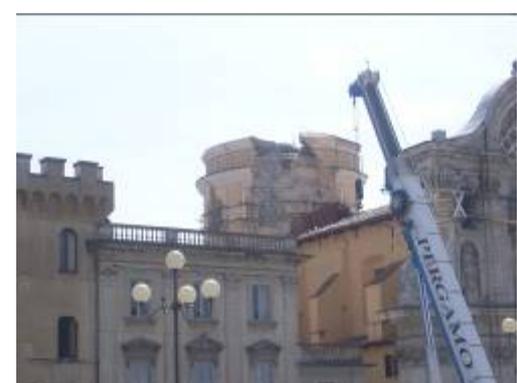
(e) Duomo

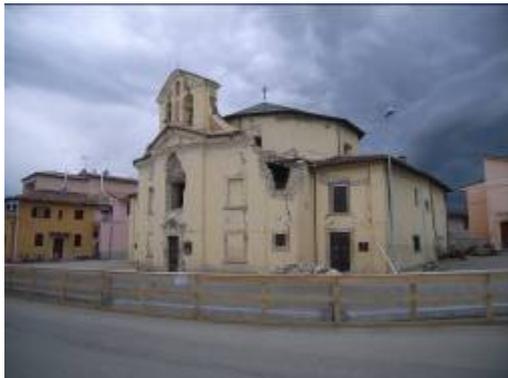
Figure 4.11 shows the damages to some monuments in Paganica. Figure 4.11a shows the heavy damage of a masonry wall where security provisions have been constructed. Figures 4.11b, 4.11c and 4.11d show a comparison among different situations for the Concezione church: before the earthquake, just after it and in the phase of safety provision measures. Damages are spread all over the building with local collapse of poor quality masonry. Figure 4.12e shows a tower facing on the Concezione square just before the earthquake in comparison with Figure 4.13f where the same tower exhibits diagonal cracks at 45 degree angle inclination clearly showing a torsional damage mechanism.

(c) Concezione church just after the earthquake

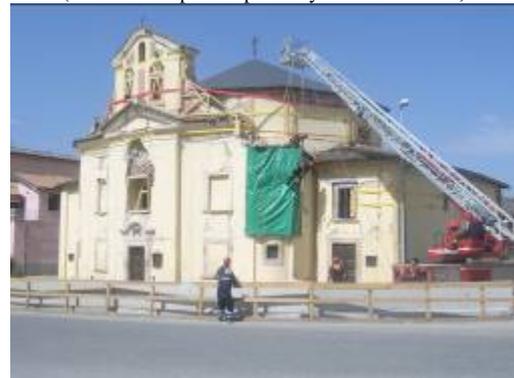
(d) Concezione church during the security provisions

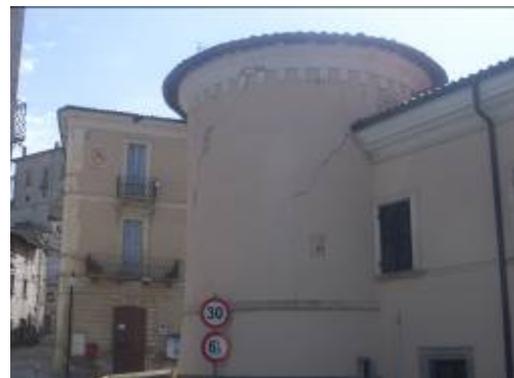
(f) Concezione square after the earthquake
