# IDSL Sea Level Measurement Devices

*Report on the deployment  
and first year of work of the  
IDSLs in the Mediterranean  
area*

ANNUNZIATO Alessandro  
GALLIANO Daniele A.  
BONAITA Matteo

2016

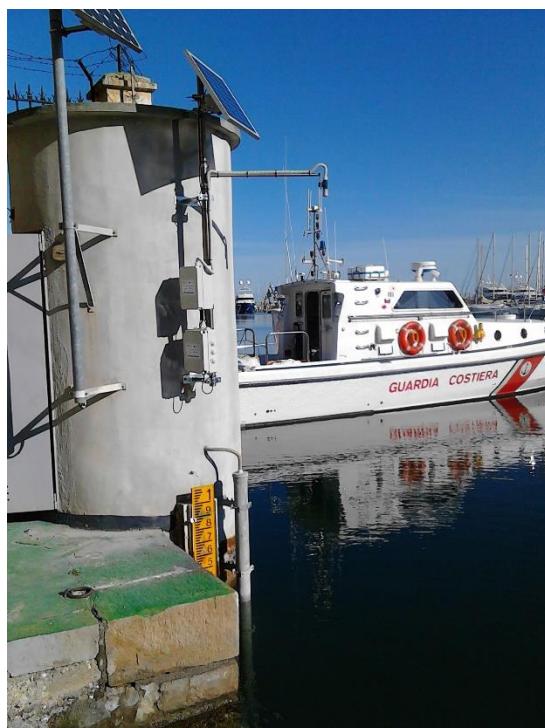
Figure 1 The Imperia device, installed onto a cabin by ISPRA in the compound of the Coast Guard

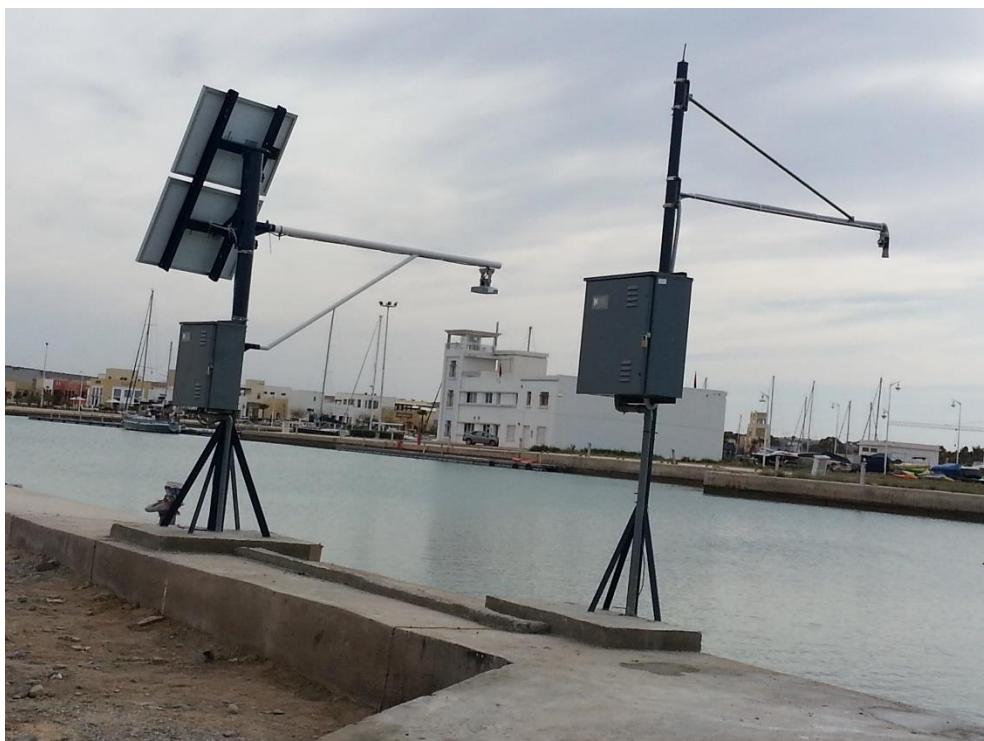
| Date | Description | Notes | Status | Level |
|---|---|--|---|---|
| 07/05/2016 07:00 | Sudden changes of sea level noticed today. The reason could be the location of the temperature sensor inside the container box. | It would be desirable to move out the temperature sensor | Ongoing | Yellow |

Figure 2 Saidia Marina, Maroc

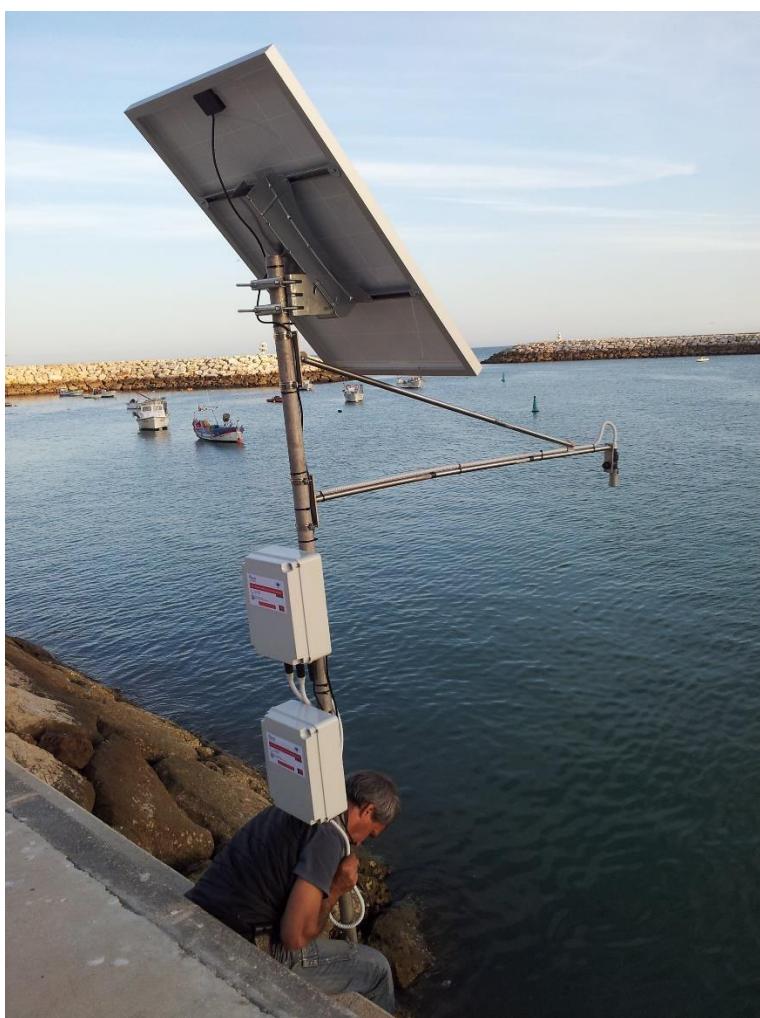
| Date | Description | Notes | Status | Level |
|---|--|--|--|---|
| 27/04/2016 00:00 | The device stopped working | Probably the card is damaged but as this device has no watch dog, it cannot restart | Need to replace the card or the device | Red |
| 27/01/2016 00:00 | During the survey, it was discovered that the sensor was strongly hit, the arm was deformed and the sensor itself rotated (picture below). This was the reason of incorrect signal in low tide. The arm has been realigned but the response is not yet optimal with several incorrect values detected. | It would be useful to: change the installation position in a more boat free location and in that occasion to replace the sensor with a new one | Ongoing | Red |

| Date | Description | Notes | Status | Level |
|---|--|--|--|---|
| 10/06/2016 00:00 | The Control box has been replaced with a new one | New CB and new card | Operational | Green |

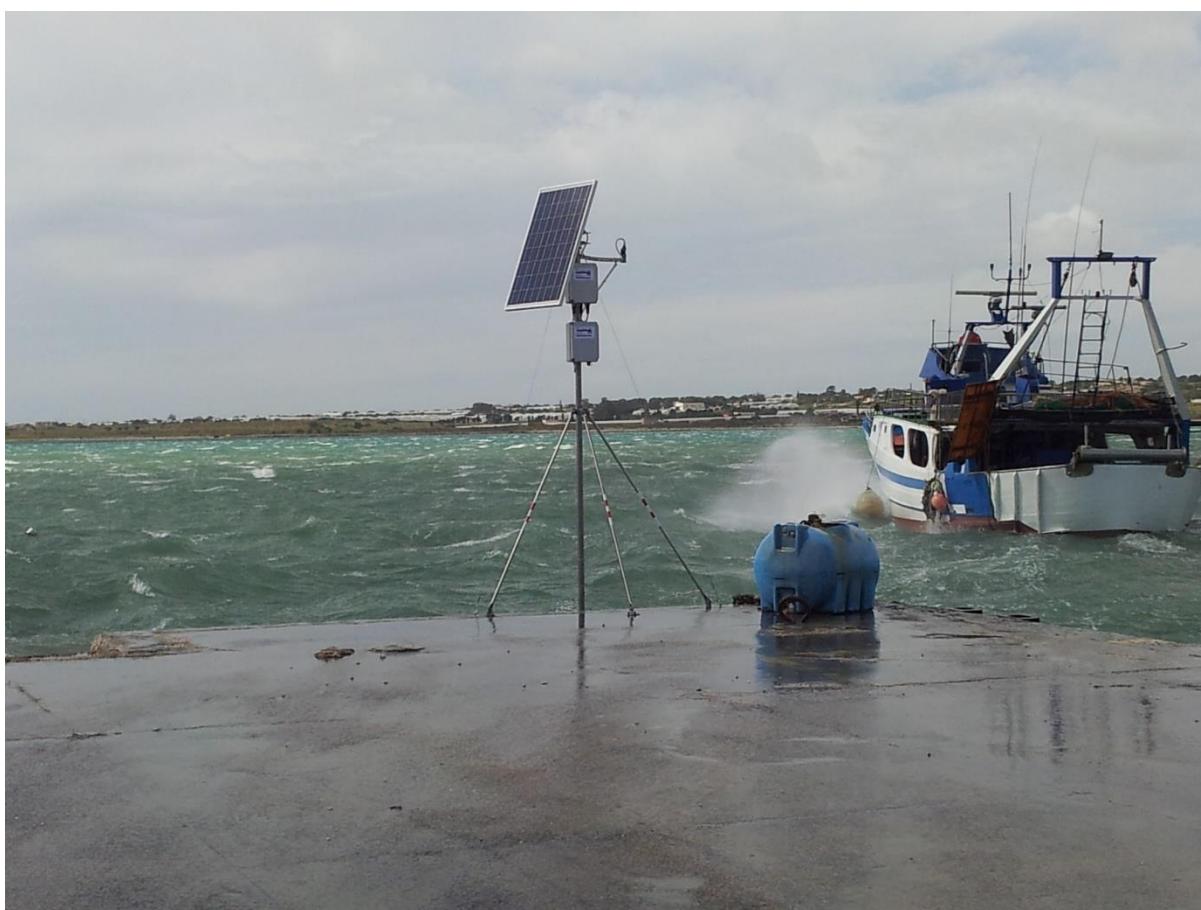
The IDSL device in Portopalo has been installed on March, 1<sup>st</sup> 2016 in the western port structure, at the end of the walkable dock. After the installation, a very strong storm occurred which posed some problems in the data collection, because the sensor is unable to measure when very stormy conditions with foam and white water are present. For this reason, JRC/INGV and ISPRA are discussing to identify another more suitable position for this device. In any case the data are arriving to the JRC server as expected.

| Date | Description | Notes | Status | Level |
|---|---|--|---|---|
| 01/03/2016<br>00:00 | First part of the installation | Need to finalize the installation with tension wires and second pole support | | Yellow |

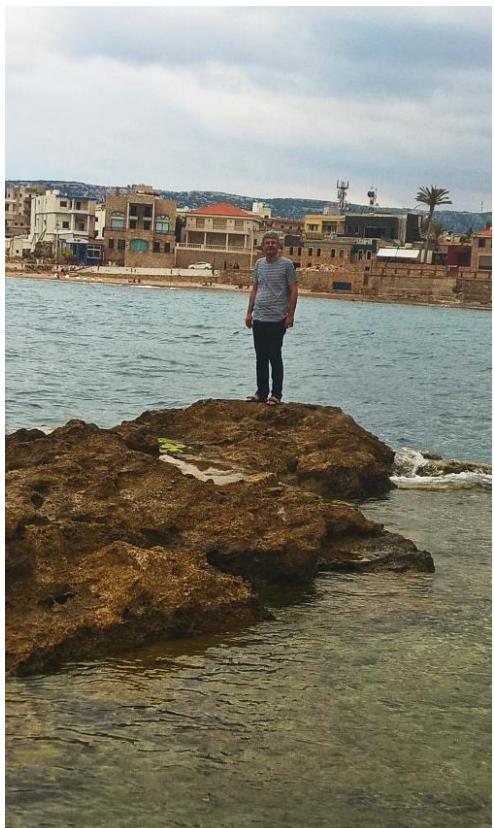
*Survey location inspection*

The installation has been performed as foreseen in the Survey report (Figure 1). The sensor was positioned on a rock surrounded by water in front of the BioMarine Institute building. The IDSL is attached to an aluminium pylon on top of a concrete basement. This is a challenging solution, which provides a very good observation point of the tide. In front of the sensor, the sea depth is about four meters, even if right below the radar sensor it is only 1,5 meters deep, due to an underwater rock.
