JRC TECHNICAL REPORTS

European Solar Test Installation

Characterisation of c-Si modules after 20 years of outdoor exposure on an electric vehicle.

2017

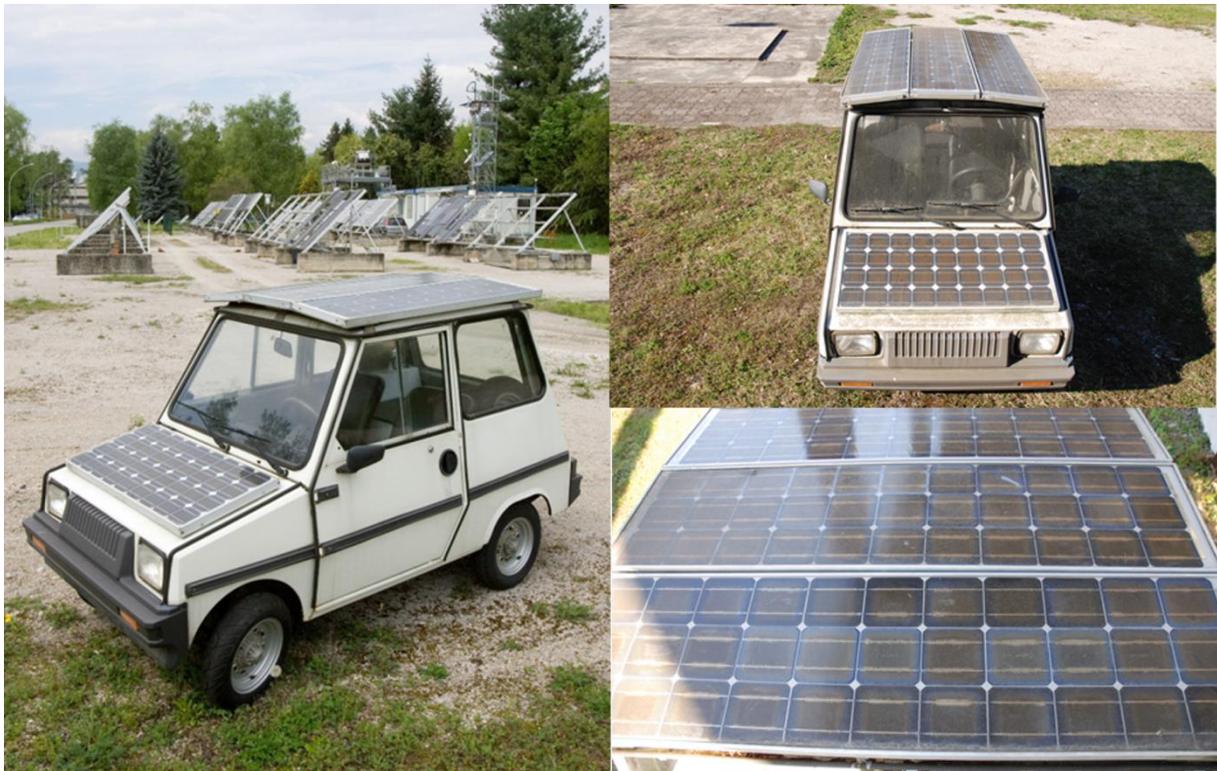
Figure 1 View of the photovoltaic modules on the electric vehicle.

The IY41 module was mounted in the bonnet of the car with a tilt angle of 12 degrees. The IY42 and IY44 were mounted on the roof of the car with a tilt angle of 8 degrees meanwhile the IY43 remained horizontal on the roof, subjected to long-term continuous outdoor exposure for more than 20 years without cleaning (Figure 1 and Figure 2). The car was a Mazzieri model with an electric motor of 7 cV of maximum power and a maximum speed of 70 Km/h. The average energy consumption is 20 kWh/100 Km according to ECE test cycle and the minimum range is 100Km by road, at 80% depth of discharge (DOD). The modules were connected to a battery and the
