**EUROPEAN COMMISSION  
JOINT RESEARCH CENTRE**

## **The Molise (Italy) earthquakes of 31 October and 1 November 2002: Report and analysis from a field mission**

*E. Mola, G. Tsionis, F. Taucer, A. Pinto*

EUR 20664 EN

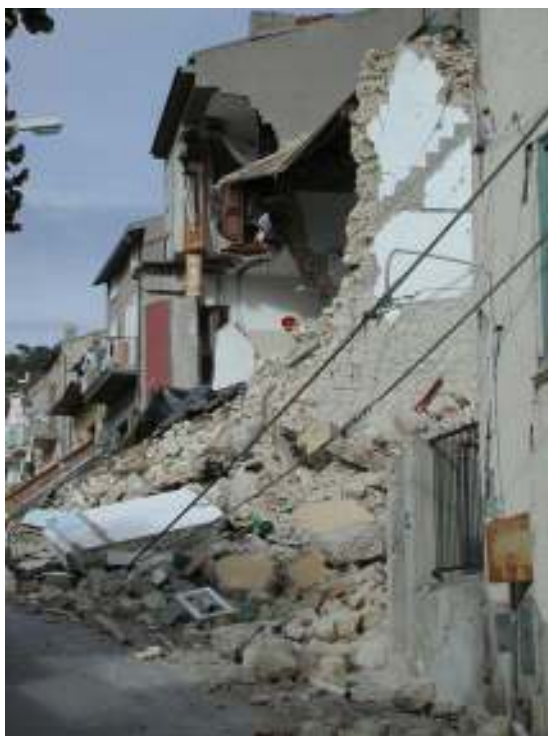
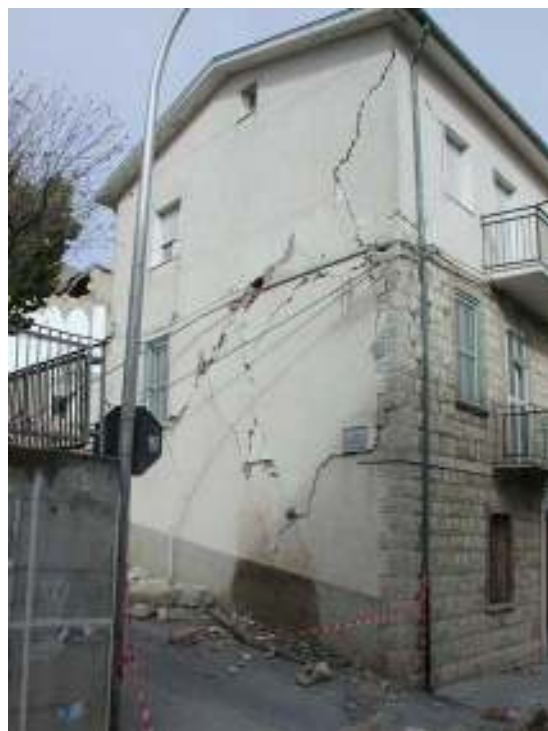
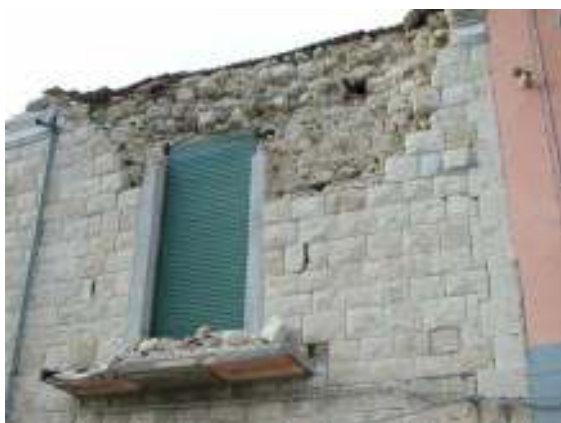
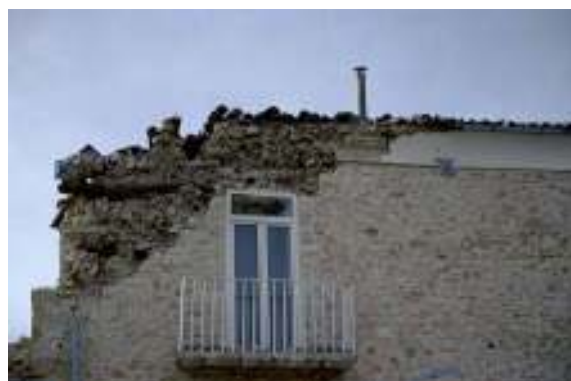
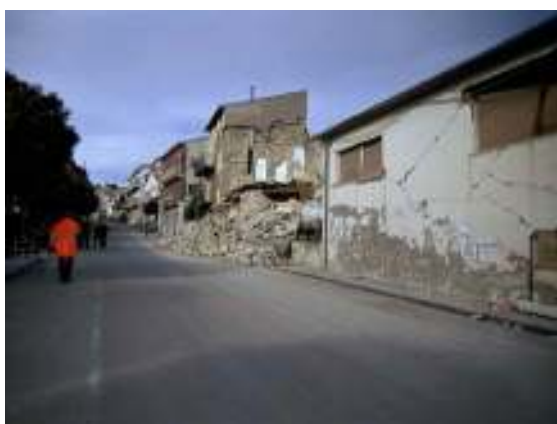
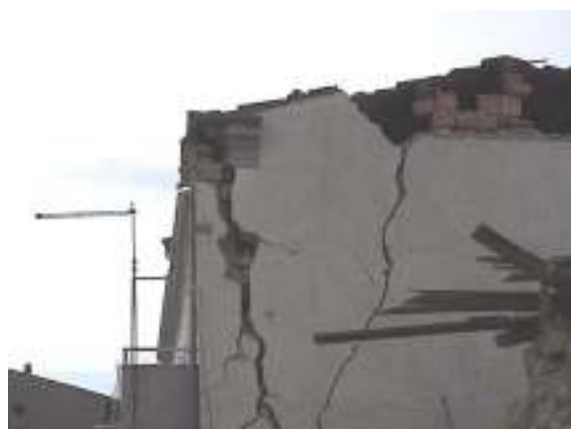
Figure 4.1. Damage to non-engineered masonry buildings in San Giuliano di Puglia

In what concerns the quality of the bearing walls, mostly made of rubble stone or tufo blocks, it was observed that stones were small in size and the lime mortar was coarse. The bearing walls were sometimes externally plastered or had a façade made of good quality stone tiles (see Figures 4.1c and 4.1d). However, the connection between these tiles and the rubble stone was inefficient and did not provide any contribution to the strength of the main walls; this is evident in Figures 4.1c and 4.1d.

The absence of ties was also common, but due to the very poor quality of masonry walls, their effectiveness would have been doubtful, unless many ('micro') and well distributed ties had been used. In fact, as shown in Figure 4.1d of a building in San Giuliano di Puglia, ties were present at the roof floor (one is visible in the picture; the other in the left-end side was identified during the field mission) but they were almost ineffective due to the poor quality of the masonry walls.

Other factors that may have contributed to severe damage and collapse of these structures are the addition of new storeys, and/or replacement of the original timber roofs with concrete roof slabs, as shown in Figure 4.1a (concrete roof slab and original timber floors) and Figure 4.1b (addition of a new storey and concrete roof-slab).

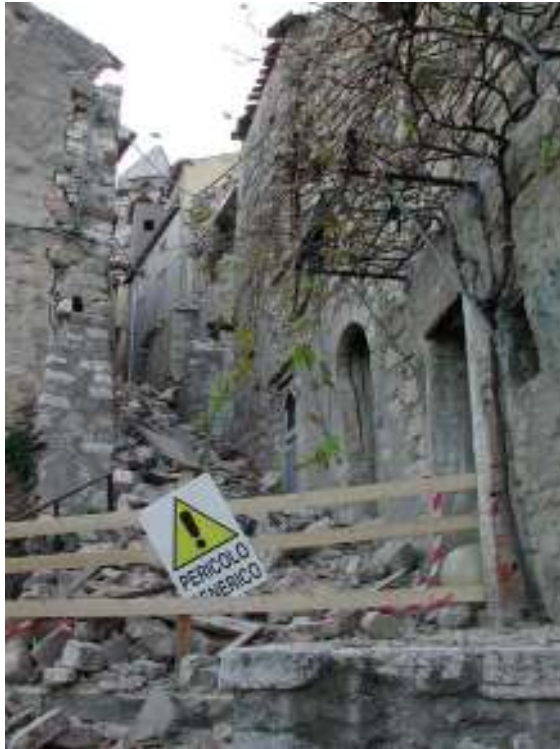
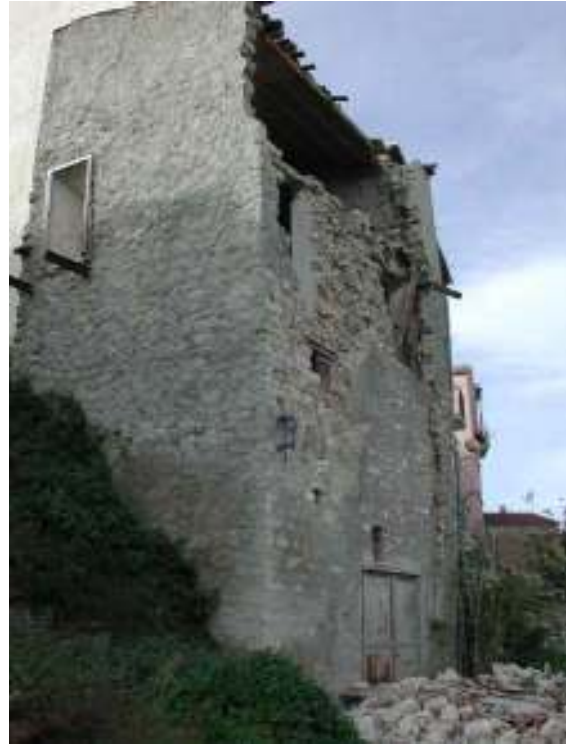
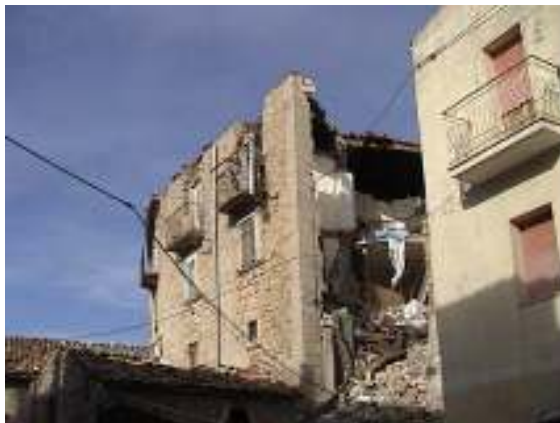
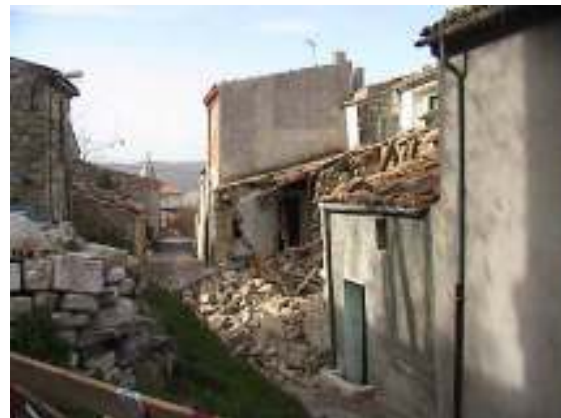
Figure 4.2. Damage to non-engineered masonry buildings in Castellino sul Biferno and Ripabottoni

Figure 4.2 shows some pictures of the oldest buildings in Castellino sul Biferno (Figures 4.2a and 4.2b) and Ripabottoni (Figures 4.2c and 4.2d) where the poor quality of masonry and more specifically, the lack of maintenance is evident. The impression is that most of these buildings were abandoned or were used as storage, including animal keeping.

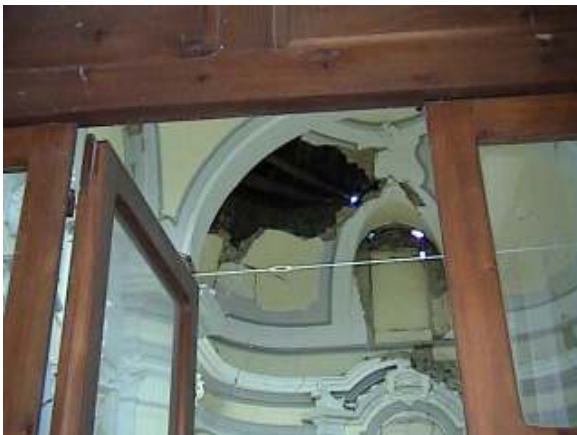
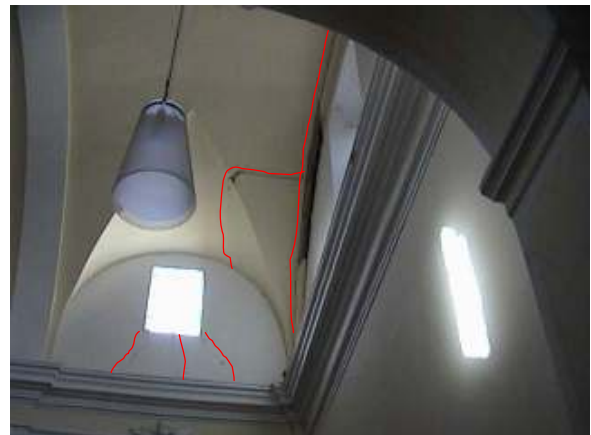
Both churches of Ripabottoni were seriously damaged. The façade of the old church was separated from the lateral walls and the cusp was separated from the rest of the façade (Figure 4.6). More serious damage was observed at the interior of the church. The vault of the apse partially collapsed (Figure 4.7a) and extended cracking was observed in the apse. The dome was seriously cracked, but a collapse mechanism did not fully develop, possibly thanks to the beneficial effect of the tie rods at the base. The vaults of the nave were also cracked and separated from the adjacent walls (Figure 4.7b).

Figure 4.7. Old church in Ripabottoni, partial collapse of the dome (a) and damage of the arches and vaults (b)

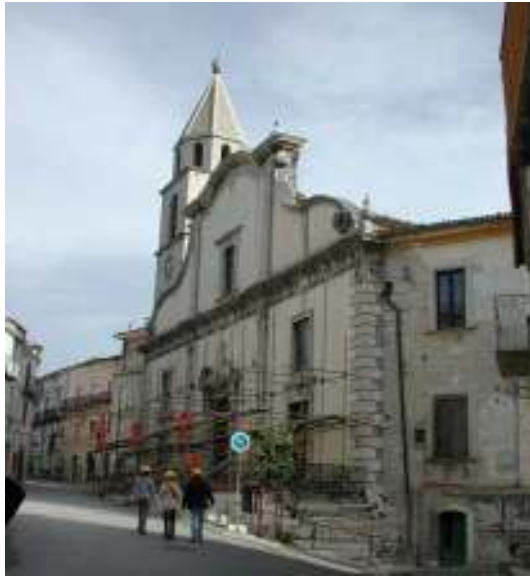
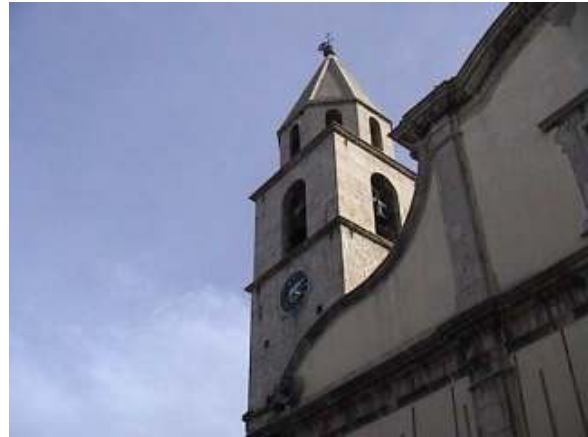
Figure 4.8. New church in Ripabottoni, façade (a) and bell tower (b)

The new church of Ripabottoni is situated at a short distance from the old one and suffered similar damage. No significant damage was observed at the façade and the bell tower, but scaffolding was installed for protection of the façade against overturning (Figure 4.8). At the interior, the vaults of the transept presented diagonal cracks that continued above the arches (Figure 4.9a). The pillars showed vertical cracks at all faces (Figure 4.9b), while the triumphal arch presented extensive wide cracks.

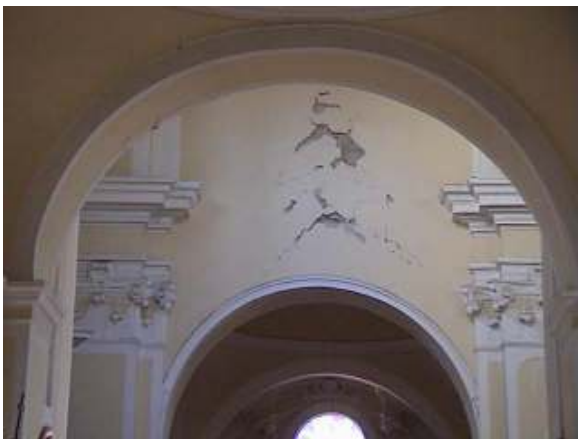
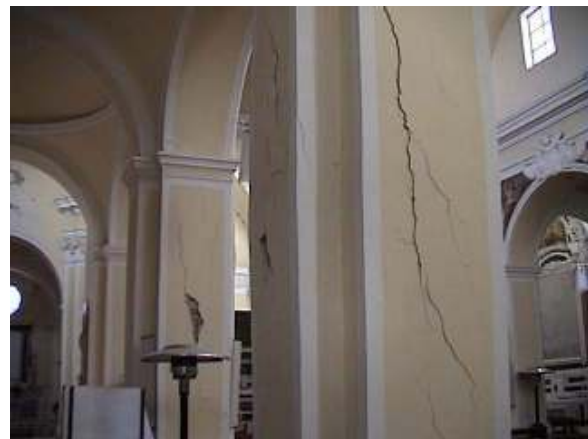
Figure 4.9. New church in Ripabottoni, damage of the vaults (a) and the pillars (b)

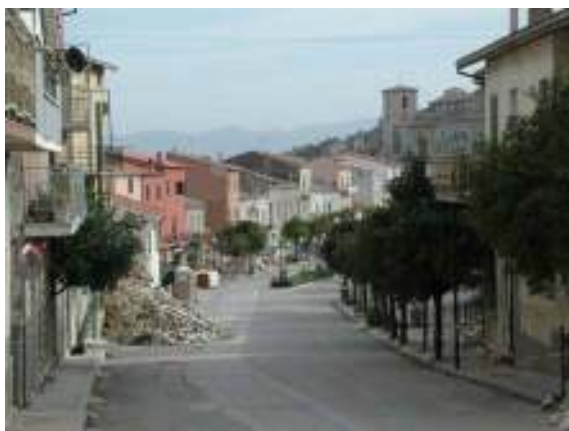
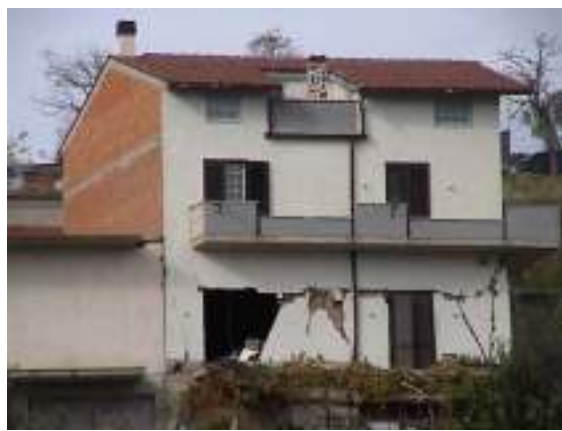
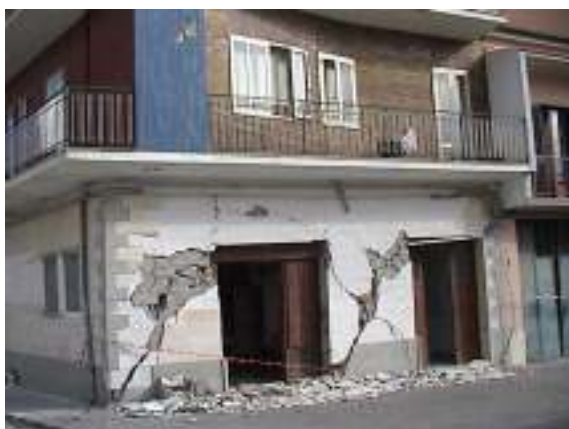
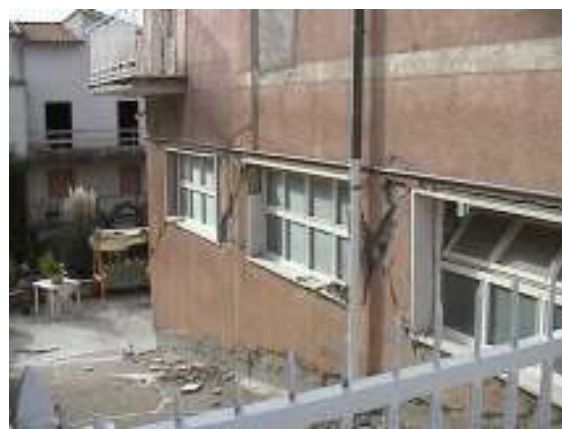
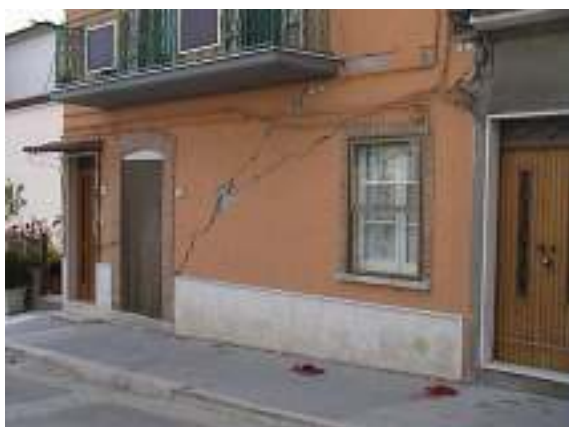
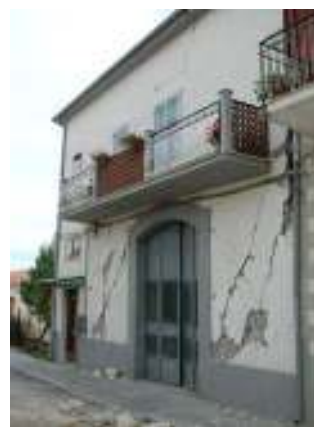
Figure 4.10. Damage to engineered plain masonry buildings with RC floors in San Giuliano di Puglia

Typical examples of masonry buildings with RC slabs in San Giuliano di Puglia are presented in Figure 4.10, confirming the large percentage of openings in the ground floor. Furthermore, all the pictures show severely damaged buildings in the extremity of building blocks, a phenomenon that has been commonly observed in previous earthquakes.

These buildings represent typical cases of engineered structures, which could have been designed for improved earthquake resistance if the zone had been qualified as seismic zone. Anyway as-built seismic resistance is not sufficient for the case of low-moderate seismicity.

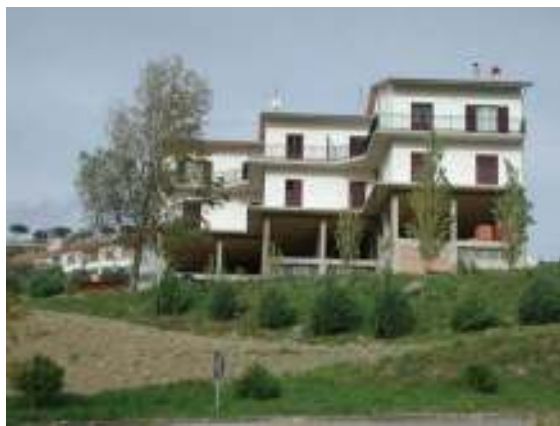
(a)

It is however pointed out that some damage to RC structures, specifically to infill panels, was identified in a few buildings in San Giuliano di Puglia, Bonefro, Colletorto and Santa Croce di Magliano. These buildings generally show particular features such as open ground floor or extremely irregular configurations. As shown in Figure 4.11a, a building in the upper part of San Giuliano di Puglia, without infill walls in the ground floor (just above the garages) suffered some structural and severe non-structural damage at the ground floor. The set of buildings shown in Figure 4.11b are located in the same area, 100 meters from the building in Figure 4.11a and did not suffer any damage.

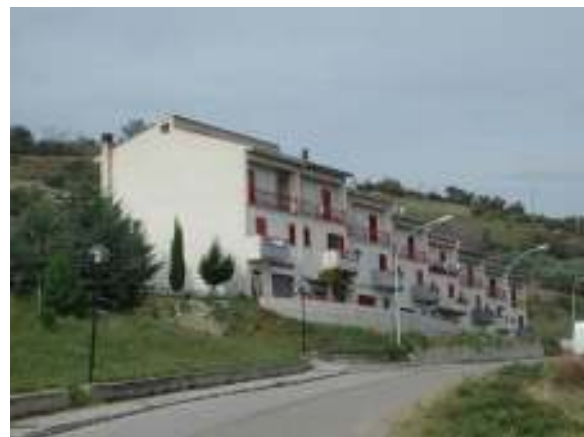
(b)

Reinforced concrete structures represent only a very small part of the housing/building stock of the small towns affected by the earthquake. For example, in San Giuliano di Puglia, only a few RC houses constructed recently exist in the upper part of the town and no-damage (see Figure 4.11b) or minor non-structural damage was identified in these RC structures (houses and buildings).

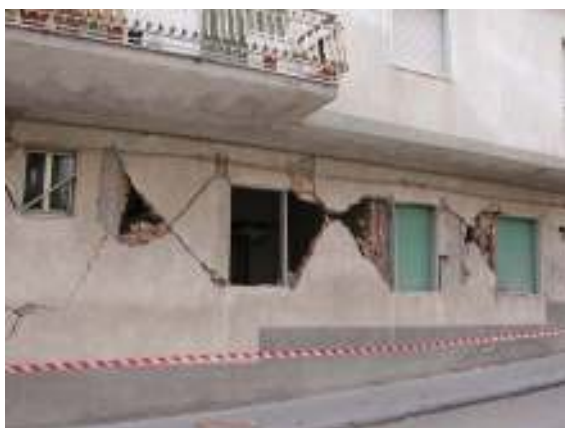
(c)

Another building in San Giuliano di Puglia, in the most affected area of the town, shown in Figure 4.11c, shows extremely severe damage in the ground floor, where the relative area of openings (windows and doors) is quite high.

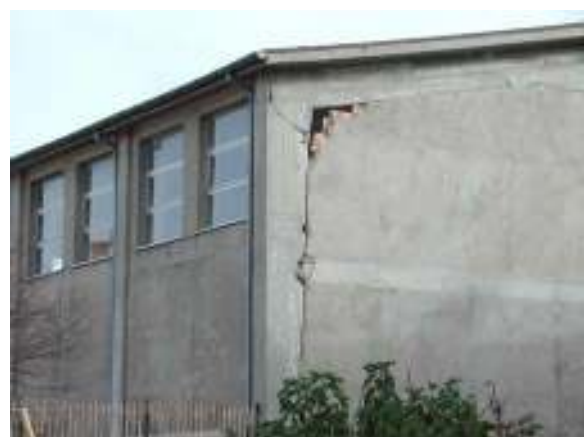
(d)

The structure shown in Figure 4.11d is the gymnasium, adjacent to the collapsed school of San Giuliano di Puglia. It is a simple RC structure with a long infill brick-wall in the West side, which suffered crushing of the infills in the upper-left corner and provoked shear failure of the left column in the joint region. In fact, it was reported that the long brick-wall was reinforced recently with a horizontal RC beam (visible in Figure 4.11d), which inhibited failure of the wall itself and allowed for development of a larger compression strut and consequently for higher shear forces transmitted in the wall-column interface.

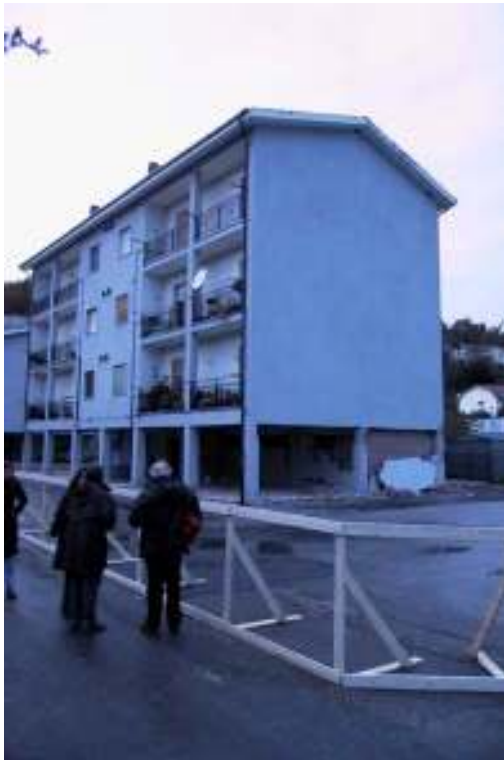
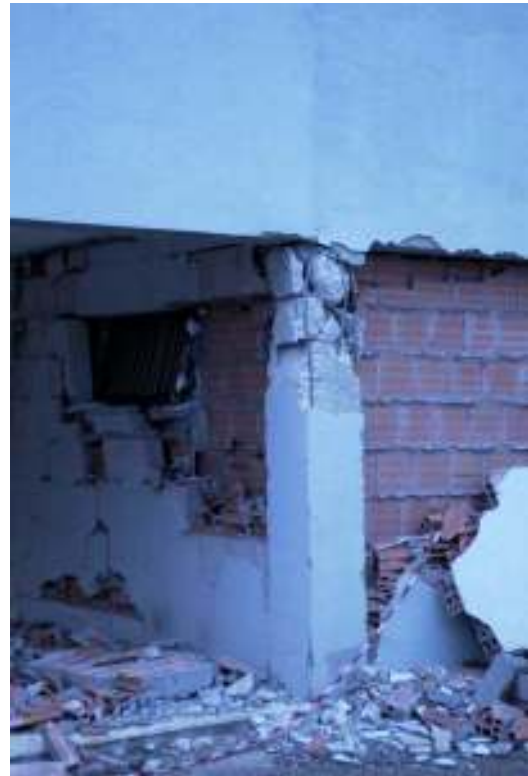
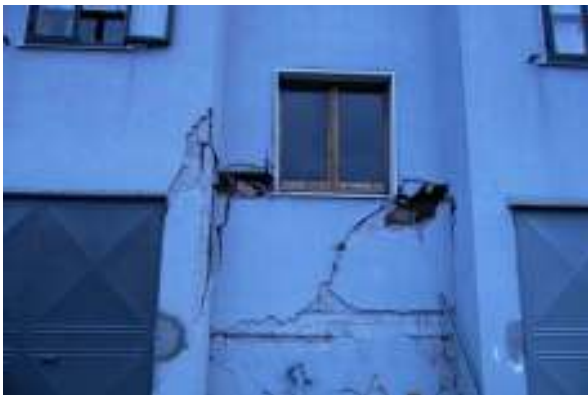
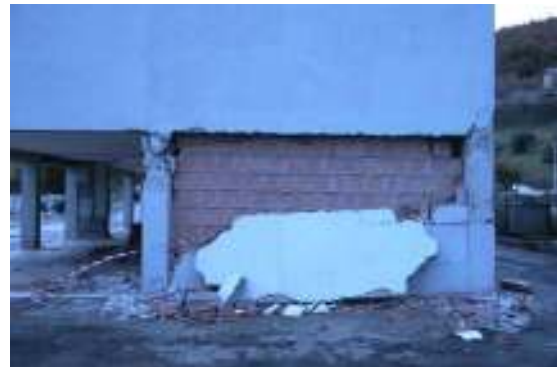
Figure 4.12. Reinforced concrete building in Pozzo di Terra – Bonefro [Giannini et al., 2002]

Severe damage to a set of RC buildings was reported in Bonefro (Figure 4.12) [Giannini et al., 2002]. The building also presents an irregular configuration in plan with a partially-open ground-storey. Furthermore, there are two aspects to underline, namely: the long and thin infill panels (double wall fully disconnected) which can buckle prematurely, and the poor reinforcement and detailing of the RC columns (see Figure 4.12b). This structure represents a typical RC building of the 60's.

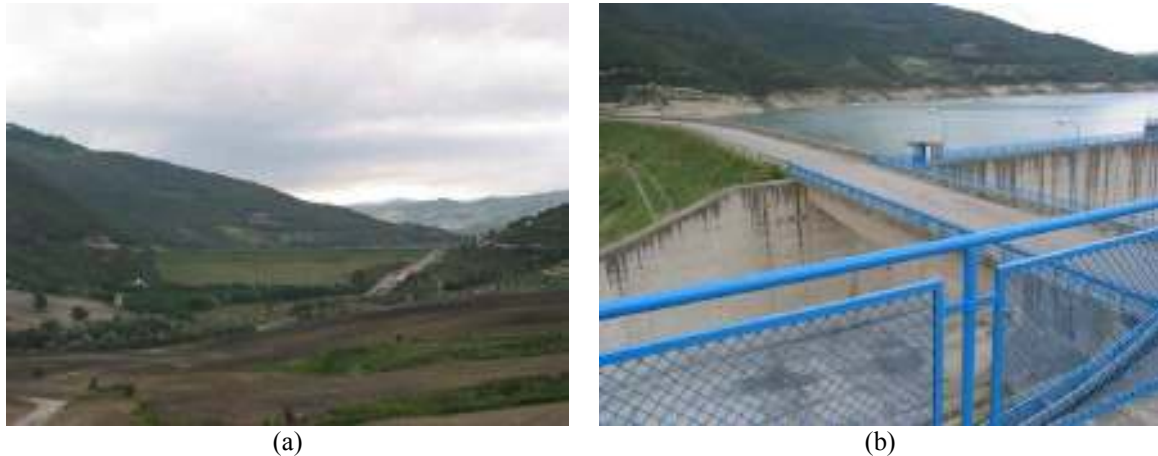
Figure 5.1 The Occhito dam: (a) bird's-eye view and concrete body of the dam (b) [SSN, 2002]

The most important dam in the area is the Occhito dam, located at less than 30 km from the epicentral area. The RC body of the dam did not suffer any damage, nor any landslides were evident on the side slopes of the reservoir (Figure 5.1). No interruption of the activity of the dam was reported and the field inspections did not reveal any important damage [SSN, 2002].
