NESC -1 Inspection Task Group Final Report

**PART I:
Analysis Of The Inspection Results
From The Pre- and Posttest Round Robin Trials
EUR 19653/I EN**

Network for Evaluating Structural Components

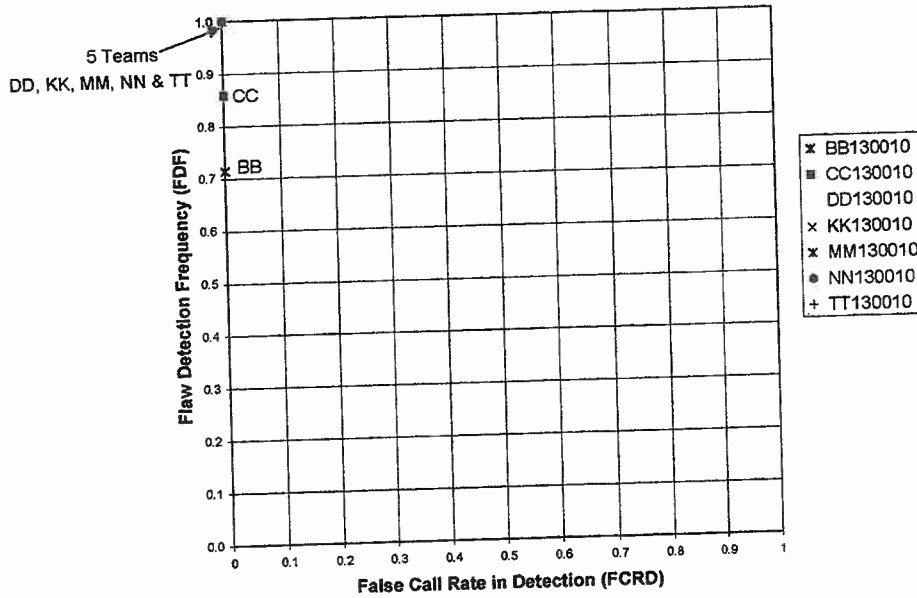
Detection rate is plotted versus false call rate for the pre-test inspections in Figure and for the post-test inspections in . In this type of presentation the y-axis relates to the safety of an inspection and the x-axis relates to the potential cost of unnecessary repairs. In the figures, optimum performance is located in the upper left corner of the figures (FDF > 0.8 and FCRD < 0.2). From Figure and it is clear that for 5 of the 7 pre-test inspection teams and 9 of the 12 of the post-test teams performance is excellent, i.e., all defects detected and no false calls. All of these teams used ultrasonic techniques. The performances of the teams using Eddy Current techniques were not as good.

Figure 9 Detection Frequency (safety) versus False Call Rate in Detection (economical aspects) for the pre-test inspection teams

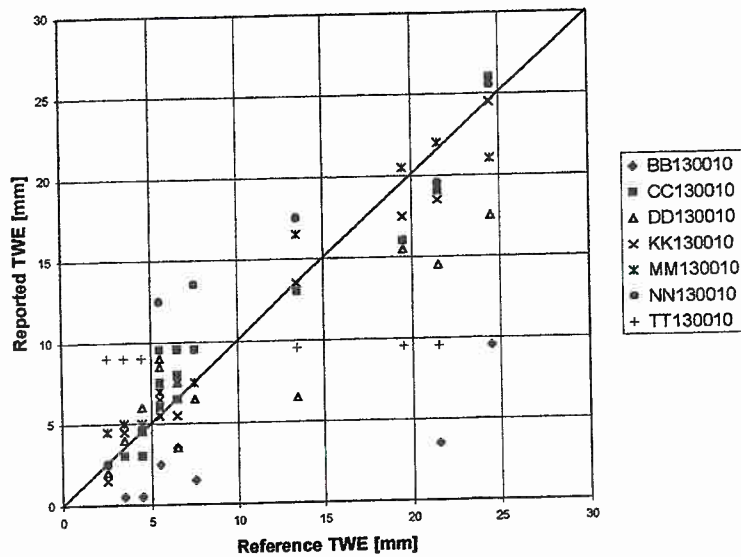
The sizing performance for defects sized between 0 and 30 mm is given in Figure 1 and this shows that sizing accuracy was good for some teams but that others teams significantly undersized this range of defects. For defects below 10 mm, there was a significant range of both under- and oversizing.

Figure 12 Measured TWE versus reference TWE for all defects with a TWE below 30 mm in pre-test inspections

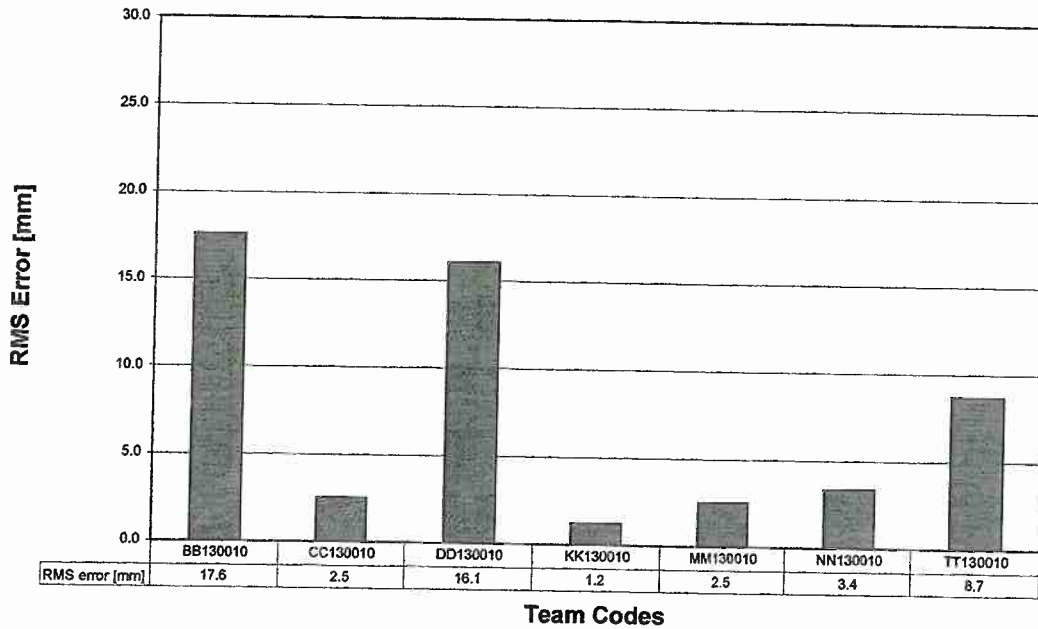
The RMS error for the pre-test teams on all defects is plotted in Figure . This analysis shows the same behaviour as that observed for standard deviation. When similar analysis is limited to defect sizes less than 30 mm, Figure , the changes are similar to those noted above for standard deviation, in that results for the four good teams remain virtually unchanged (also unchanged for team TT), but the RMS for team BB and DD noticeably improves, particularly that of team DD.

Figure 15 RMS error in TWE sizing for all pre-test inspections

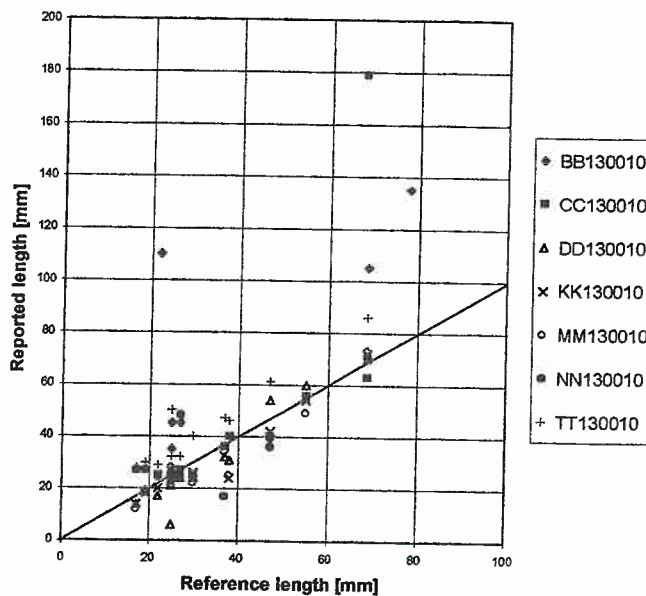
In Figure 28 it can be seen that 2 teams (BB, NN) oversized considerably a number of defects. These defects are in general the grouped indications of real sub-clad cracking. Team DD undersized 1 of the smaller defects (defect D) significantly.

Figure 28 Measured length versus reference length for all defects with a length below 80 mm in pre-test inspections

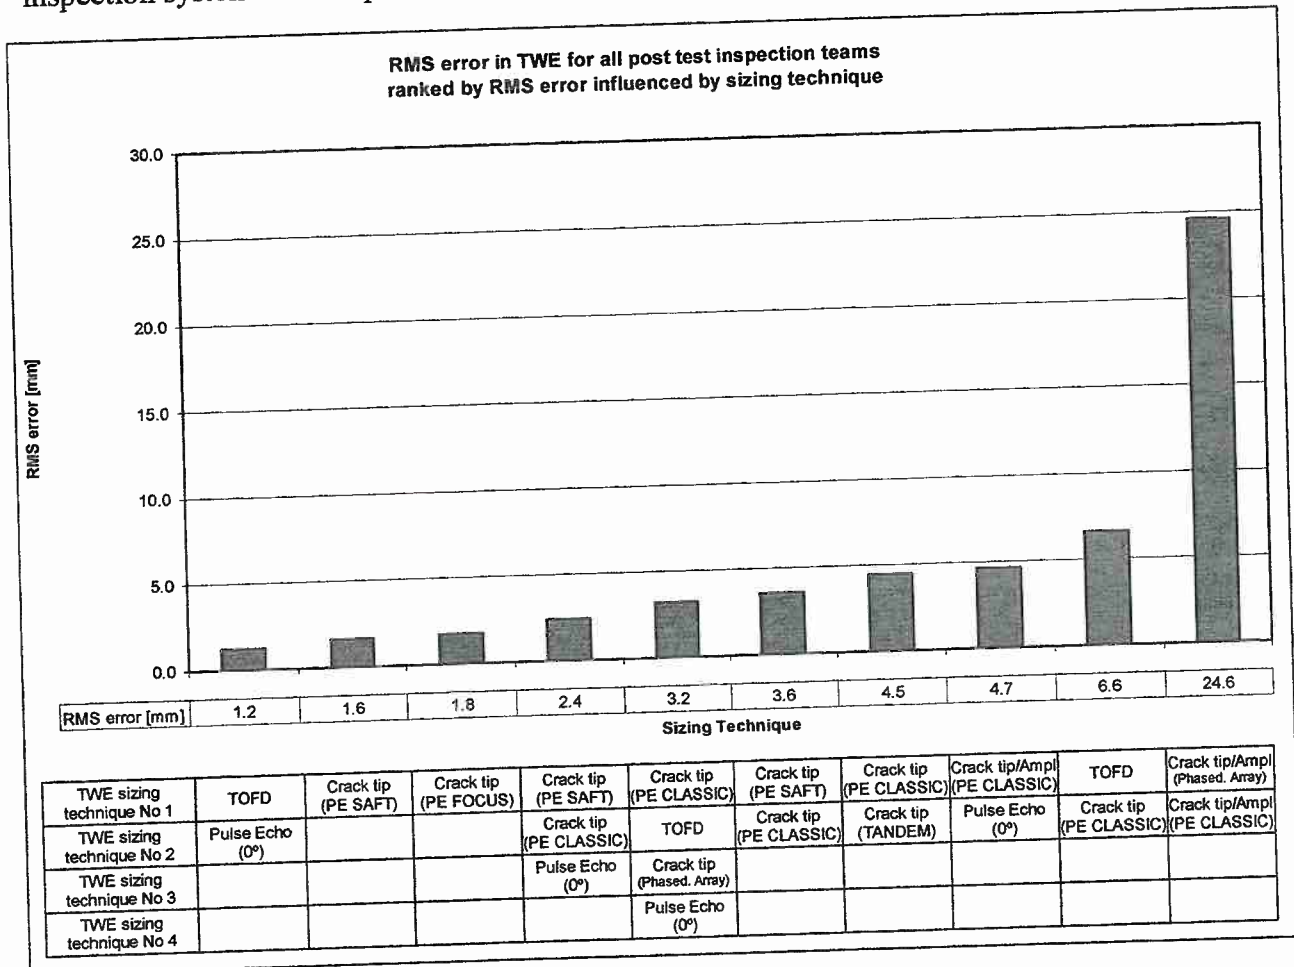
Figure 48 RMS error for the post-test inspection teams classified according to the type of TWE sizing technique used

In Figure 48 the RMS error is plotted for the different inspection teams which are classified according to the type of TWE sizing technique used:

The four teams, which performed best in TWE sizing, with an RMS error of 2.4 mm or less, all utilised the tip-diffracted wave from the crack tip to size the defects, however they used different techniques to obtain the crack tip signal. The techniques used are listed below.
