JRC SCIENTIFIC AND POLICY REPORTS

Corrosion-Related Accidents in Petroleum Refineries

Lessons learned from accidents in EU and OECD countries

EUR 26331 EN

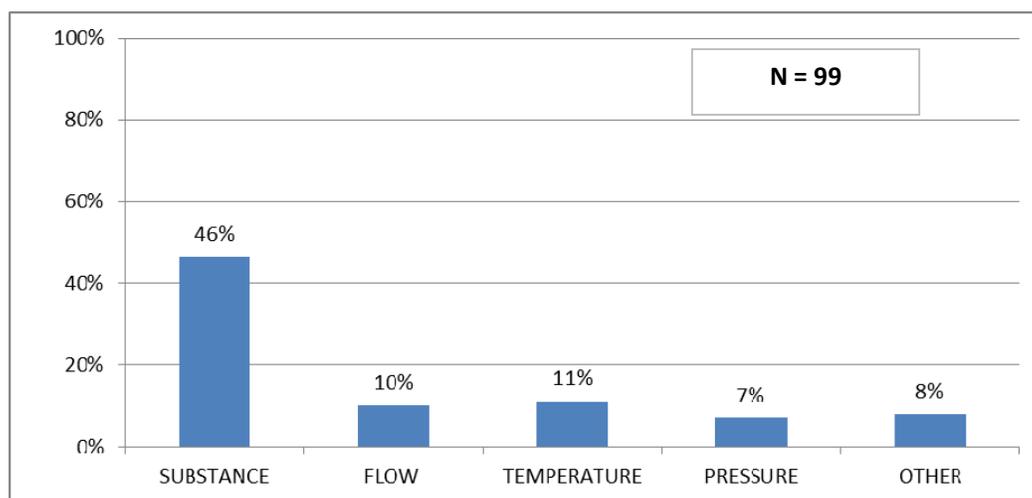
FIGURE 10. PROCESS CONDITIONS CITED AS CONTRIBUTING TO CORROSIVE CONDITIONS ACCIDENTS STUDIED (53 CASES IN TOTAL)

In 53 cases process conditions were identified as contributing to the corrosive conditions preceding the accident. The most commonly cited contributor was the substance (46). Flow (either high, low, turbulent or unequal) was cited in ten cases, and temperature (mostly high, but in a few cases, low) and pressure (mostly high) were cited as contributors in 11 and 7 cases respectively. In eight cases other exacerbating process conditions were present, including operation outside design parameters and variation across process cycles.

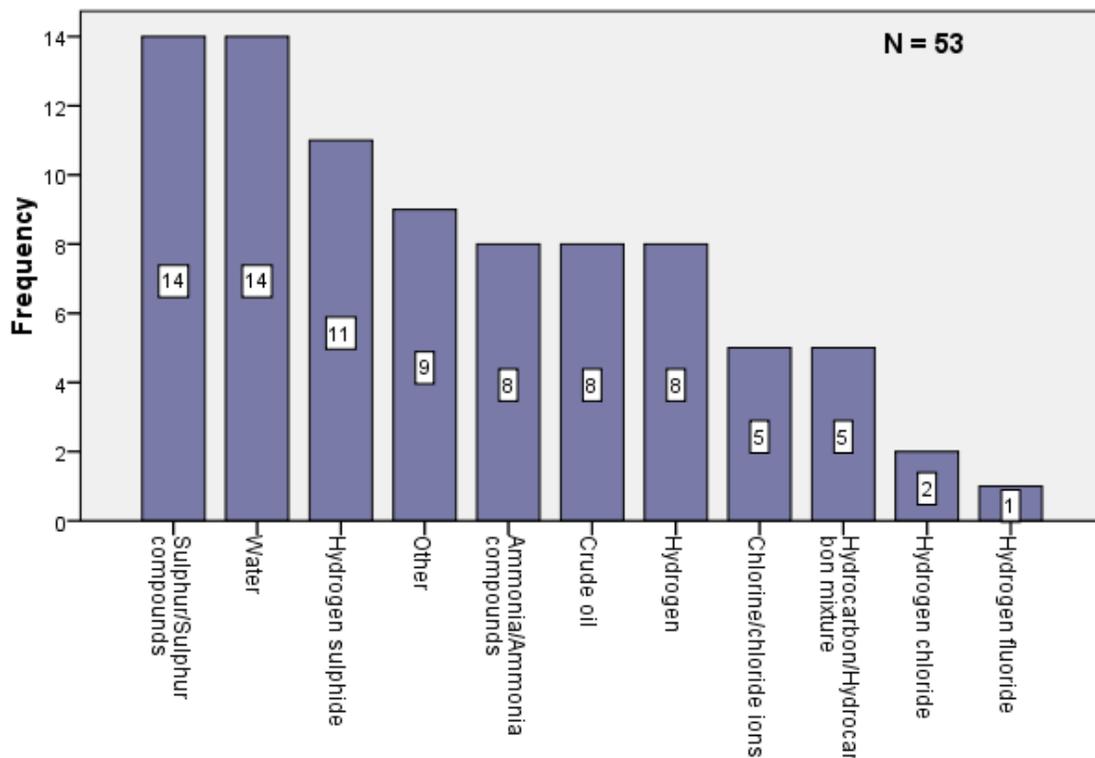
FIGURE 11. PROCESS-RELATED SUBSTANCES CITED AS CONTRIBUTING TO CORROSION FAILURES¹⁷

Ammonia and ammonia compounds, chlorine and chloride ions, and hydrogen were each cited in eight cases as a potentially dominant corrosive agent influencing the equipment failure, mainly in the distillation and storage units. Hydrogen chloride was reported as the corrosive agent in two of the accidents studied. Only one accident studied identified hydrofluoric acid as a contributing factor. Many refineries do not use hydrogen fluoride for alkylation and hence, this risk is not necessarily present in all refineries. Other process-related substances cited in the accidents included recycled content, phosphoric acid and nitrogen and nitrogen compounds.

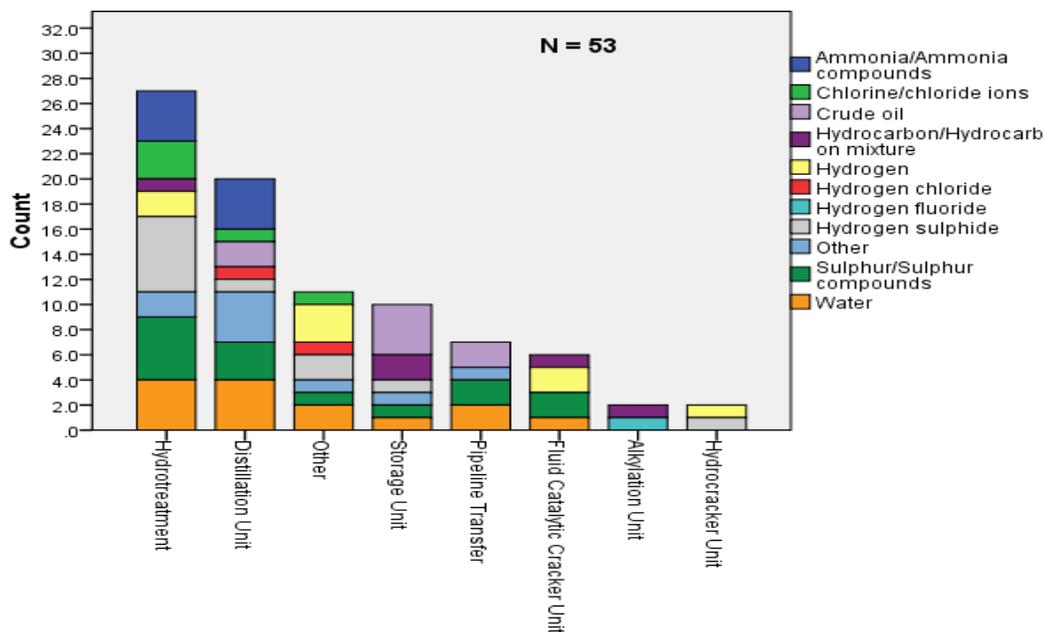
FIGURE 12. PROCESS SUBSTANCES CONTRIBUTING TO CORROSION FAILURE IN ASSOCIATION WITH THE PROCESS UNIT OF ORIGIN¹⁸

Figure 12 above shows which process units were identified as the origin of the accident in association with process substances indicated as contributing to the corrosion failure. Although some substances are cited slightly more frequently than other, the frequency is not high enough in any one unit to indicate dominance of a particular substance. Rather, this figure illustrates the wide diversity of substances throughout refinery production that can accelerate corrosion rates.

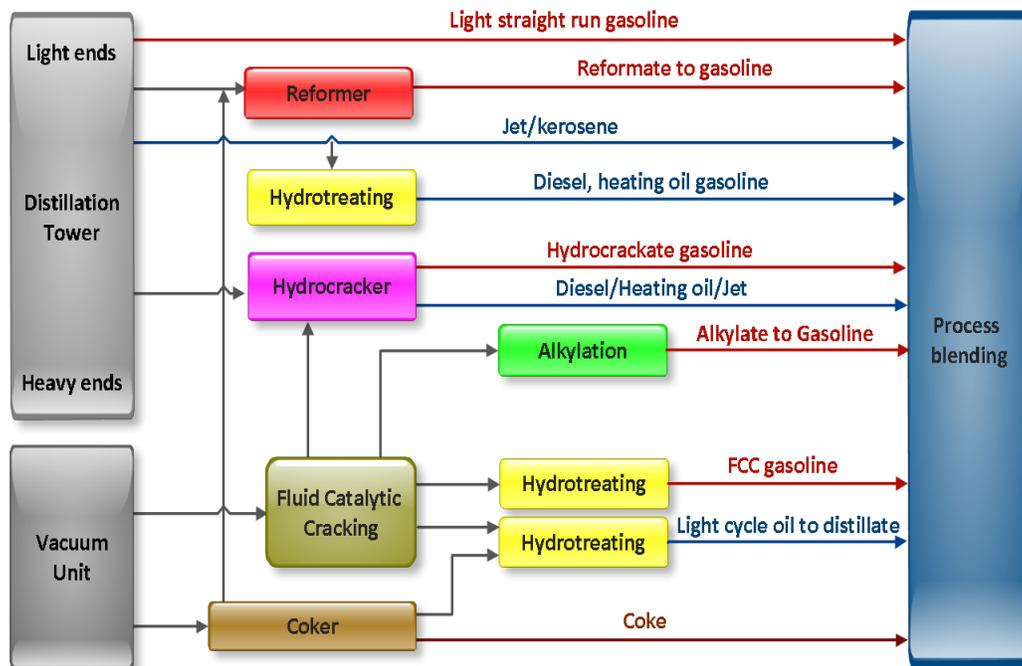
FIGURE 14. SIMPLIFIED DIAGRAM OF A REFINERY PROCESS
(SOURCE: U. S. DEPARTMENT OF ENERGY) [4]

Refining processes, such as distillation and thermal cracking, breakdown and manipulate the molecules in the crude oil feedstock to convert it into marketable products. Treatment processes remove impurities and byproducts from the feedstock and refining output. As much as possible these "unwanted" substances are either recycled into the refining or treatment process (e.g., hydrogen) or sold as products in their own right (e.g., sulphur). After desalting, the crude feedstock is fed into the distillation unit, the first main processing operation. The distillation process results in output of heavier and lighter fractions of petroleum product.

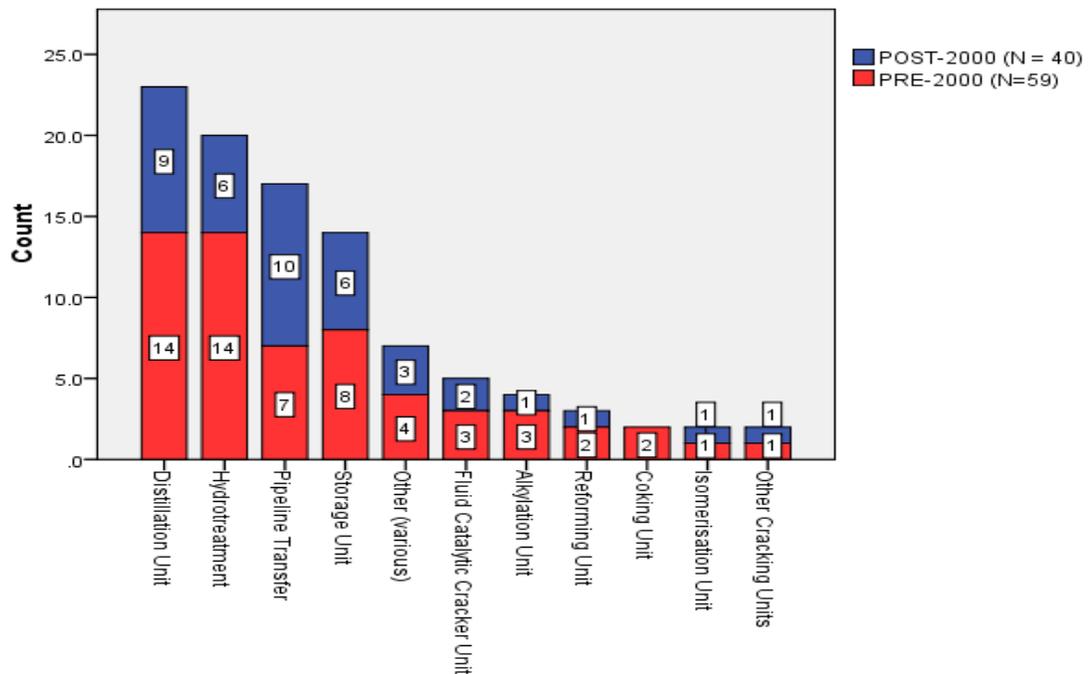
FIGURE 15. UNIT OF ACCIDENT BY ORIGIN OF CASES STUDIED

Figure 15 below shows the processes most often cited at the origin of the accident in the cases studied. It highlights typical units where important corrosion failures may occur. Out of 99 cases, the highest percentage (23%) started in the distillation unit, followed closely by hydrotreatment units (20%). In the cases studied there were substantially fewer cases involving such units after 2000 compared to prior years. Conversely, the number of cases involving the pipeline transfer network is proportionally somewhat higher after 2000. The “Other” category includes units for sulphur recovery, solvent extraction, saturated gas, olefin manufacturing and oil gasification. The study does not show any pattern linking specific units with accident consequences of a particular level of severity (see Figure 16 on the next page).

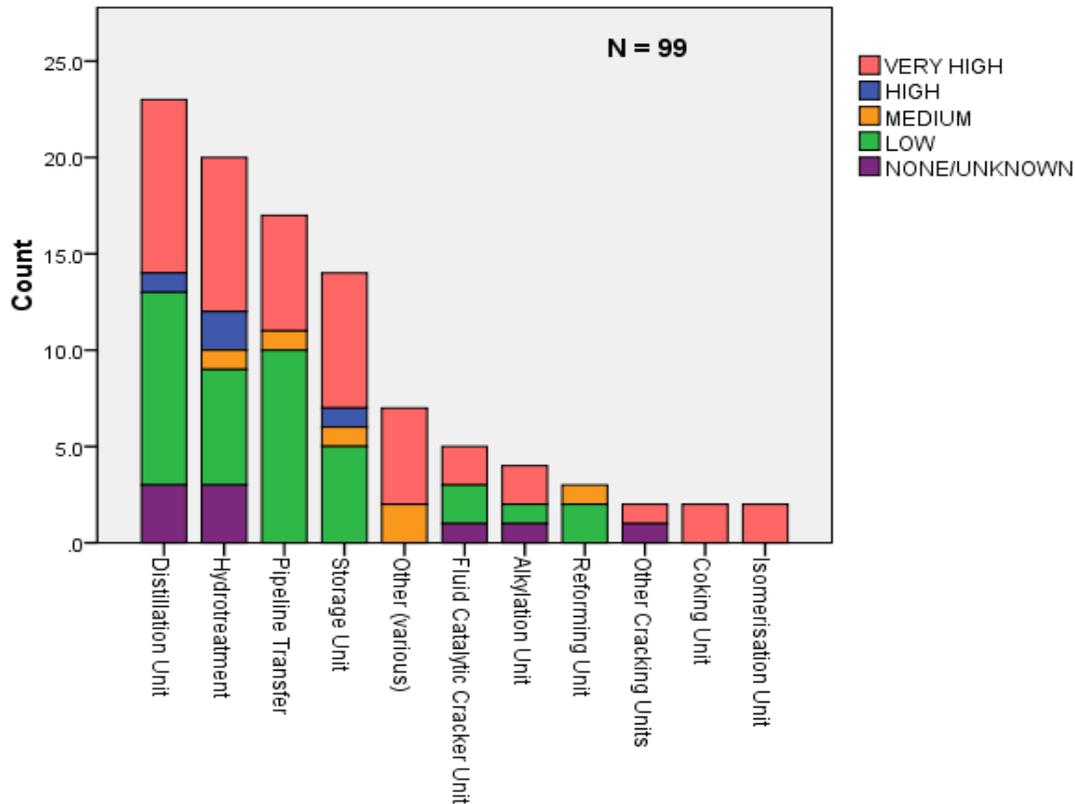
FIGURE 16. SEVERITY OF CONSEQUENCES ASSOCIATED WITH UNIT OF ORIGIN OF ACCIDENTS STUDIED

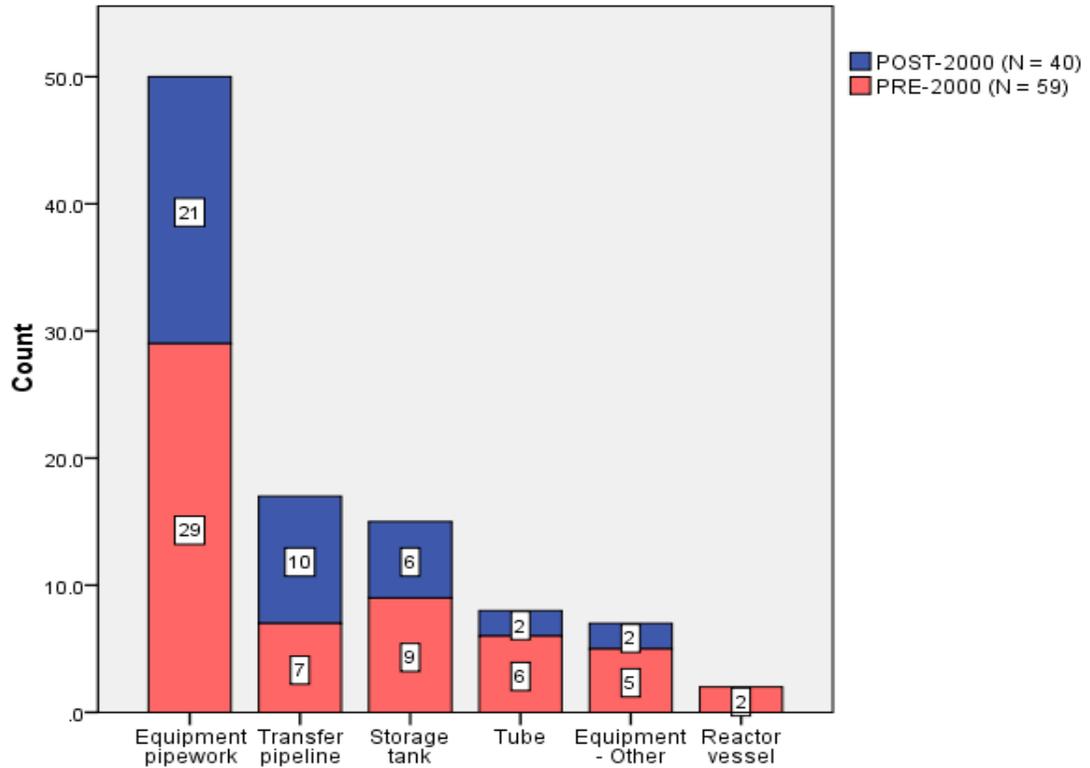
FIGURE 17. ACCIDENT ORIGIN BY EQUIPMENT COMPONENT

However, in any refinery, there will usually be points at which the pipework fails to meet the necessary design standards for a number of reasons. These reasons include age, process change, design change, risk assessment errors, and poor repair and maintenance. Notably, this list contains some of the most important technical challenges faced by refinery operators over the life time of a site and not surprisingly, these vulnerabilities are common causal factors for other mechanical integrity failures besides corrosion.

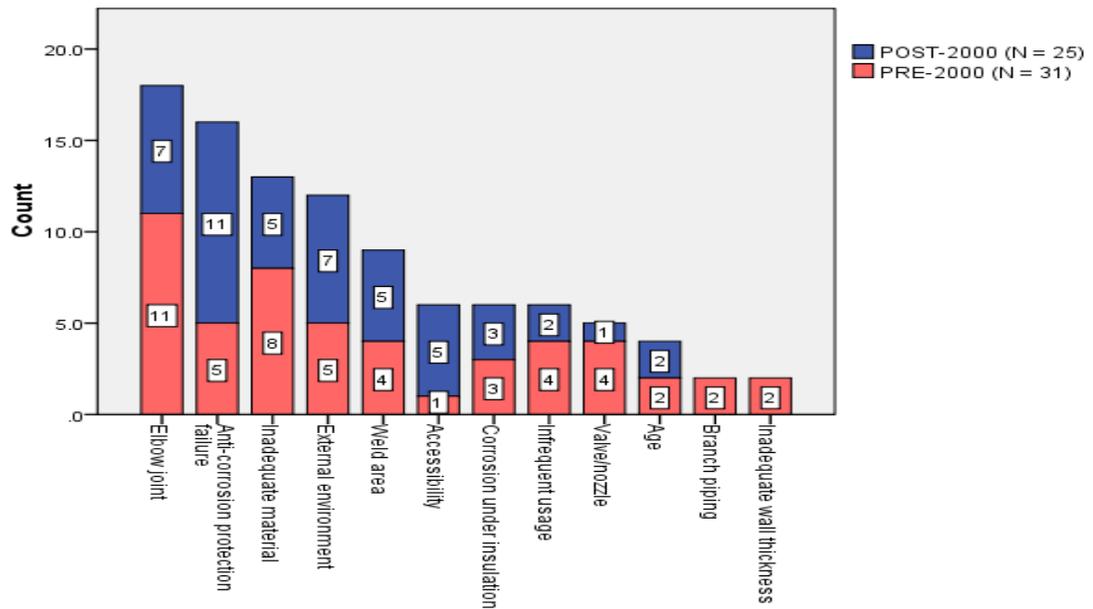
FIGURE 19. TYPES OF VULNERABILITIES SITED FOR PIPEWORK AND PIPELINES CONTRIBUTING TO CORROSION ACCELERATION OF EQUIPMENT INVOLVED²⁰

Most of these vulnerabilities were associated with corrosion failure in pipework but factors such as equipment configuration adequacy of anti-corrosion protection, and welded parts were also associated with other types of equipment as highlighted by various observations in the reports studied. (See Figure 20 on page 53.) Many of the factors cited are commonly referenced in the scientific literature as potentially contributing to acceleration of the corrosion rate under particular conditions. For more information on why these factors are more vulnerable to corrosion forces, there are numerous scientific references and articles in the literature on corrosion

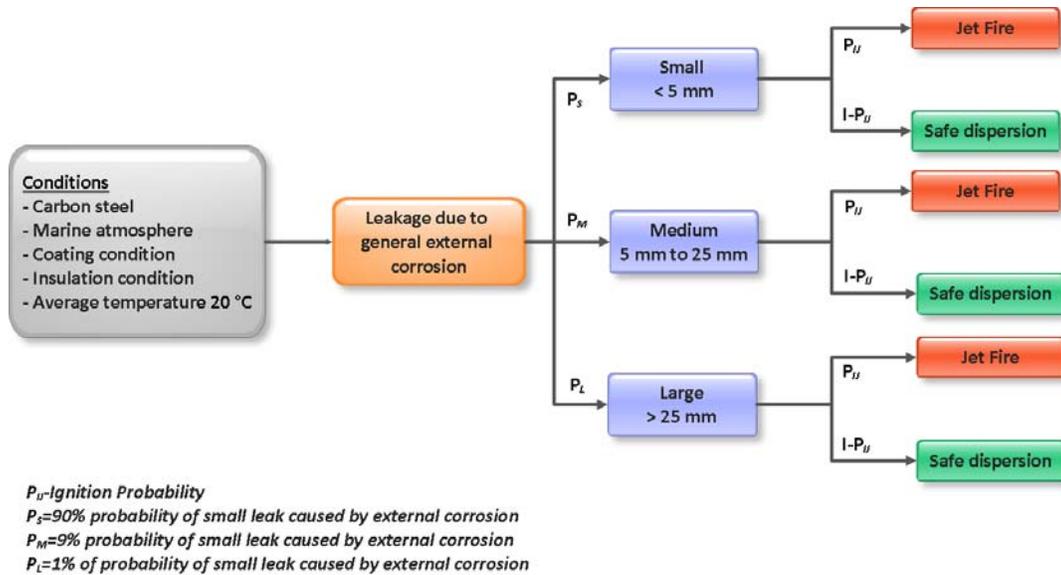
FIGURE 25. EXAMPLE OF CONSEQUENCE EVENT TREE - CARBON STEEL PIPE CONTAINING LPG EXPOSED TO EXTERNAL CORROSION

The outcome of the risk assessment then influences whether or not additional control measures are necessary as well as what kind and how many. A barrier analysis is sometimes another type of risk assessment used to evaluate the effectiveness of control measures selected, including detection and mitigation measures. Figure 26 and 27 on page 64 show the generic framework that could be used to assess barrier effectiveness measures for reducing risk associated with two typical potential failure scenarios one of which is corrosion.

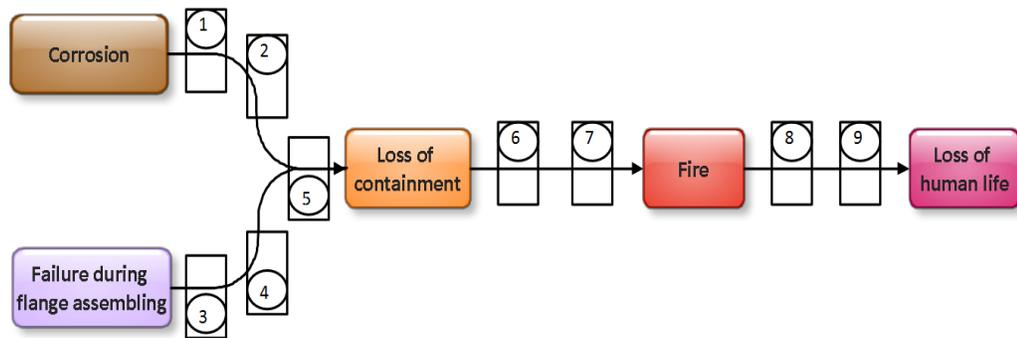
| 1. Condition monitoring to reveal corrosion | 6. Process shutdown to reduce size of release |

FIGURE 26. ILLUSTRATION OF BARRIERS INFLUENCING A PROCESS INCIDENT
 (SOURCE: S. SKLET) [38]

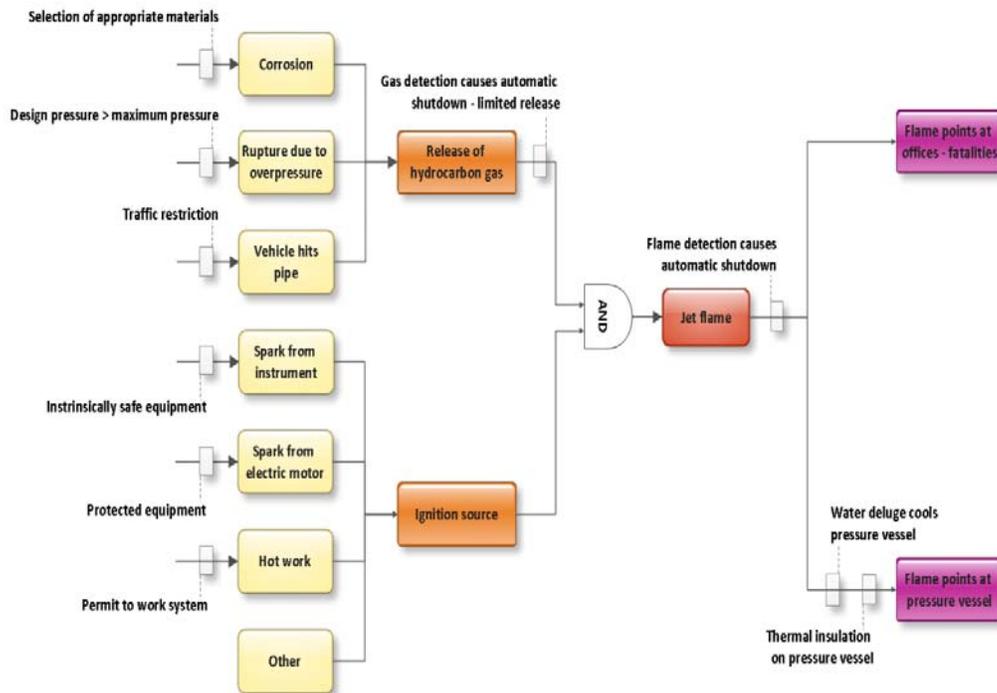
FIGURE 27. BASIC SAFETY BARRIER DIAGRAM
 (SOURCE: UK HEALTH AND SAFETY EXECUTIVE] [39]

Moreover, several other safety management components depend on the accuracy and completeness of the risk assessment, as will be discussed in other parts of this section. Figure 27 illustrates how a risk assessment focusing on corrosion hazards may influence other choices related to inspections, monitoring, detection, and emergency response.
